# CALIFORNIA PUBLIC UTILITIES COMMISSION

## Safety and Enforcement Division Electric Safety and Reliability Branch Incident Investigation Report

**Incident Number:** E20190531-02

**Utility:** Pacific Gas and Electric Company (PG&E)

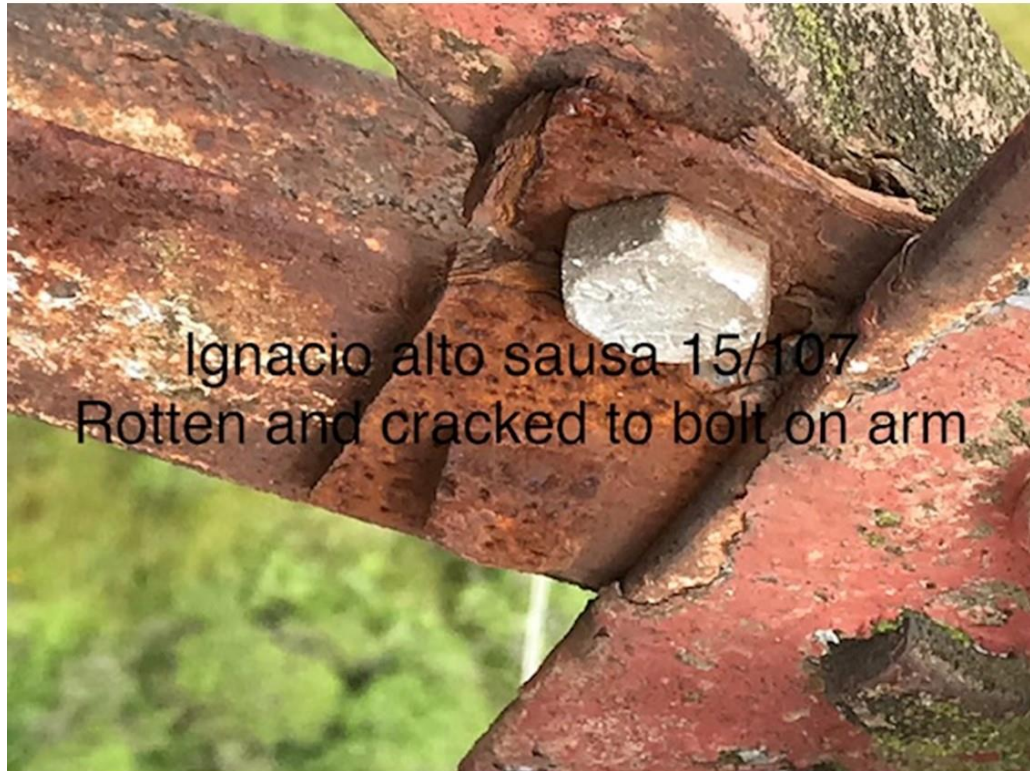
**Figure 2: Identified Deficiencies on Tower # 15/107**

On March 1, 2019, PG&E conducted a climbing inspection for Tower # 15/107 under its WSIP. As a result of the inspection, PG&E found that Tower #15/107 had a Priority Code A deficiency. Please see Figure 2 for the identified deficiency on Tower # 15/107:

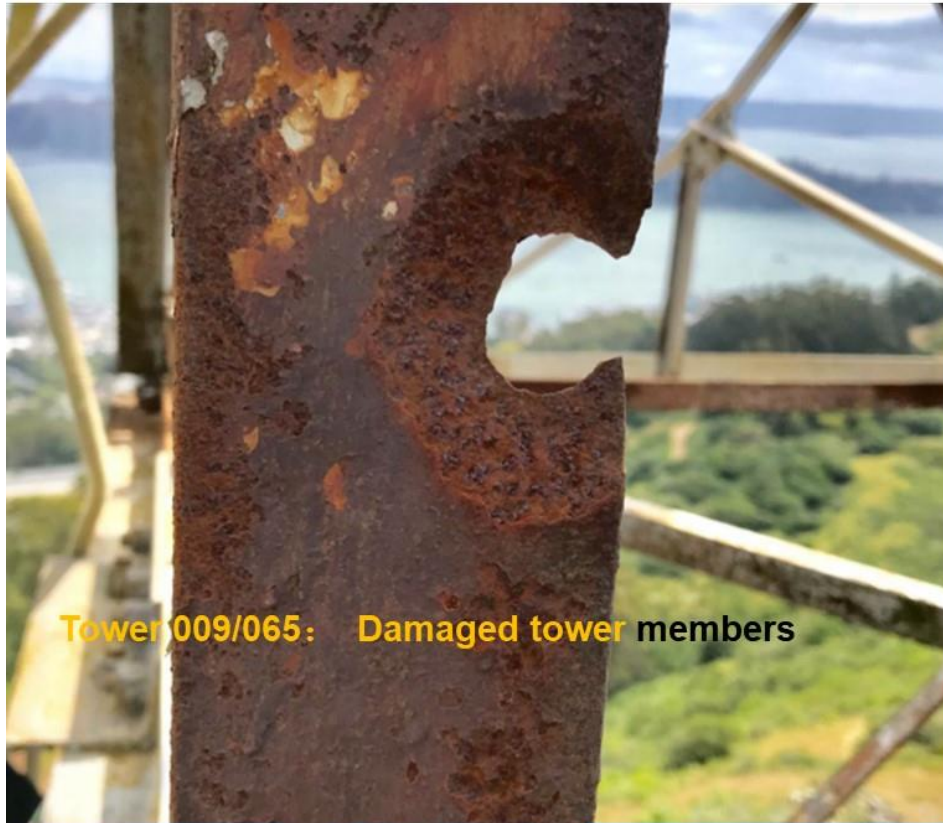
**Figure 3: Identified Deficiencies (1)**

**Tower 009/065: Damaged tower members**

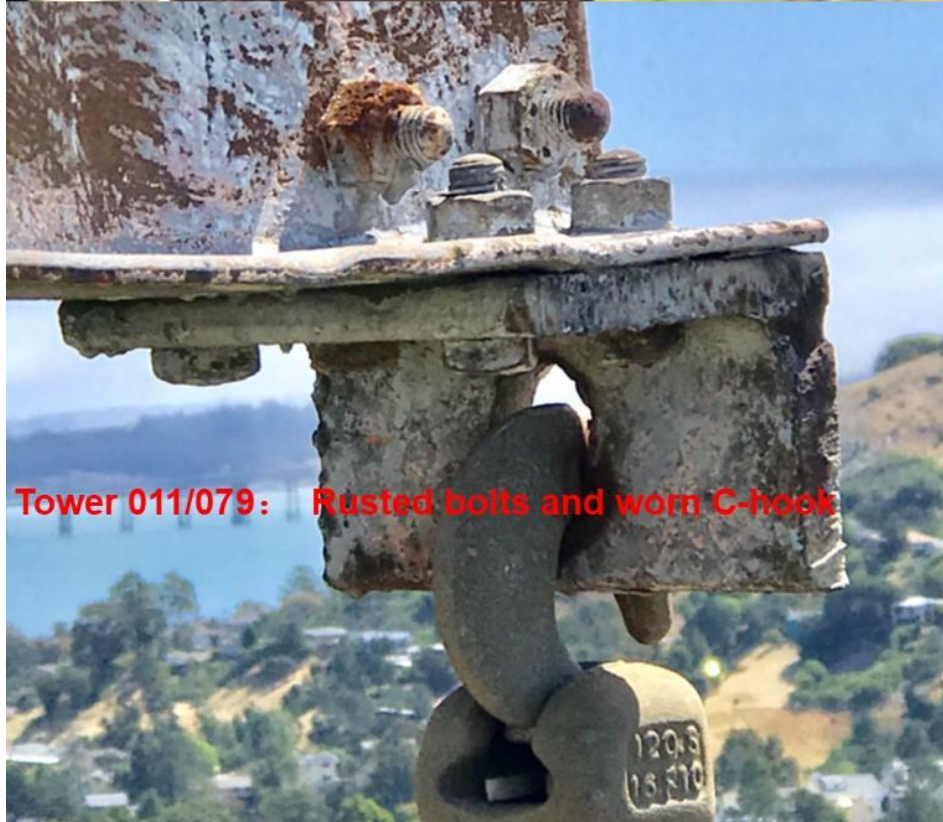
**Tower 011/079: Rusted bolts and worn C-hook**
