The Safety and Enforcement Division (SED) of the California Public Utilities Commission (Commission) submitted the attached Notice Of Probable Violations (NOPV) for non-Department of Transportation (DOT) reportable incident investigations completed as of the Second (2nd) Quarter of 2019.

Attached are San Diego Gas & Electric Company's (SDG&E's) written responses.

Attachment A
List of Incidents with Probable Violations

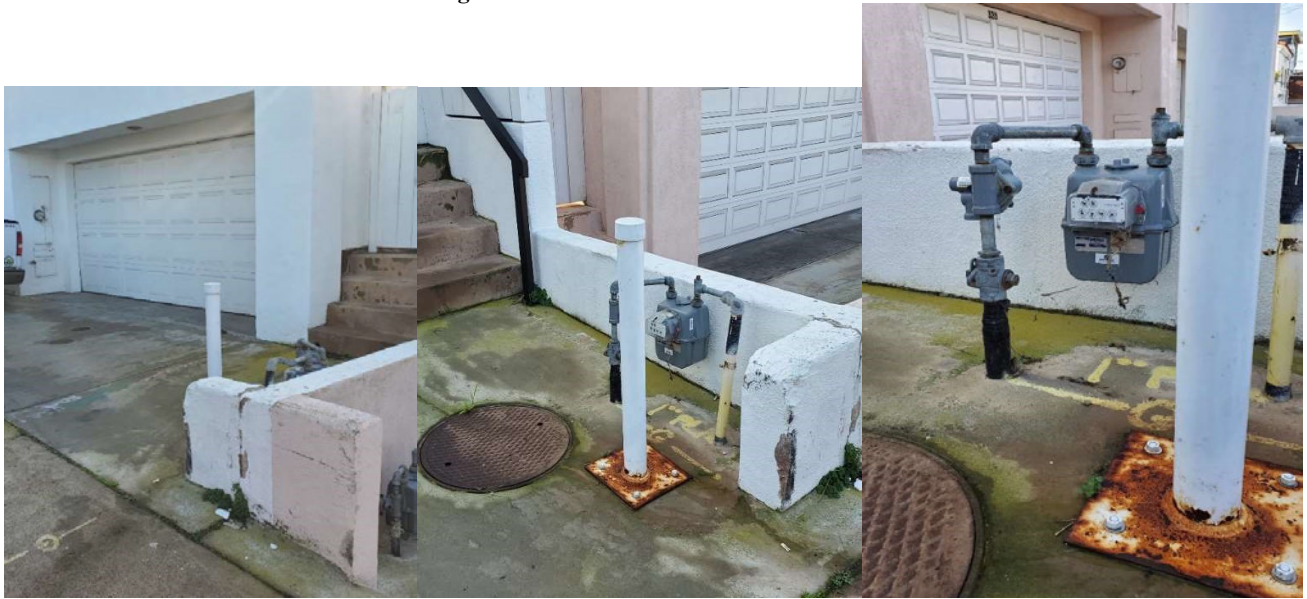
SDG&E disagrees with the SED assessment that the meter in question was unprotected or identifiable as an Abnormal Operating Condition (AOC). The meter in question is positioned with concrete block walls in close proximity on two sides and located at the base of a stairway leading to a residence (as shown in the photos provided below). Based on this positioning, the meter was considered protected.

Post Incident Installation of Meter Warning Device

SDG&E management will continue to emphasize the importance of the gas standard G8145, Leakage Surveys, Section 4.12.1, “Issue Follow up orders to investigate and correct any AOC’s encountered,” focusing particularly on Section 4.12.1.10 - “When MSA protection (barricades or barriers) are required per gas standard D7115, Barricades for Gas Meter Sets.” In addition, the gas standard D7115 will be updated to provide clarification on when to identify an exposure to vehicular traffic. An information bulletin will be circulated to communicate and reinforce the importance of reporting AOCs while performing leakage surveys/atmospheric corrosion inspections, focusing on instances related to ensuring MSAs are protected as required, per gas standard D7115.
