EA2023-1147

SUBJECT: Electric Substation and Distribution Audit of TDPUD

**TRUCKEE DONNER PUBLIC UTILITIES DISTRICT (TDPUD)
ELECTRIC SUBSTATION & DISTRIBUTION AUDIT FINDINGS**

September 11-15, 2023

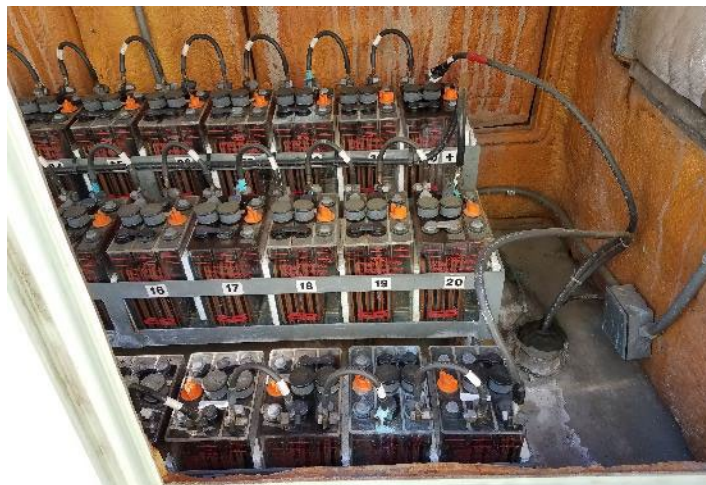
1.1. Multiple batteries have oxidation build up.

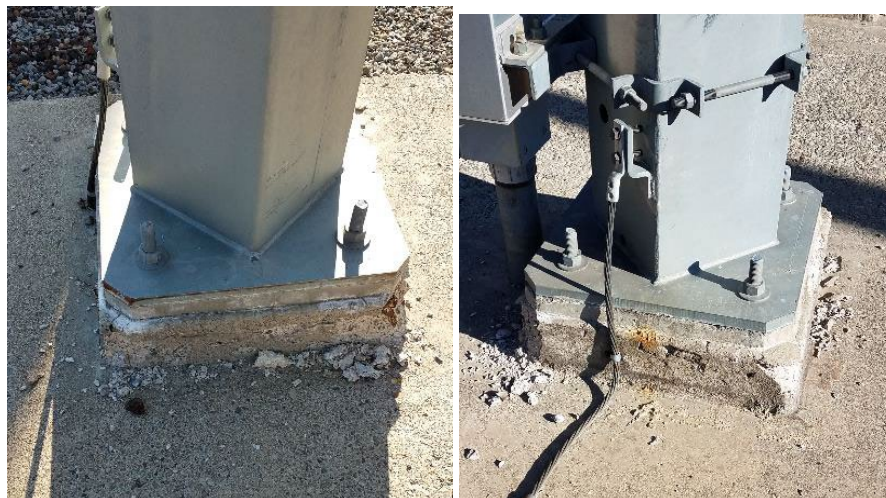
1.2. The concrete foundation at the 120 kV switch is spalling/crumbling.

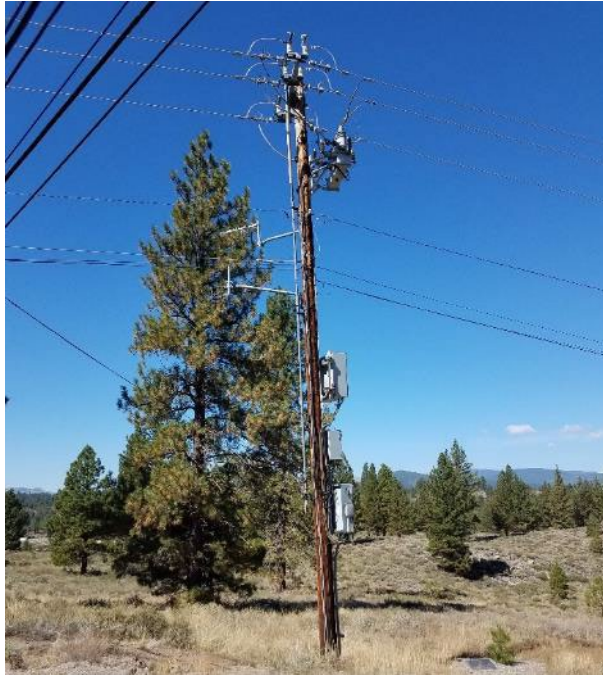
3. Glenshire Substation (pole substation)

The pole is missing a high voltage sign.
