PUBLIC UTILITIES COMMISSION

GA2022-09NCA

SUBJECT: Audit report of Carlsbad Energy Center

On behalf of Electric Safety and Reliability Branch (ESRB) of the California Public Utilities Commission (CPUC), Richard Le of my staff conducted a power plant audit of the Carlsbad Energy Center from July 11, 2022 to July 15, 2022.

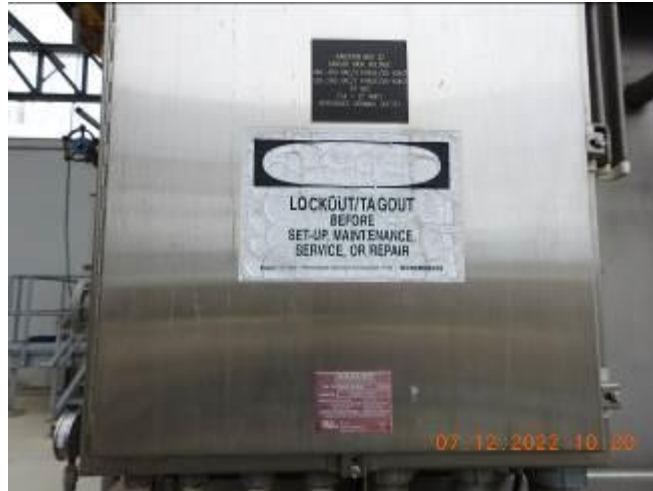
Finding No. 01: The Plant is not keeping pace with sign damage and deterioration.

ESRB staff observed faded danger signs of lock-out tag-out procedures. Damaged warning signs prevent plant staff and contractors from recognizing dangers while conducting work.

Faded danger sign on unit 9 near the turbine compartment

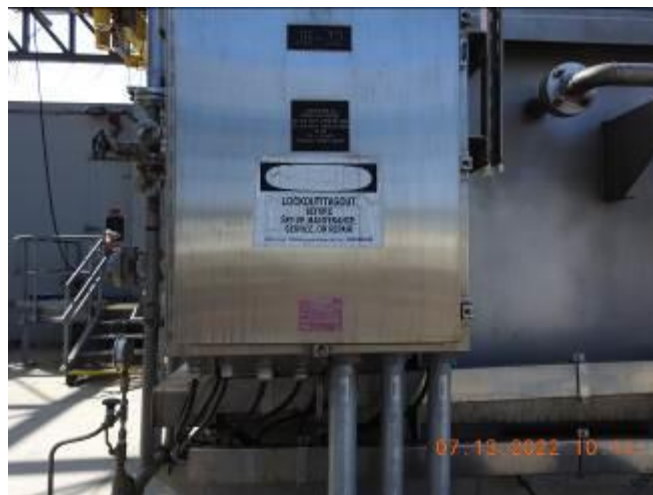
Faded danger sign on unit 7 near the turbine compartment

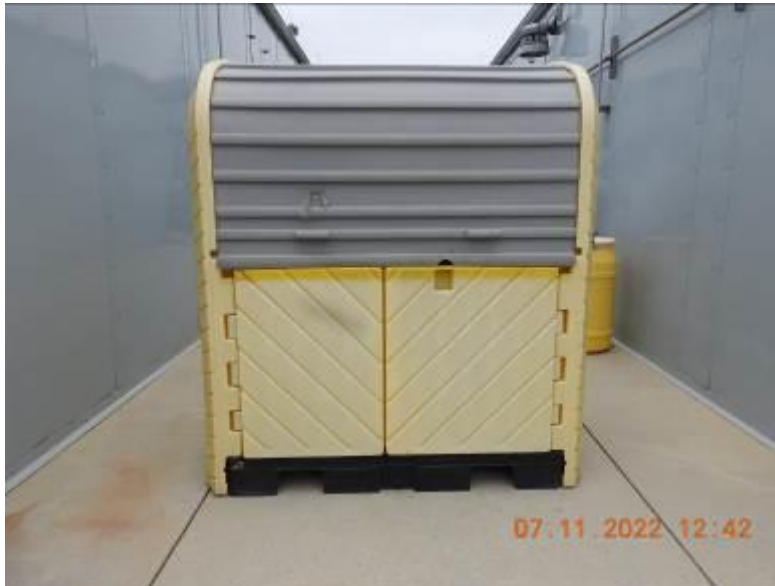
Finding 02: Missing NFPA (Fire diamond) sign on hazardous waste storage

ESRB staff found a hazardous waste storage for used oil in the fuel gas compressor area missing an NFPA sign (the fire diamond). The numbers in the diamond provide critical information related to hazards to plant staff, contractors, and emergency personnel.

Used oil storage without an NFPA sign (fire diamond)

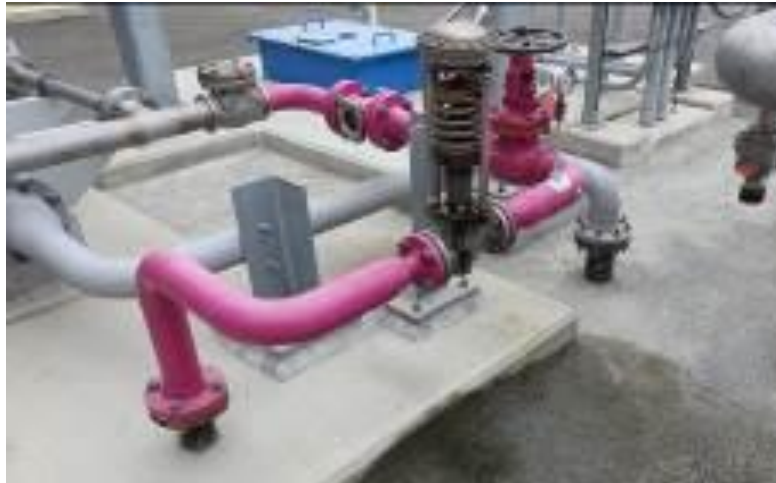
ESRB staff witnessed standing water and evidence of leaking water and oil from plant equipment. Leaks are an indication of either a lack of maintenance or damaged equipment, while standing water poses a tripping hazard.

Leak from a valve on the evaporative cooling piping for unit 10

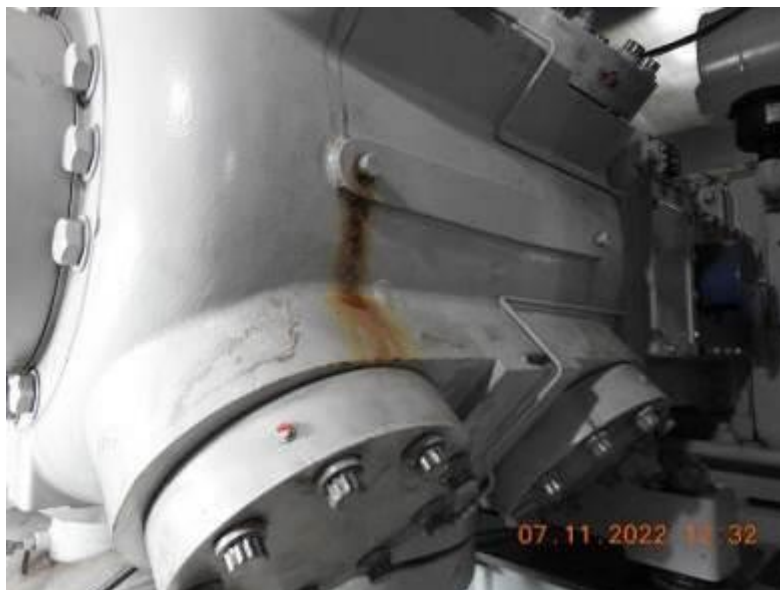
Evidence of a leak from a bolt on the gas compressor on Compressor A.

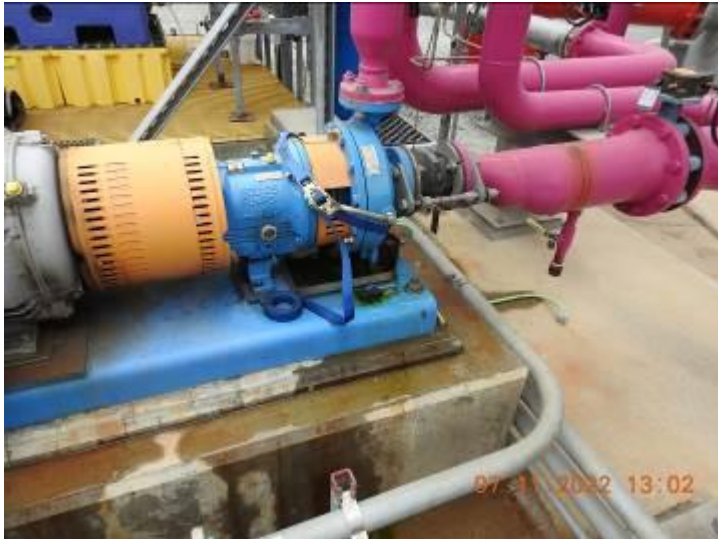
Leak from a reclaimed water pump near the reclaimed water tank.

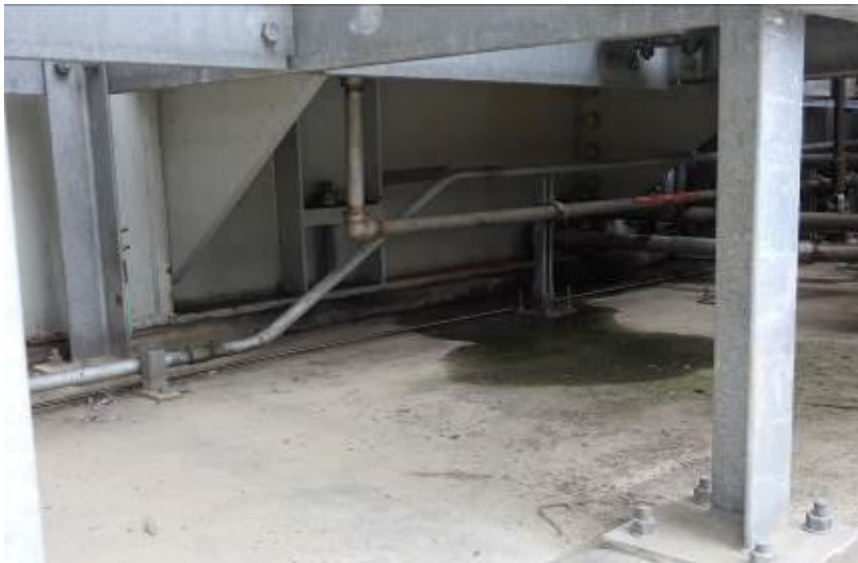
Evidence of a leak and standing water under the turbine compartment of unit 9.

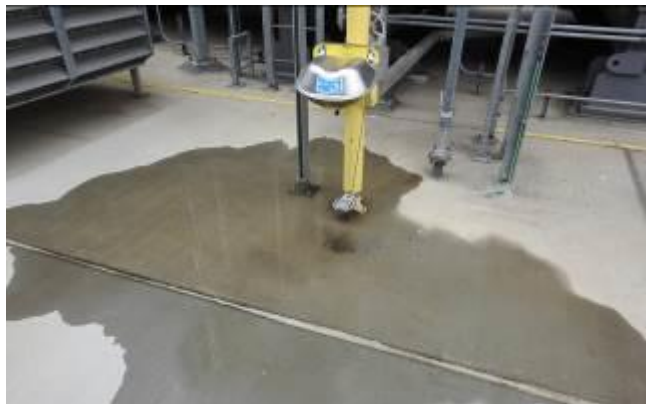
Leak from the shower station by unit 9 and standing water.

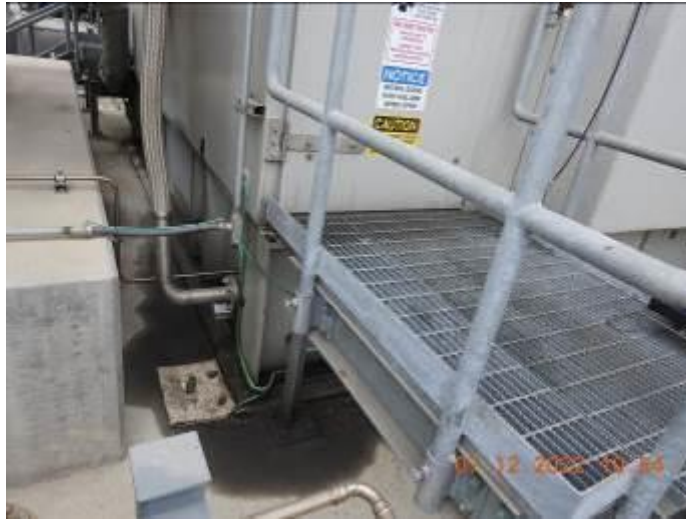
Evidence of a leak under the power turbine/generator compartment on unit 8.

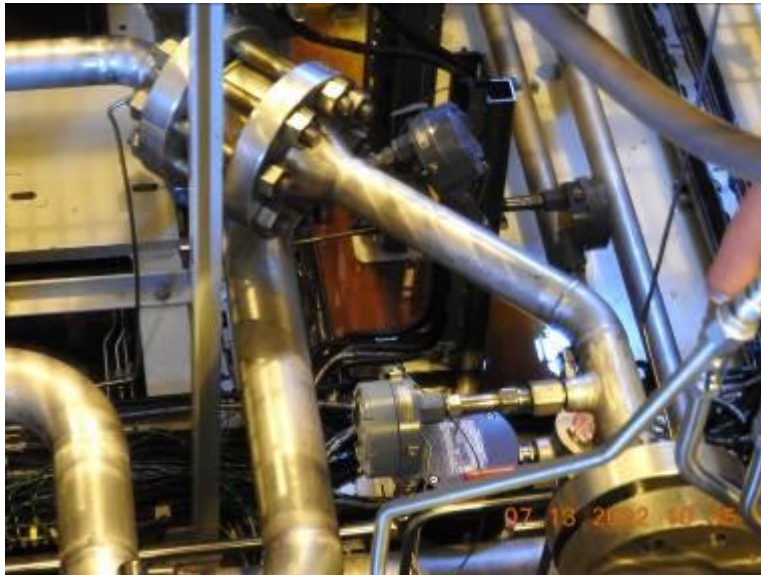
Standing water in the turbine compartment on unit 6
