SUBJECT: Generation Audit of Malaga Power Plant – Audit Number GA2023-07MLG

On behalf of Electric Safety and Reliability Branch (ESRB) of the California Public Utilities Commission (CPUC), Dmitriy Lysak of ESRB staff conducted a power plant audit of Malaga Power Plant from March 20, 2023, through March 24, 2023.

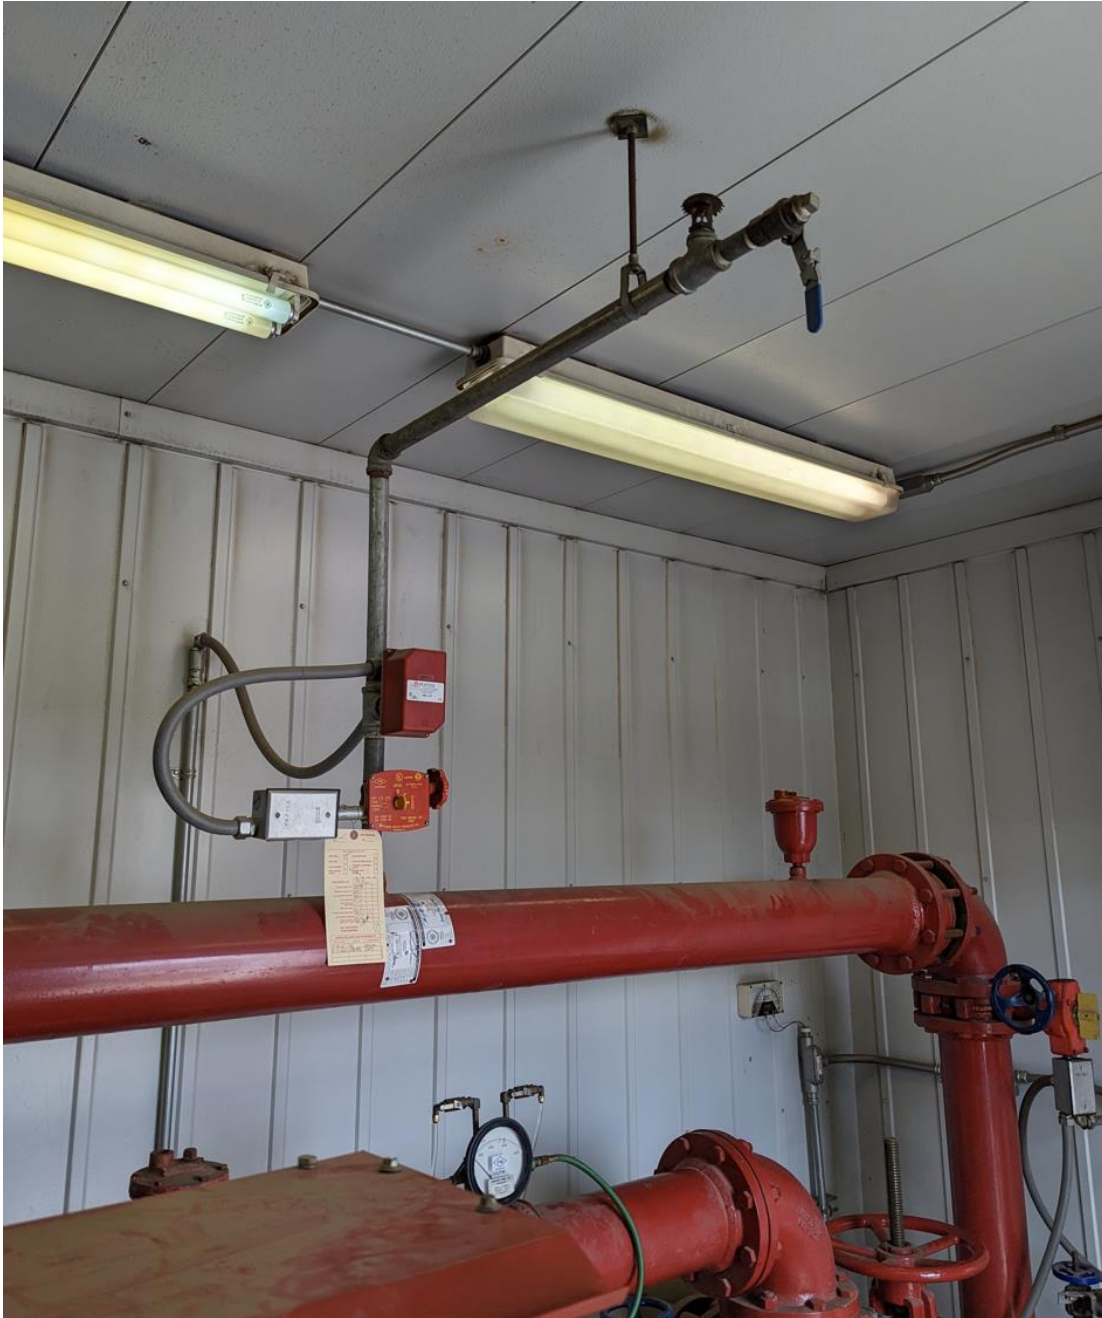
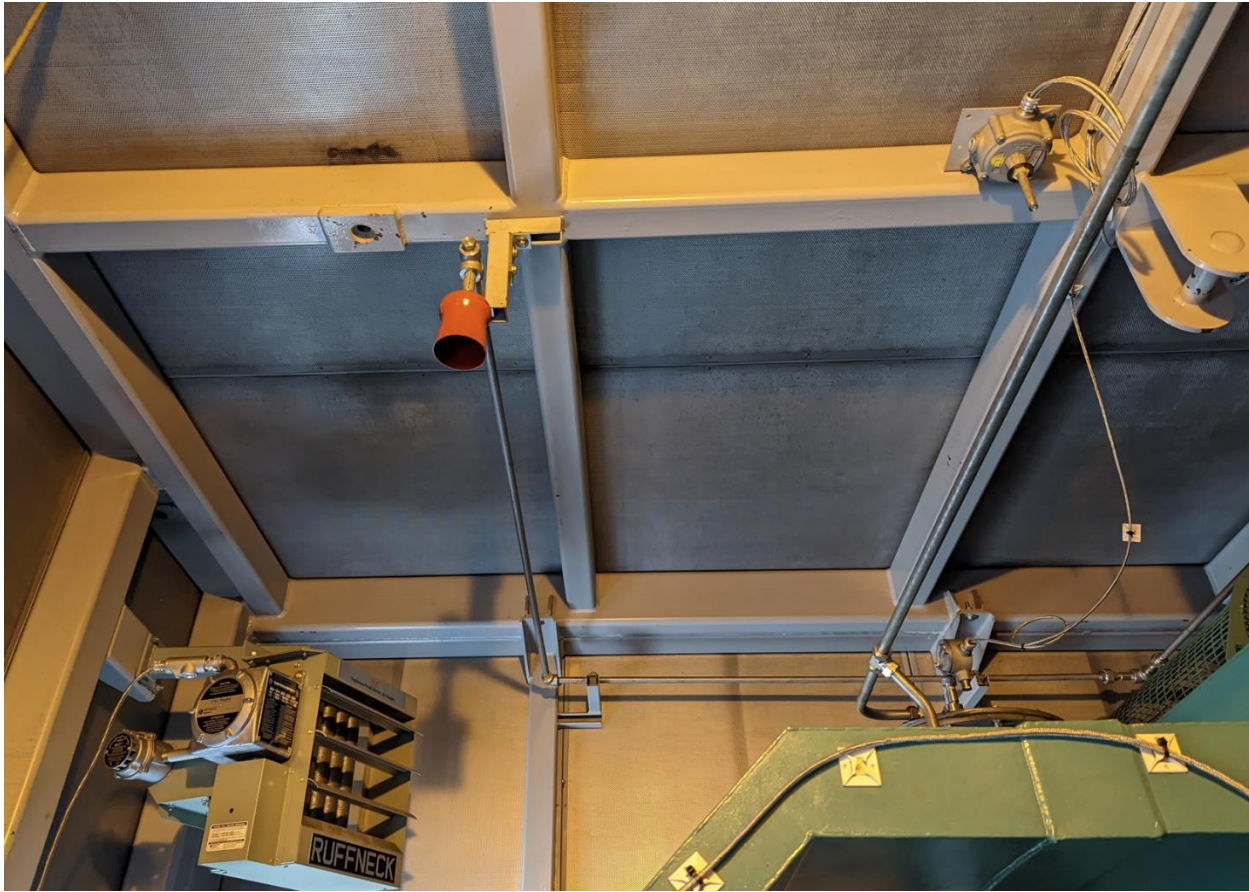
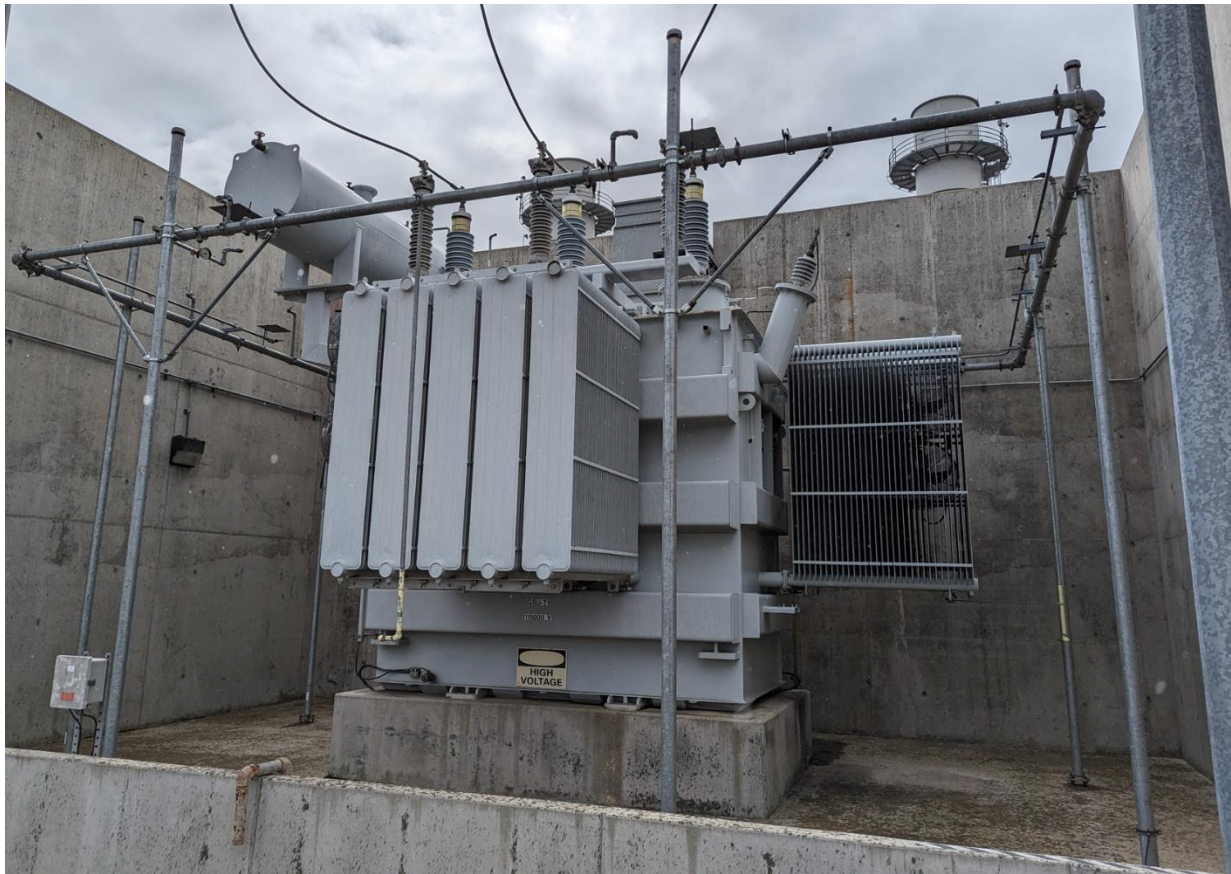
Finding 1: Fire Protection Equipment

ESRB staff observed various fire suppression equipment throughout the Plant not painted red.

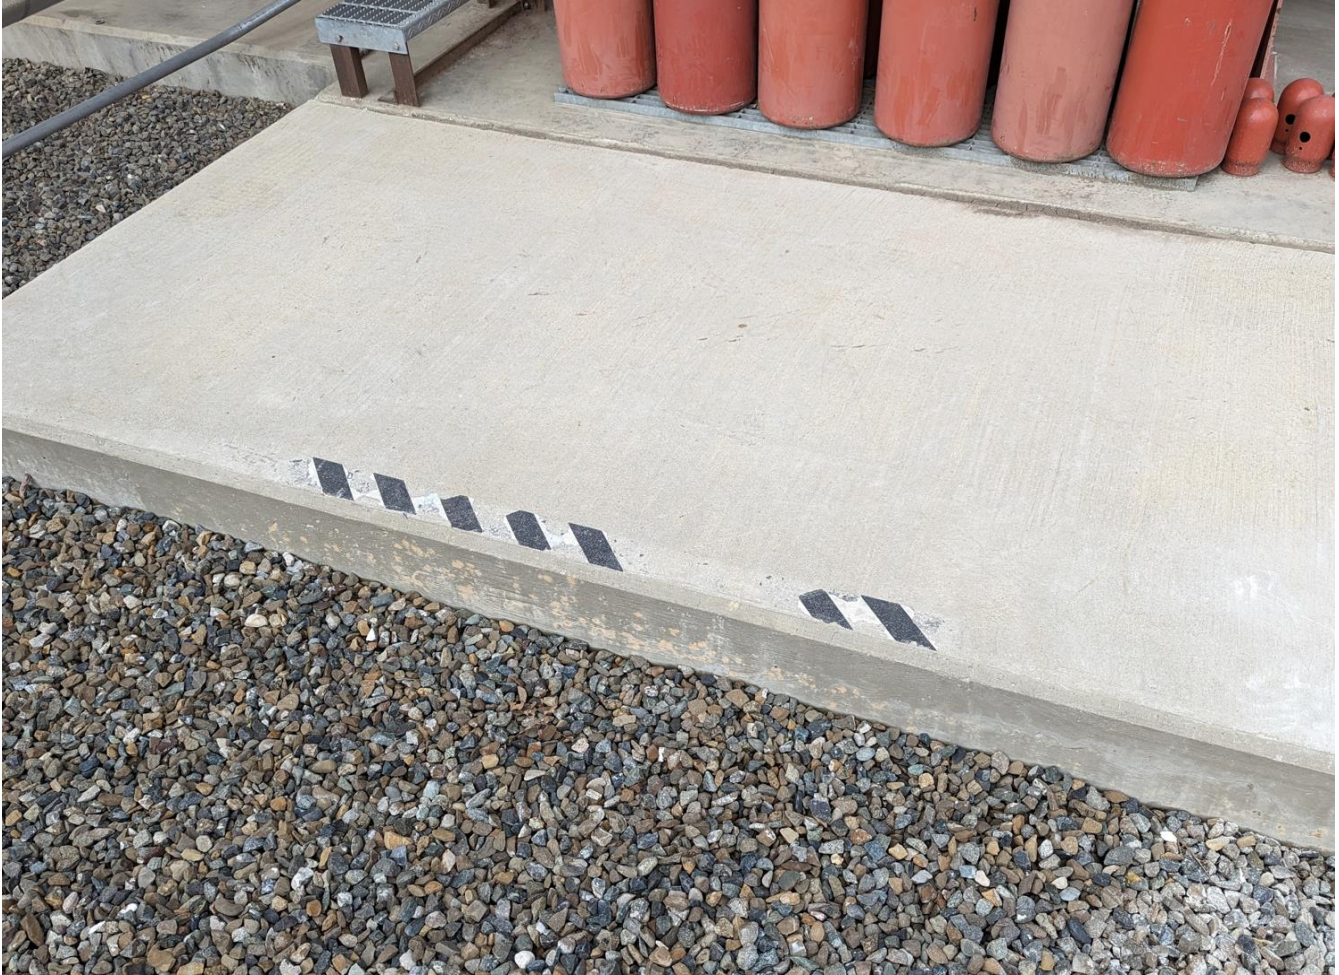
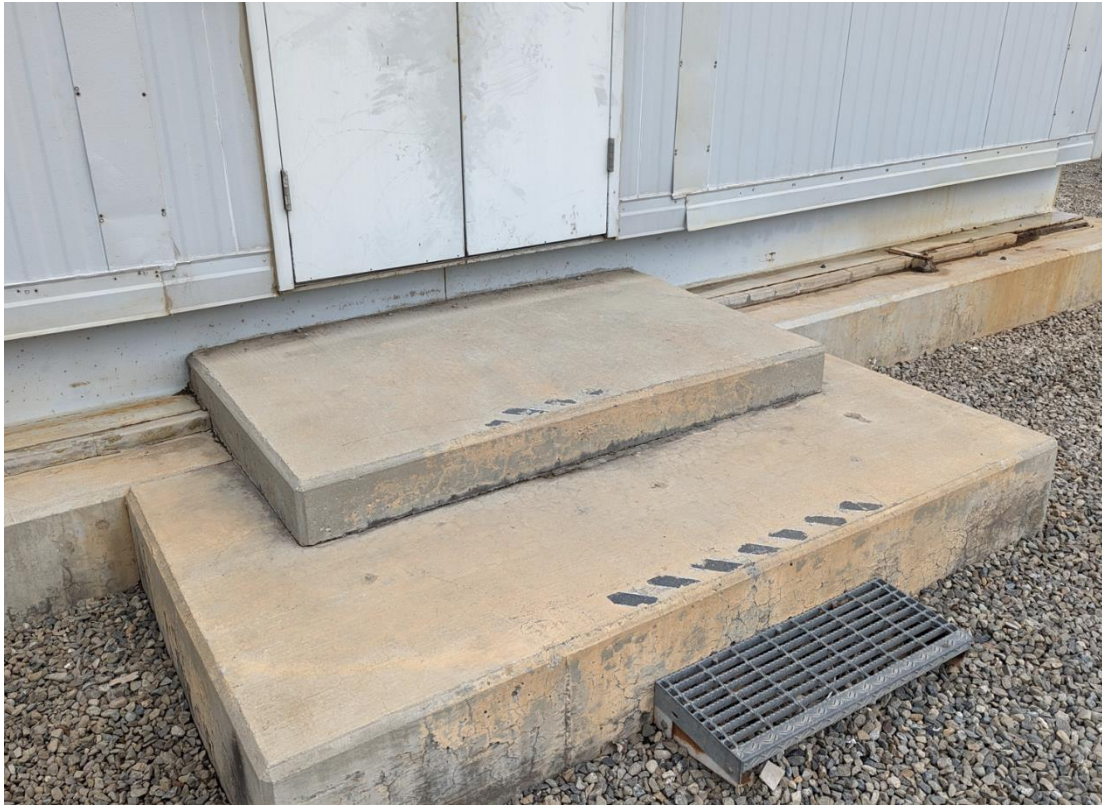
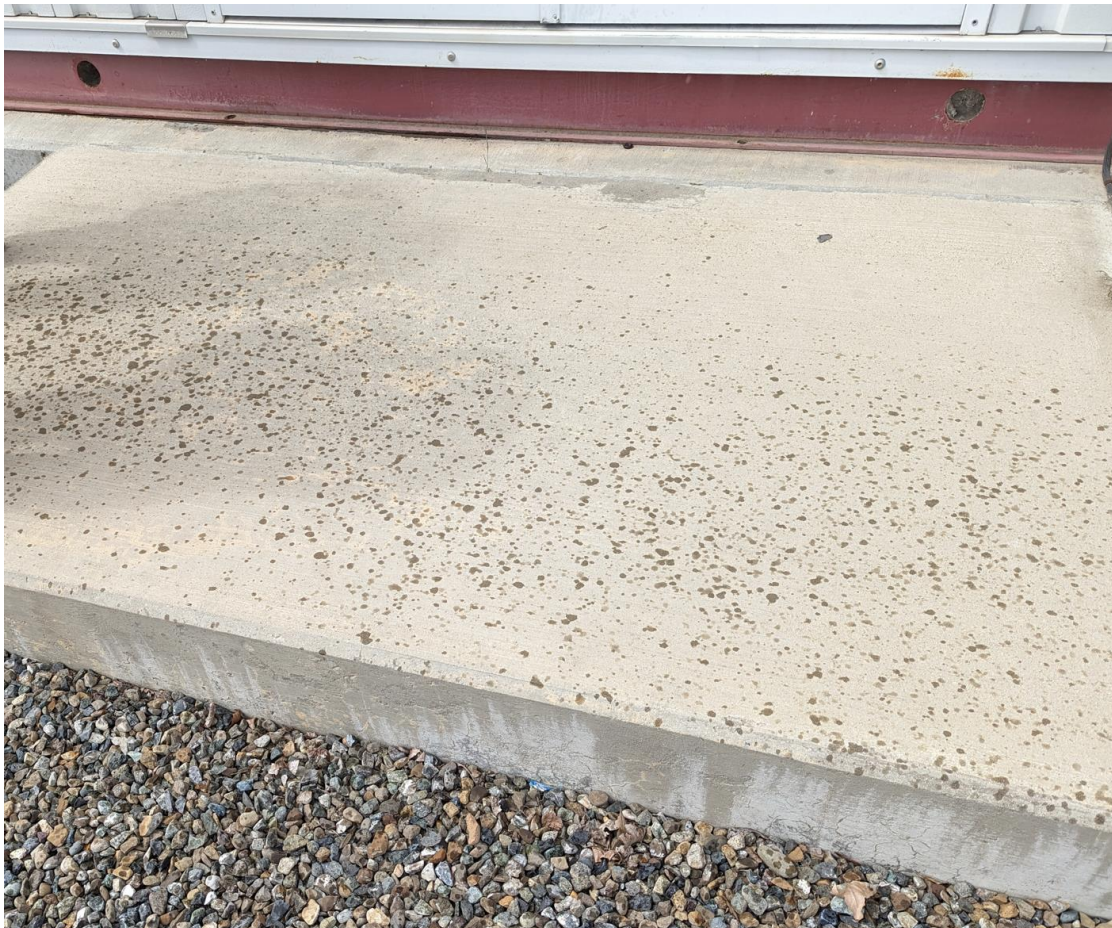
Finding 2: Faded/Missing Trip Hazard Caution Strips

ESRB staff observed faded/missing trip hazard caution strips throughout the facility. These strips shall be restored to good working condition to help prevent accidental trips.

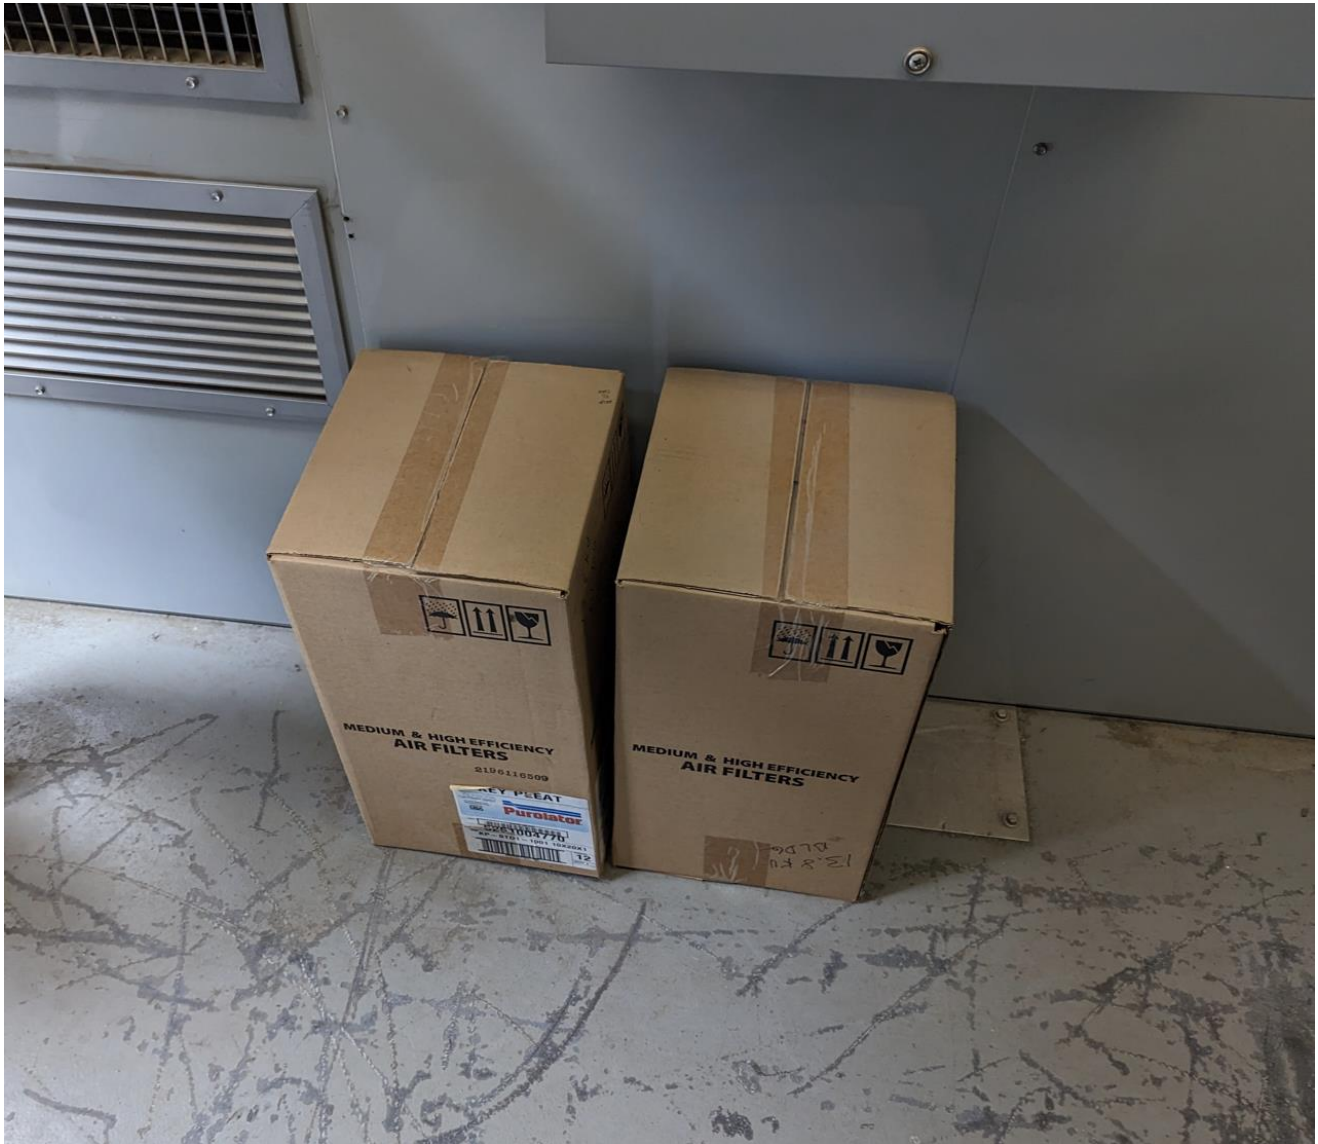
Finding 3: Improperly Stored Spare Parts

ESRB staff found spare air filters stored in a switchgear building on the floor, which may pose a tripping hazard. Spare parts shall be inventoried and stored in the warehouse.

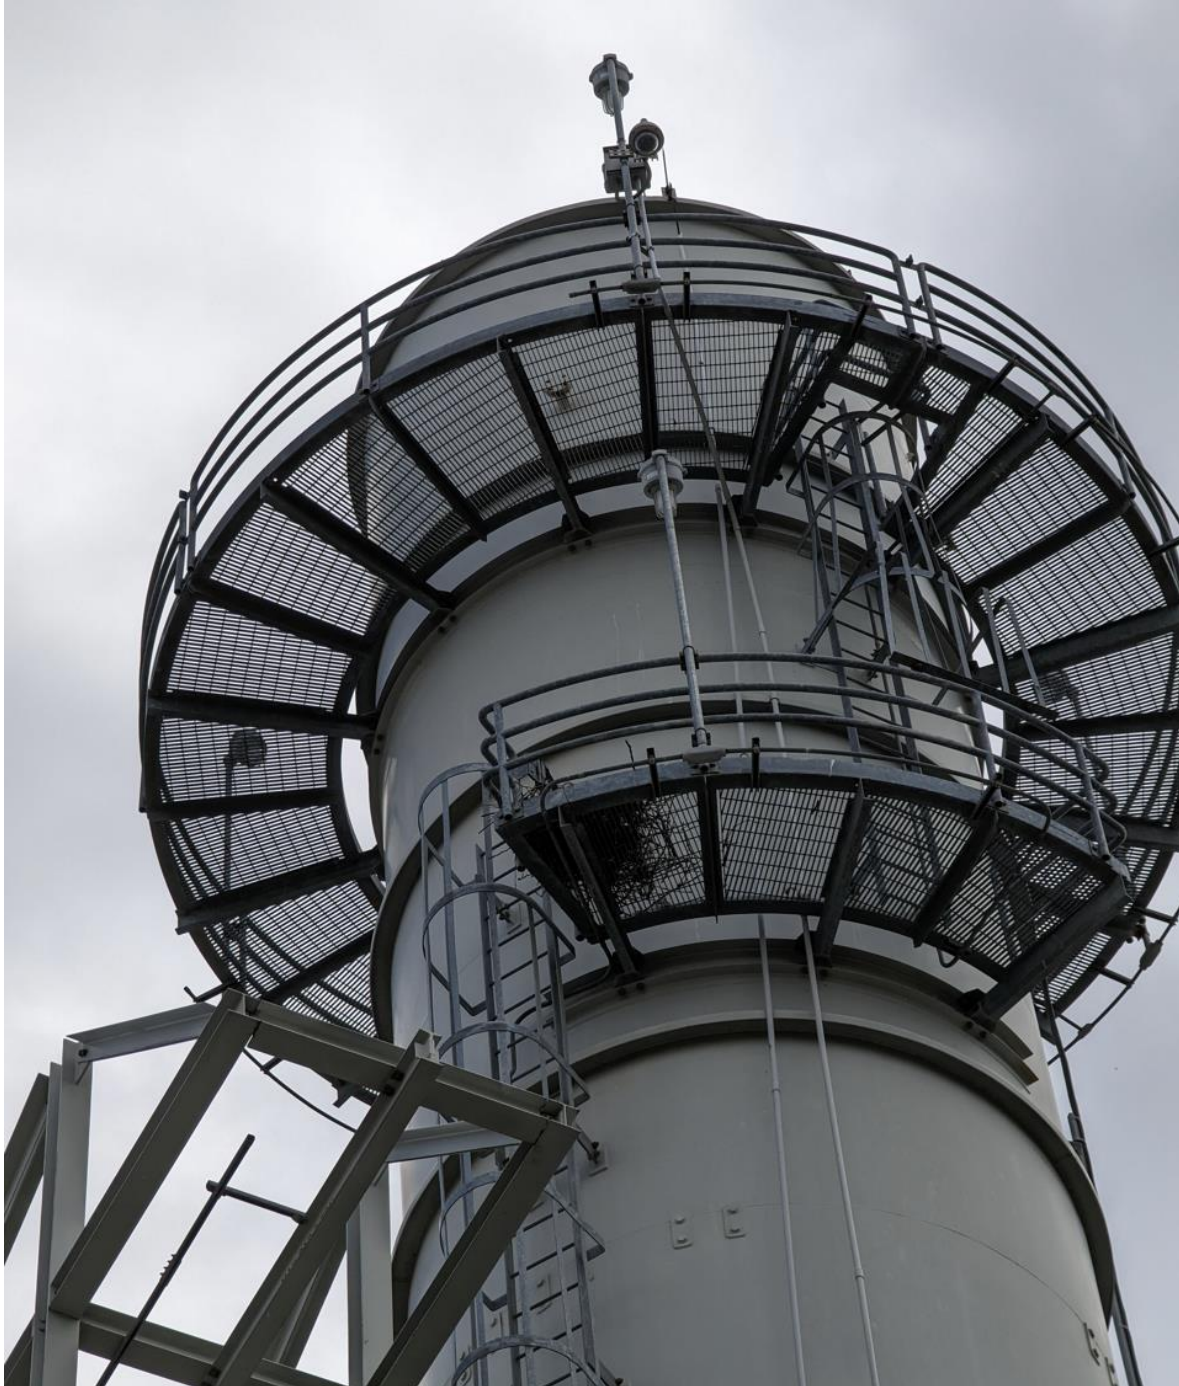
Finding 4: Birds Nest on Walkway

ESRB staff observed a large bird’s nest in a walkway near the top of the smokestack. The nest obstructs access to the top of the tower and presents a safety hazard for workers.

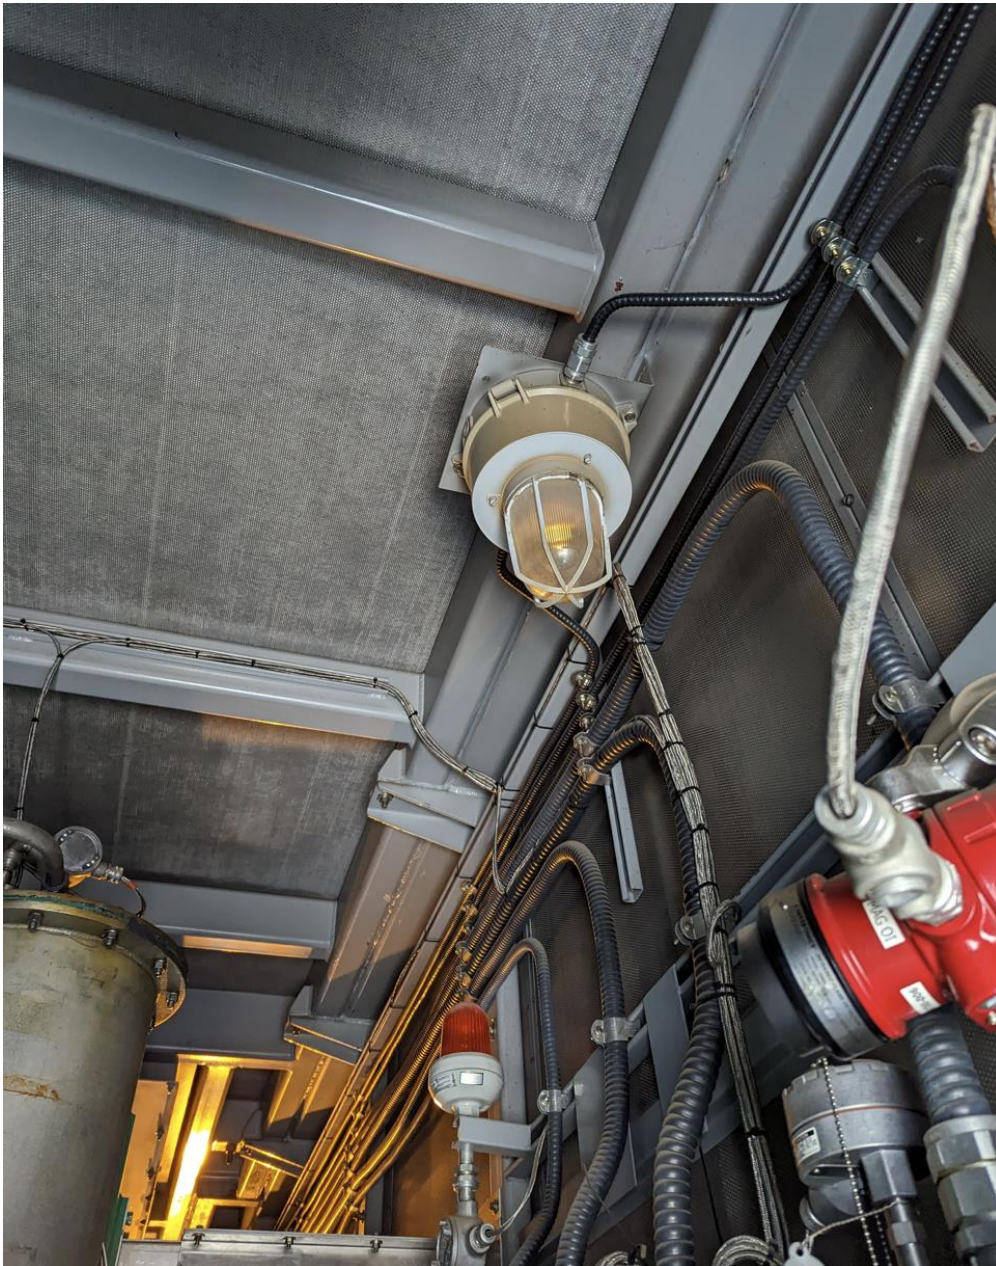
Finding 5: Turbine Enclosure Lighting

ESRB staff observed a light that burned out while inspecting inside the gas turbine compartment. Lights are important for the proper visibility and safety of Plant personnel.

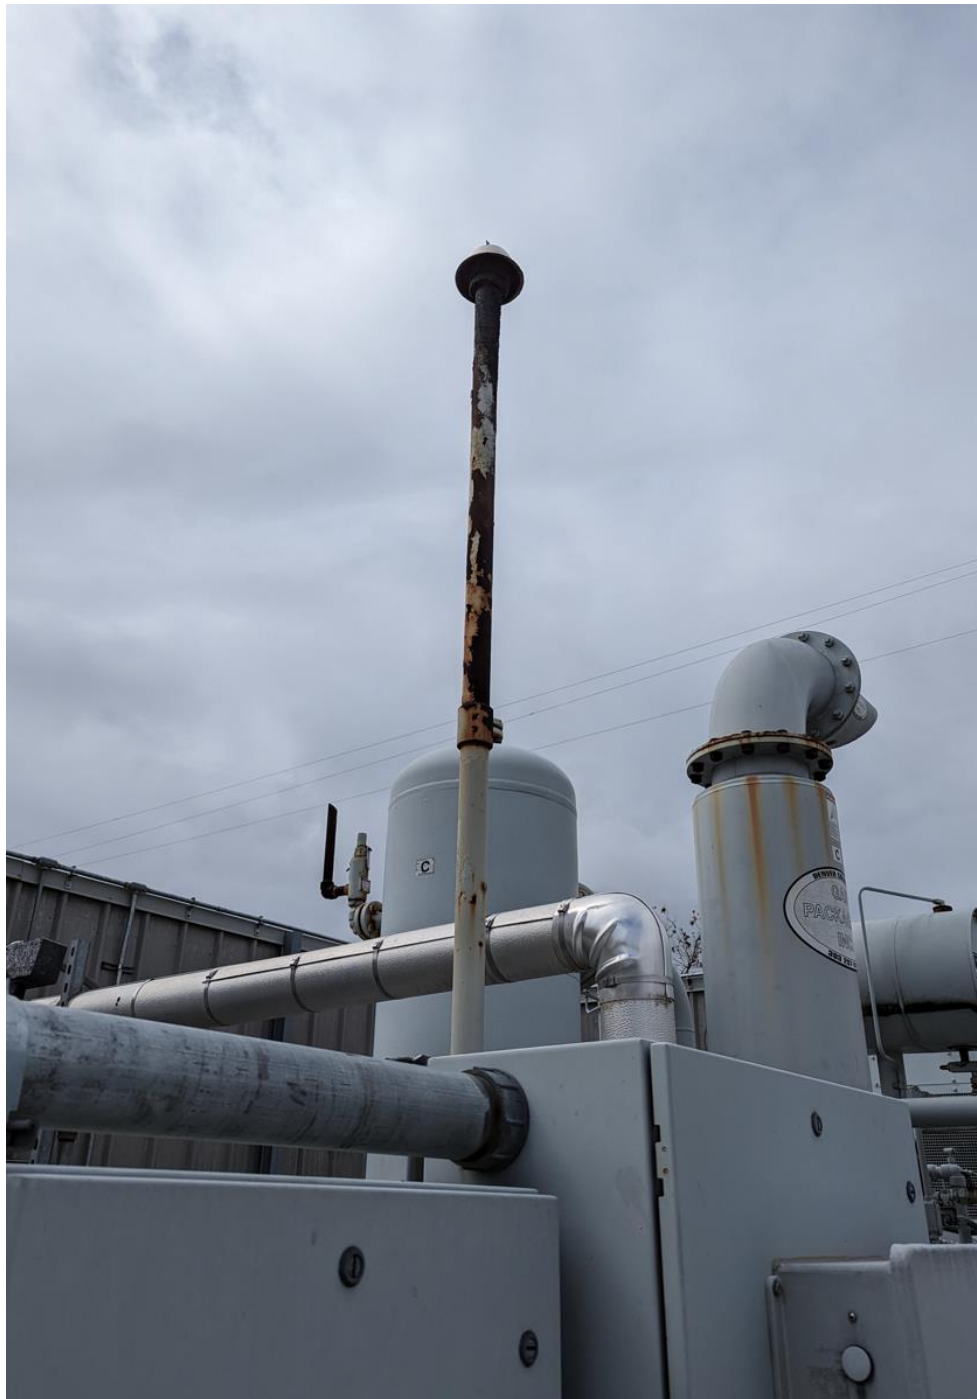
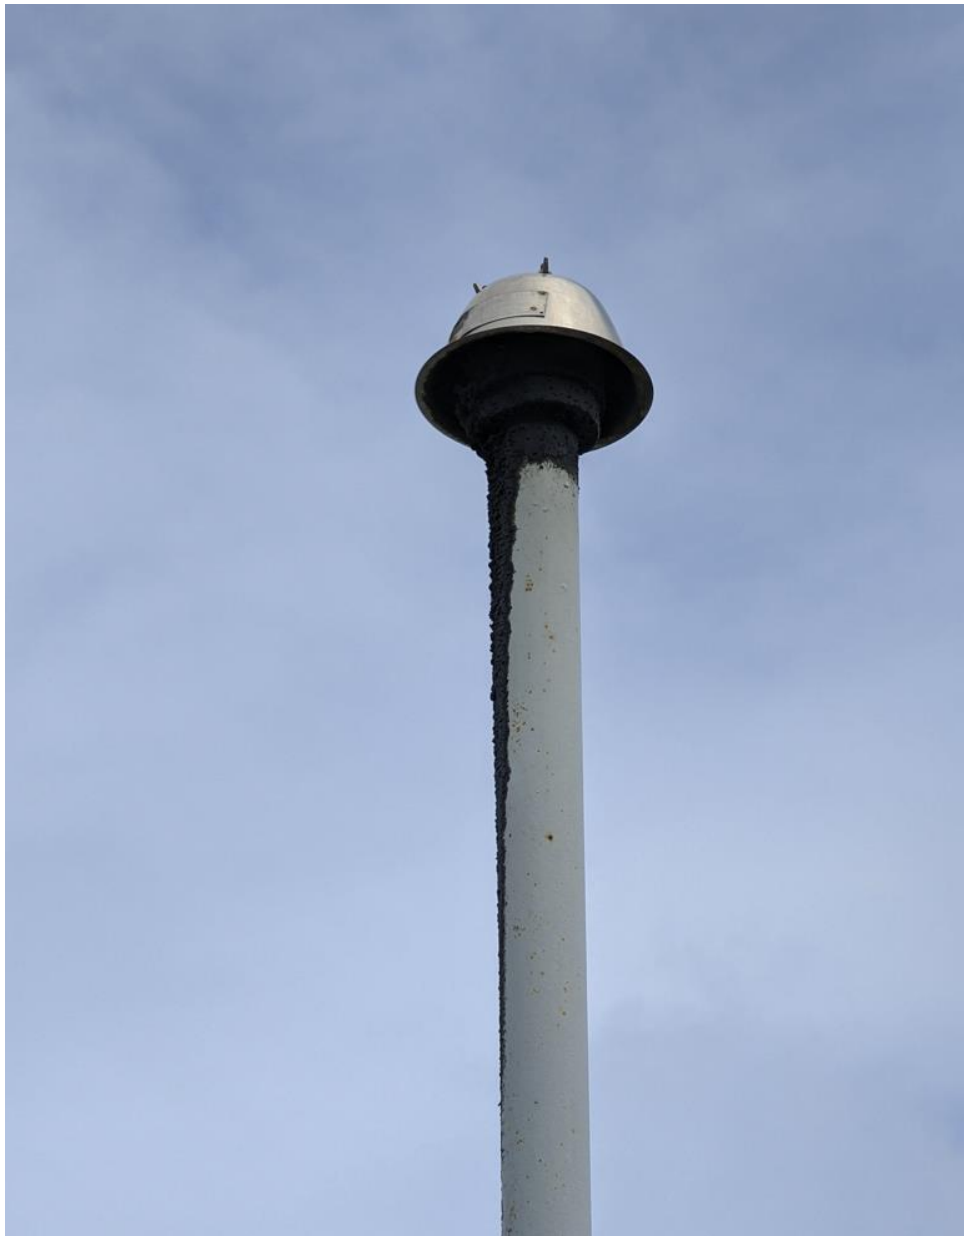
Finding 6: Natural Gas Compressor Vent Stack

ESRB staff observed surface corrosion and degradation on the gas compressor vent stack.

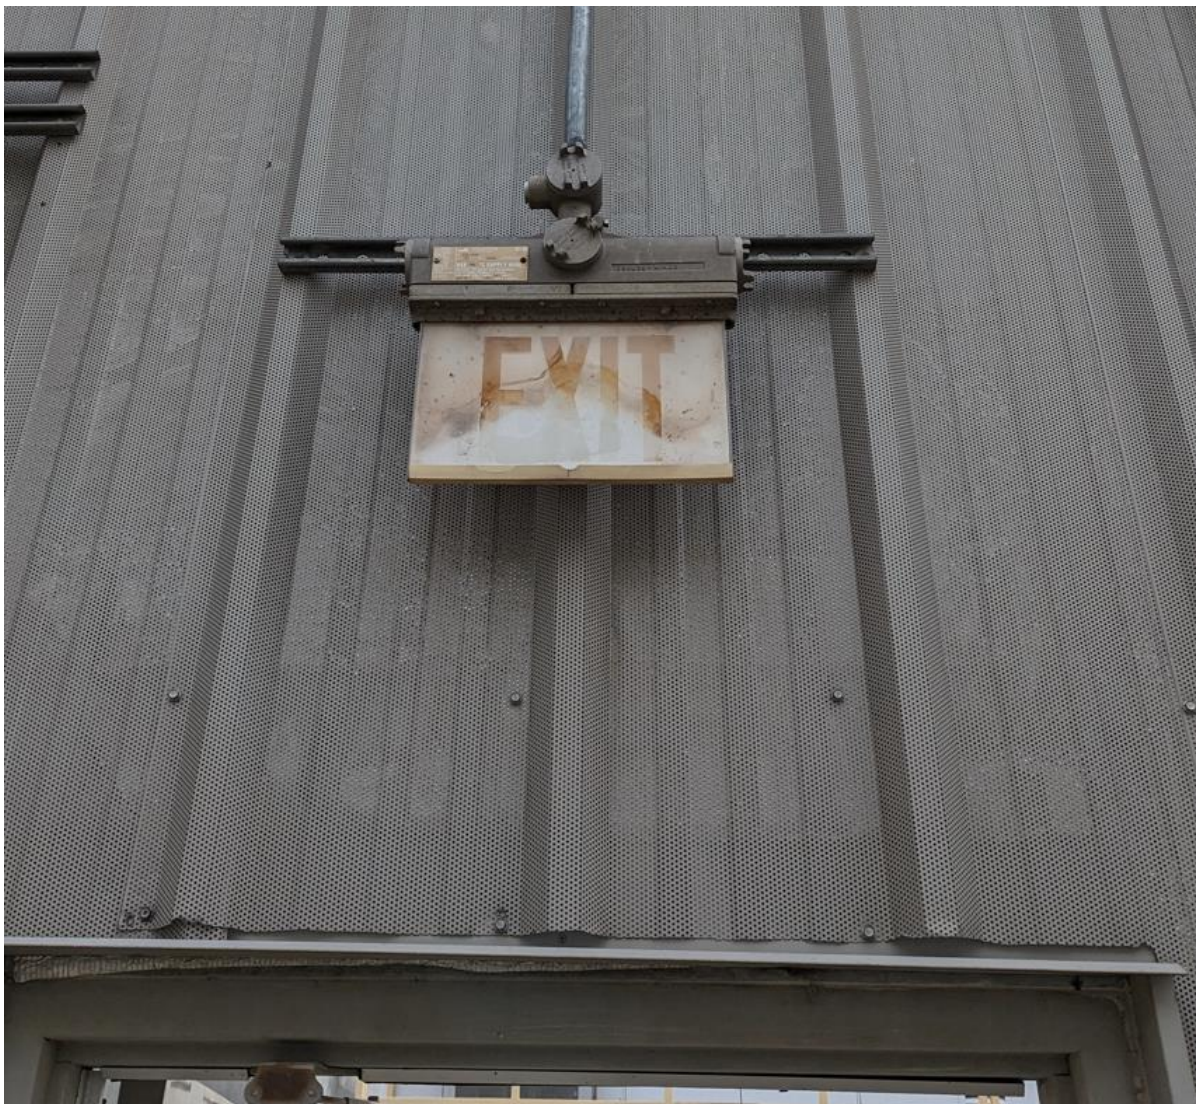
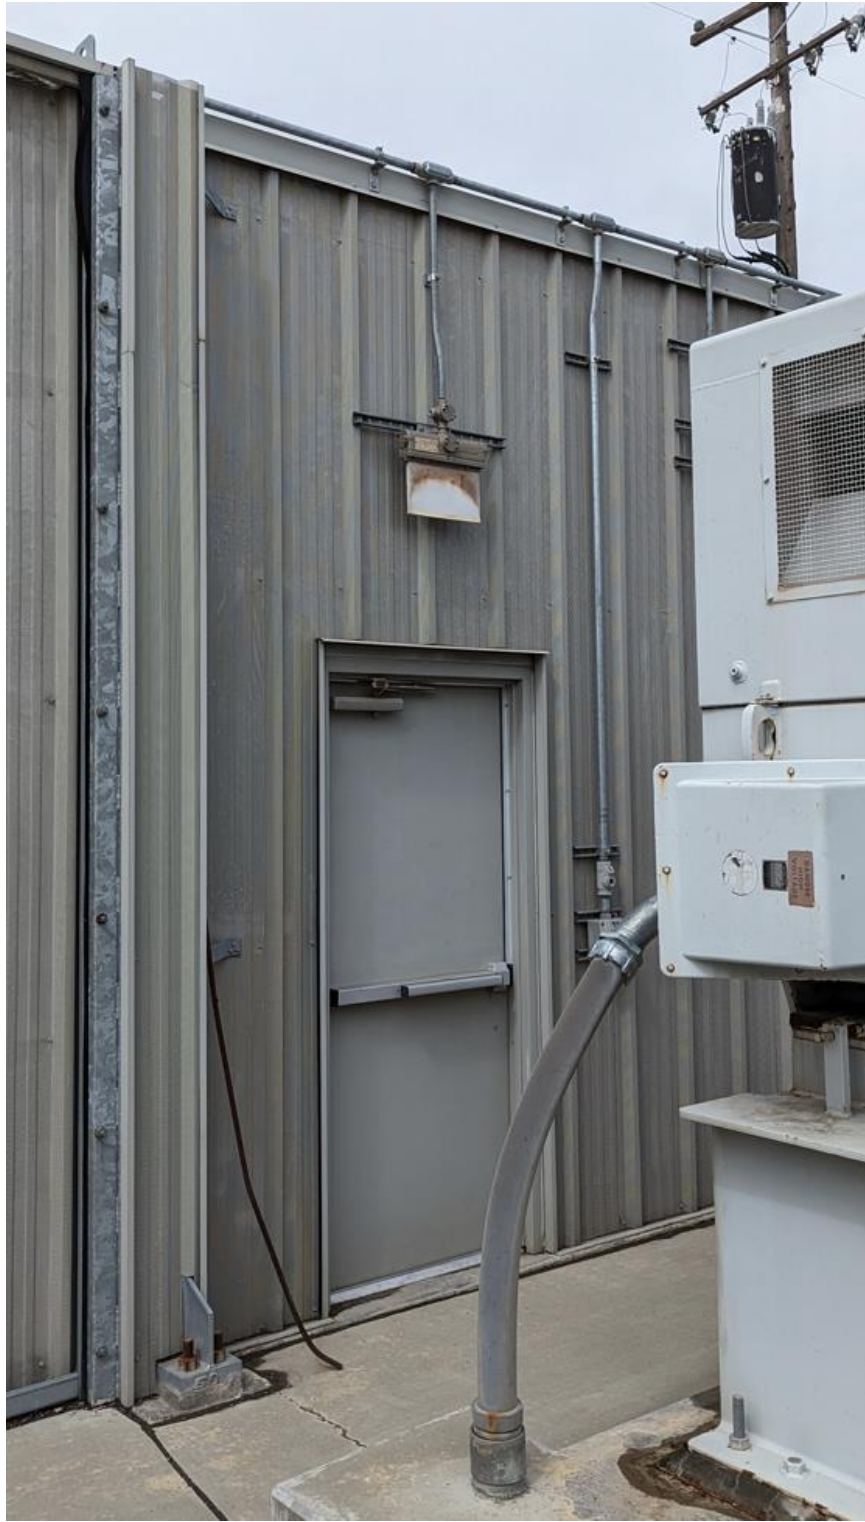
Finding 7: Damaged Exit Signs

ESRB observed damaged or illegible exit signs in the gas compressor building. Exit signs shall be kept in good working condition. These signs help inform employees, contactors, and visitors who may be unfamiliar with the Plant of exits in case of emergencies.

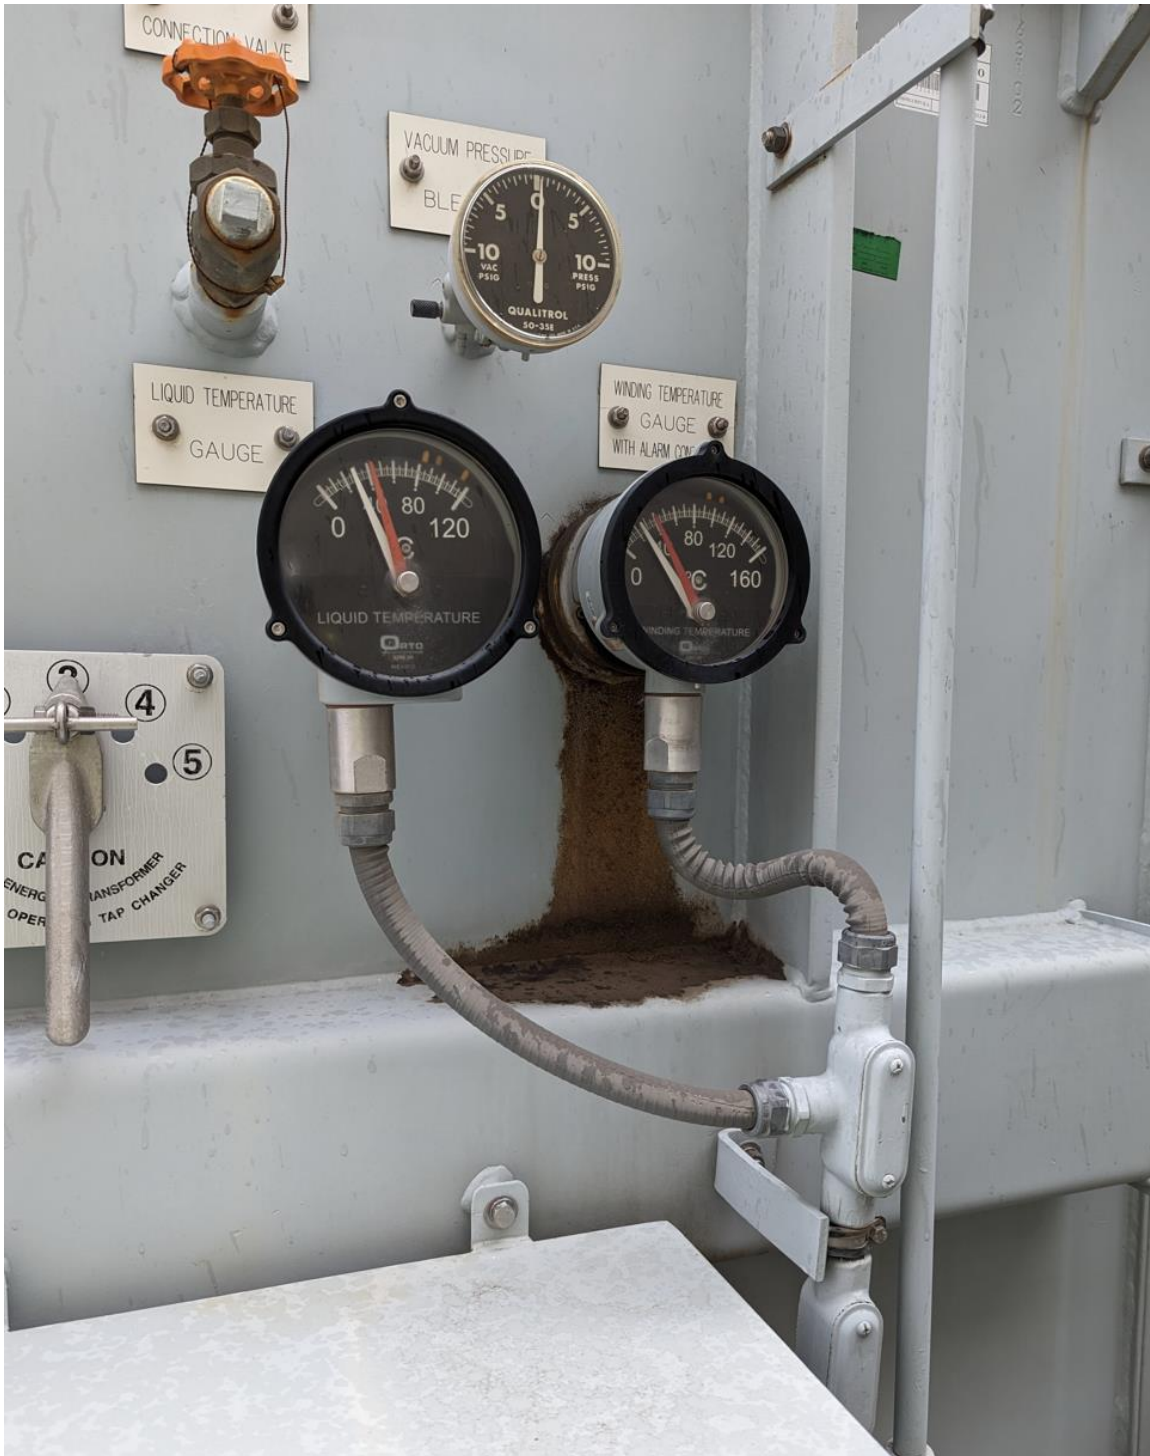
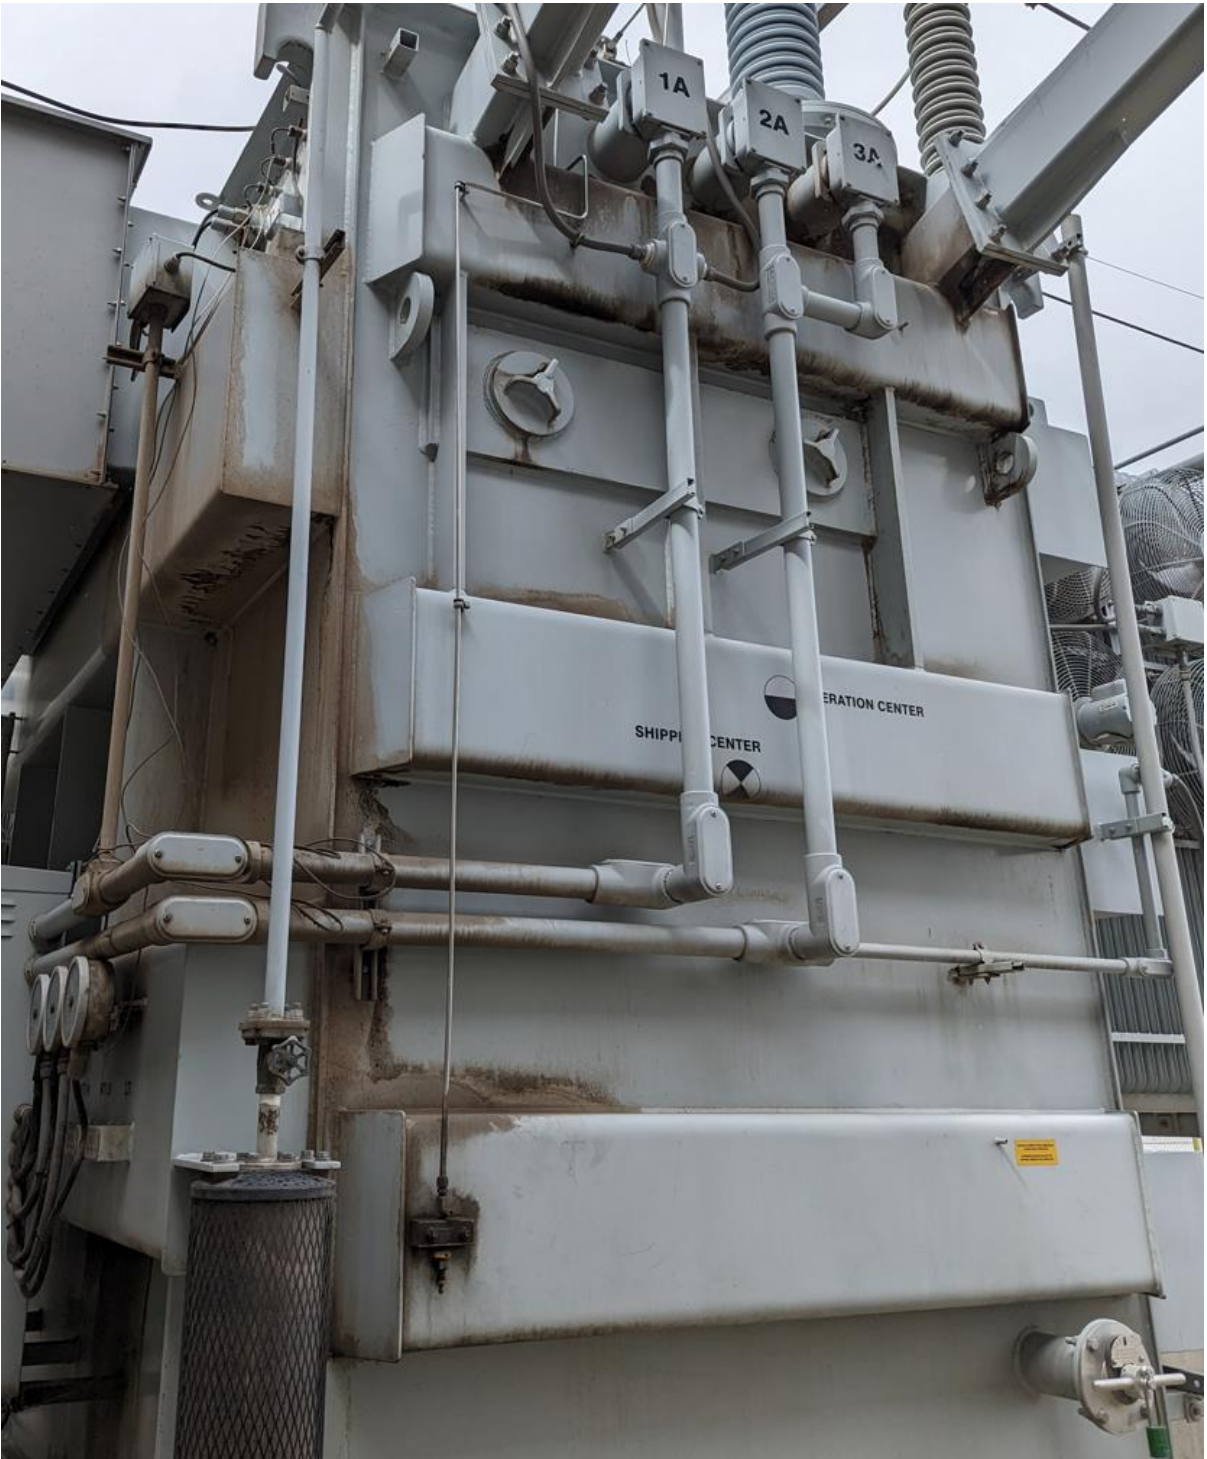
Finding 8: Transformer Oil Leaks

ESRB staff observed oil leaks on the Generator Step Up (GSU) transformer. Some leaks were already repaired but were not cleaned properly. The existing leaks shall be repaired and already repaired leaks shall be cleaned.

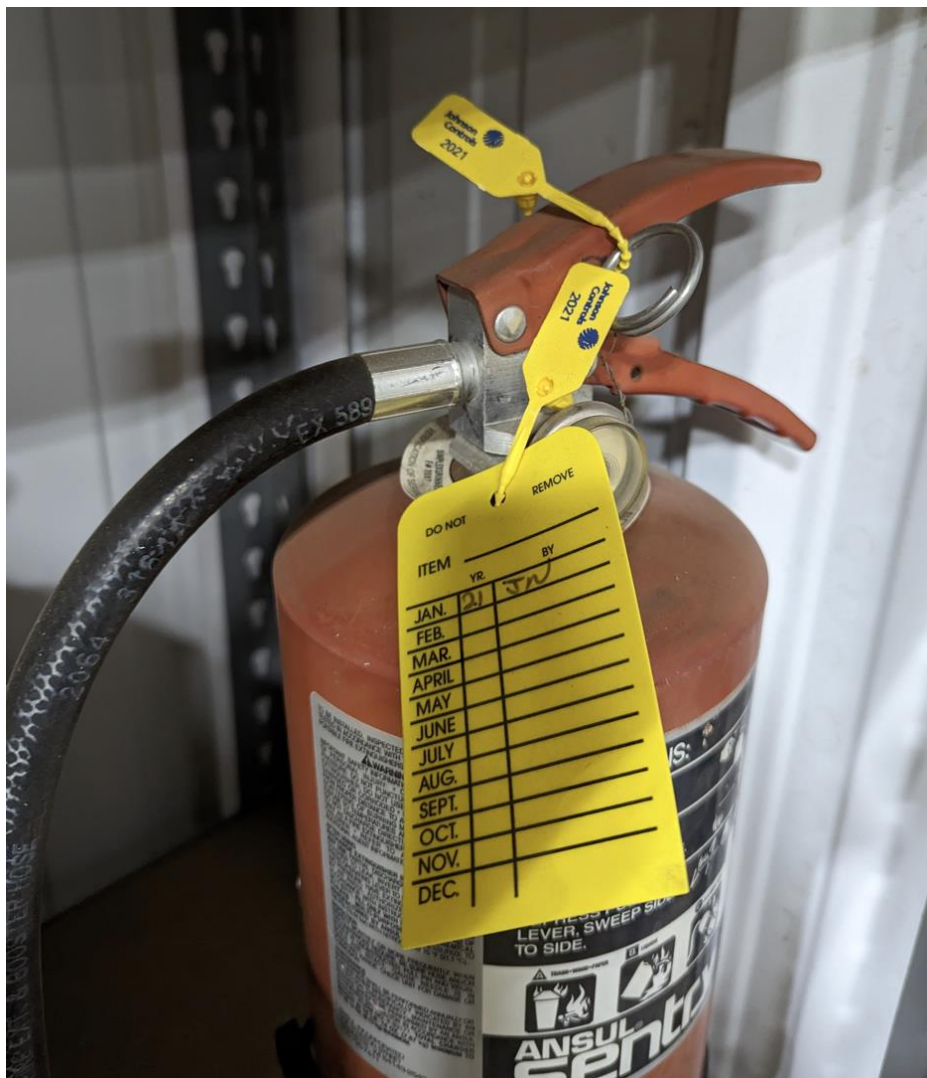
Finding 9: Fire Extinguisher Inspections

ESRB staff observed a fire extinguisher that has not been inspected since January 2021. The fire extinguisher was located in the spare parts storage building. It is not clear if the extinguisher is misplaced as it is not included in the spare parts list. The fire extinguisher shall be reinspected and returned to its proper location or added to the spare parts list.

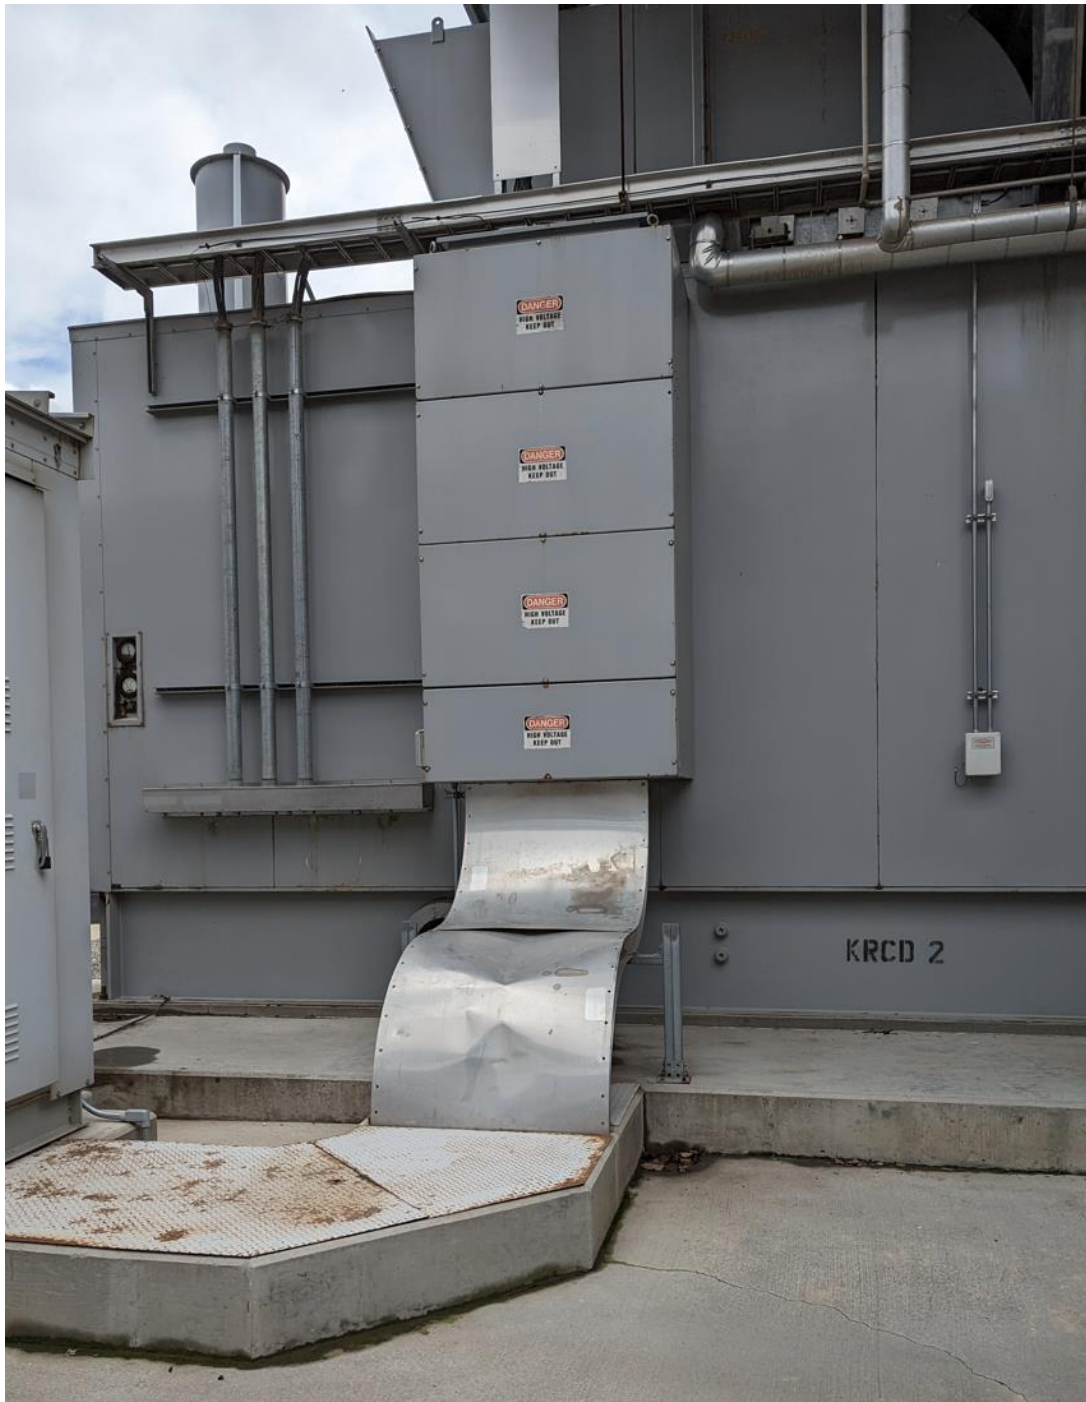
Finding 10: Damaged Generator Building Cable Tray

ESRB staff observed a damaged cable tray that leads into the generator building. The damage likely occurred when employees were working inside the access panels and stepped on the cable tray. Malaga uses scaffolding when working on the cable tray but should reiterate best practices when evidence of improper use is observed.
