**Enclosure 2 – PG&E Moss Landing Tower Collapse Direct
Cause Analysis**

**Moss Landing Tower
Collapse Analysis**

December 23, 2015

Doc. no. 1507946.000 - 2517

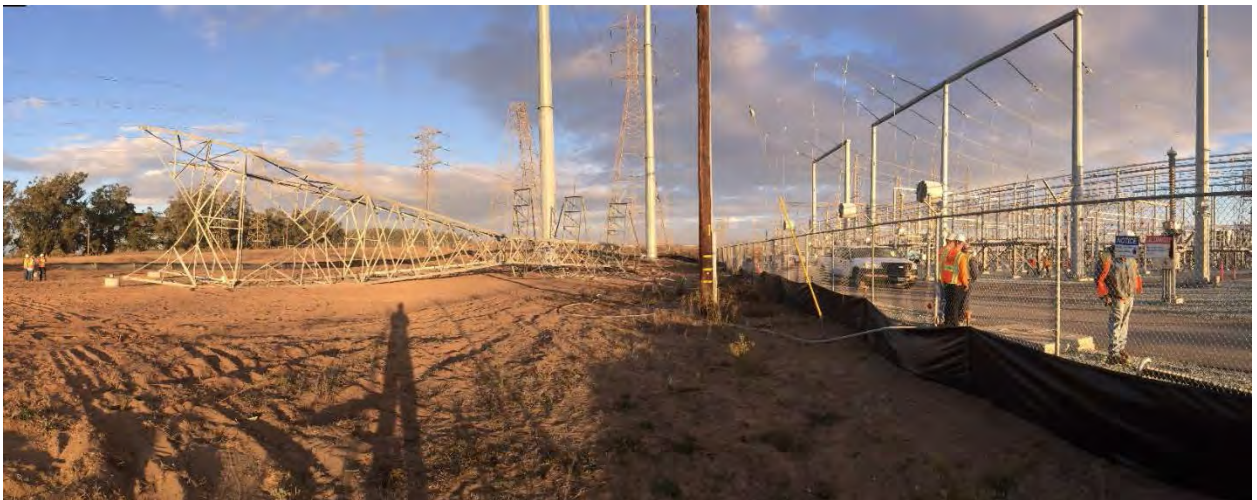
Figure 3. Failed tower as seen October 18, 2015, partial panoramic view, generally to the east.

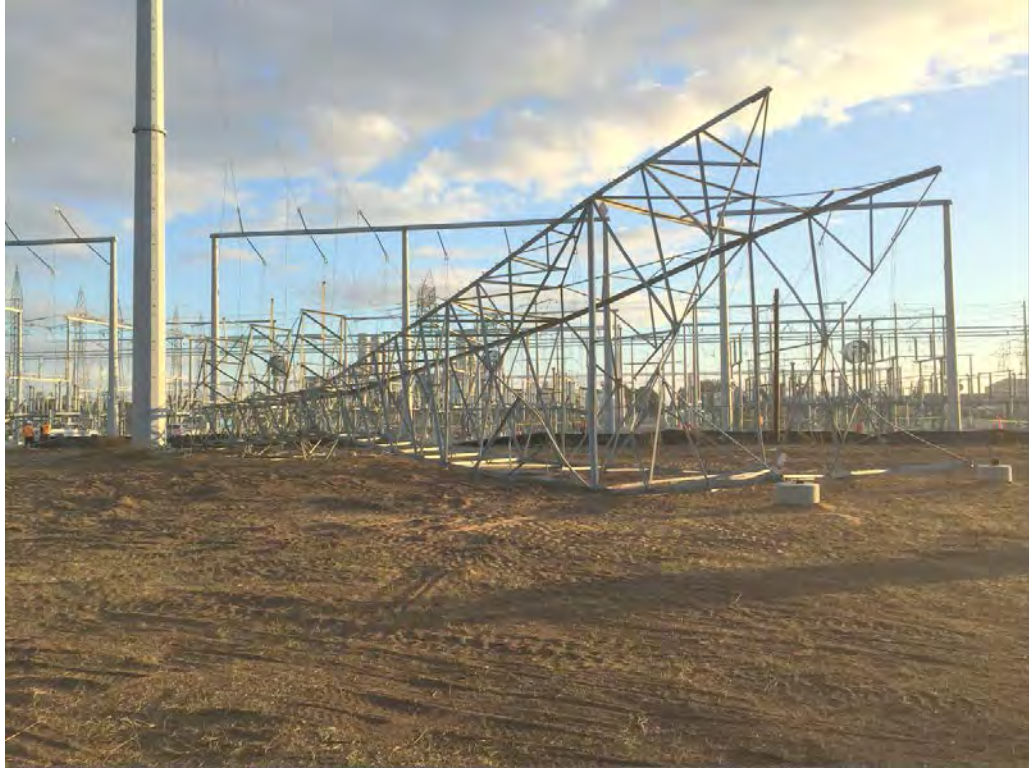
Figure 4. Failed tower as seen October 18, 2015. View to South.

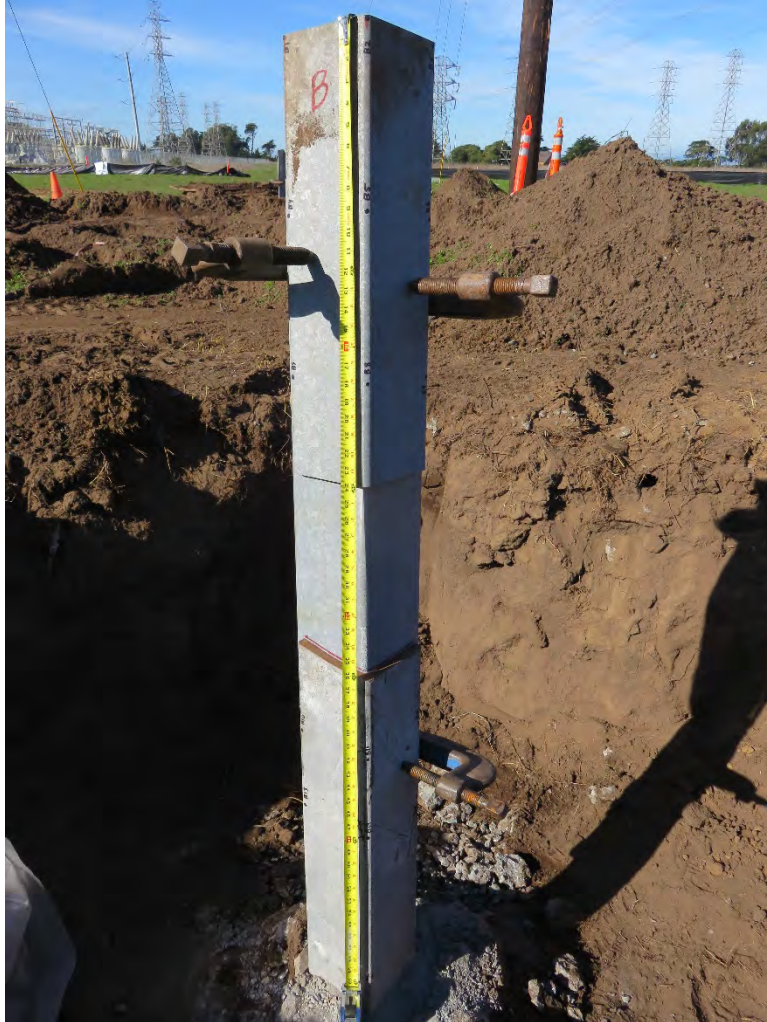
The as-built (as-measured) heel batter of the foundation stub angles were approximately one inch per foot too steep relative to the design drawings, and as such the top of any tower leg bolted to them would have been significantly outboard of its intended position. This outboard offset would be approximately 17 inches, as shown in Figure 16.

Figure 14. Measuring the plumb of stub angle on December 1, 2015 (extended to original height using additional angle sections)

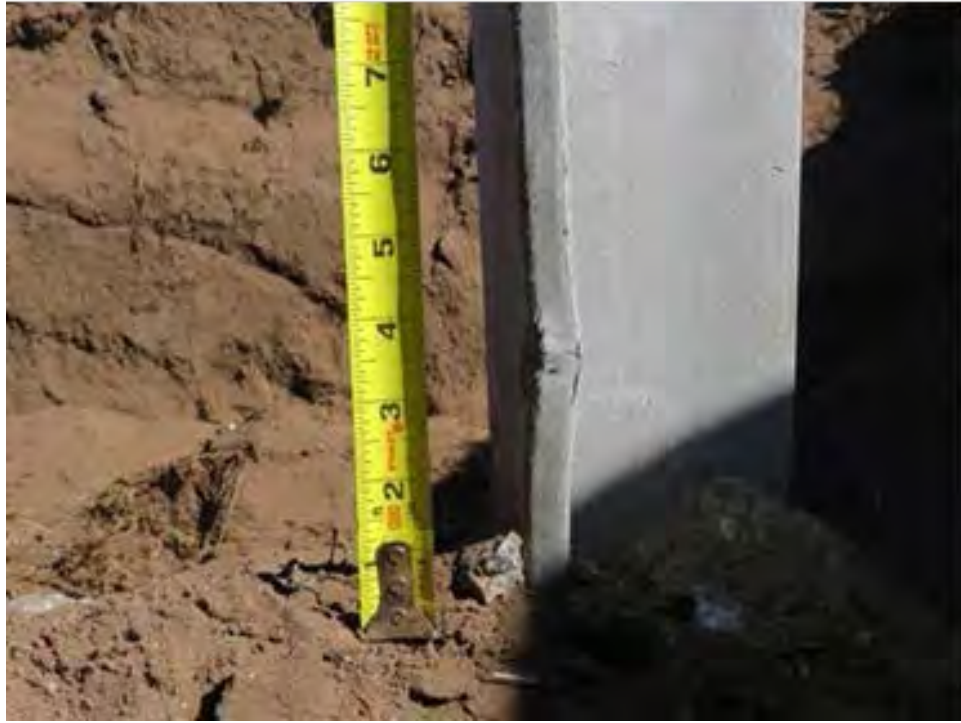
Stub A was found to be out-of-plumb by one inch per foot toward Stub D. This deviation can be attributed to local damage at the base of the exposed stub (see Figure 15) caused by the ram used to chip the surrounding concrete. The other stubs were out-of-plumb by at most 1/12 inch per foot.

Figure 15. Deformation in Stub A

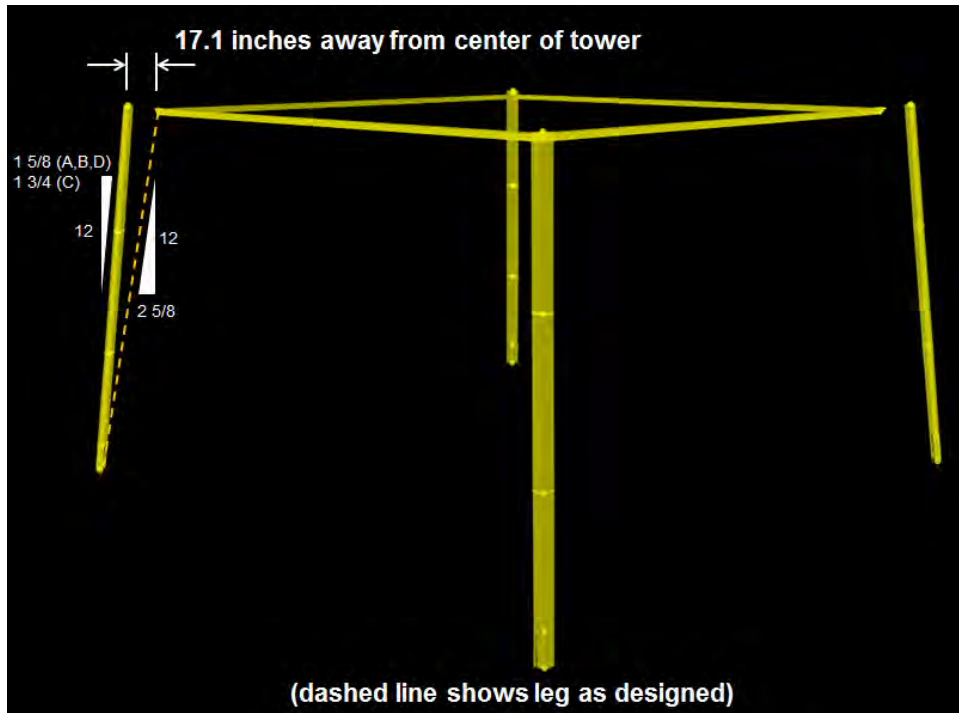
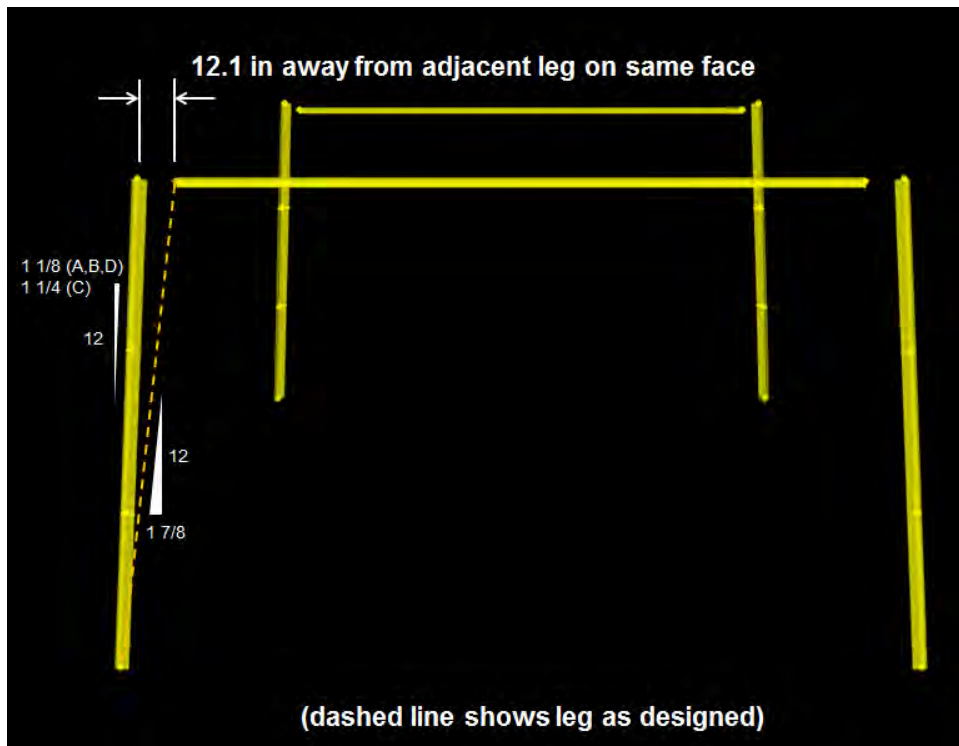
The offsets shown in Figure 16 would cause difficulty in fitting up additional members after installation of the tower legs. Installation of the double angle (2L3.5x3.25x0.25) horizontal stringers (see Figure 16) would require the each leg to be pulled inward by a significant amount, resulting in large bending moments at the critical section of each leg - a load that was unanticipated in the design. PG&E personnel reported that all of the lacing members are first bolted to the central gusset plate, then they are attached to the legs working from the bottom up, with the horizontal stringer connected to the legs last. Therefore, as each lacing connection was made, the top of the leg would displace inward by some amount, and the full 17 inches of offset may not have been apparent when workers made the top stringer-leg connection. (We note that the bolts were reportedly loose during erection of the 17.5-foot extension, and the high fit-up forces at the critical section may not have been fully realized until the bolts were subsequently tightened/cinched.)

Figure 16. Offsets caused by error in stub heel batter angle.

1. Exponent recommends that PG&E interview the crew that erected the tower to determine how the incident stubs came to be misaligned during tower foundation construction, and to implement a process to mitigate the risk of this recurring.

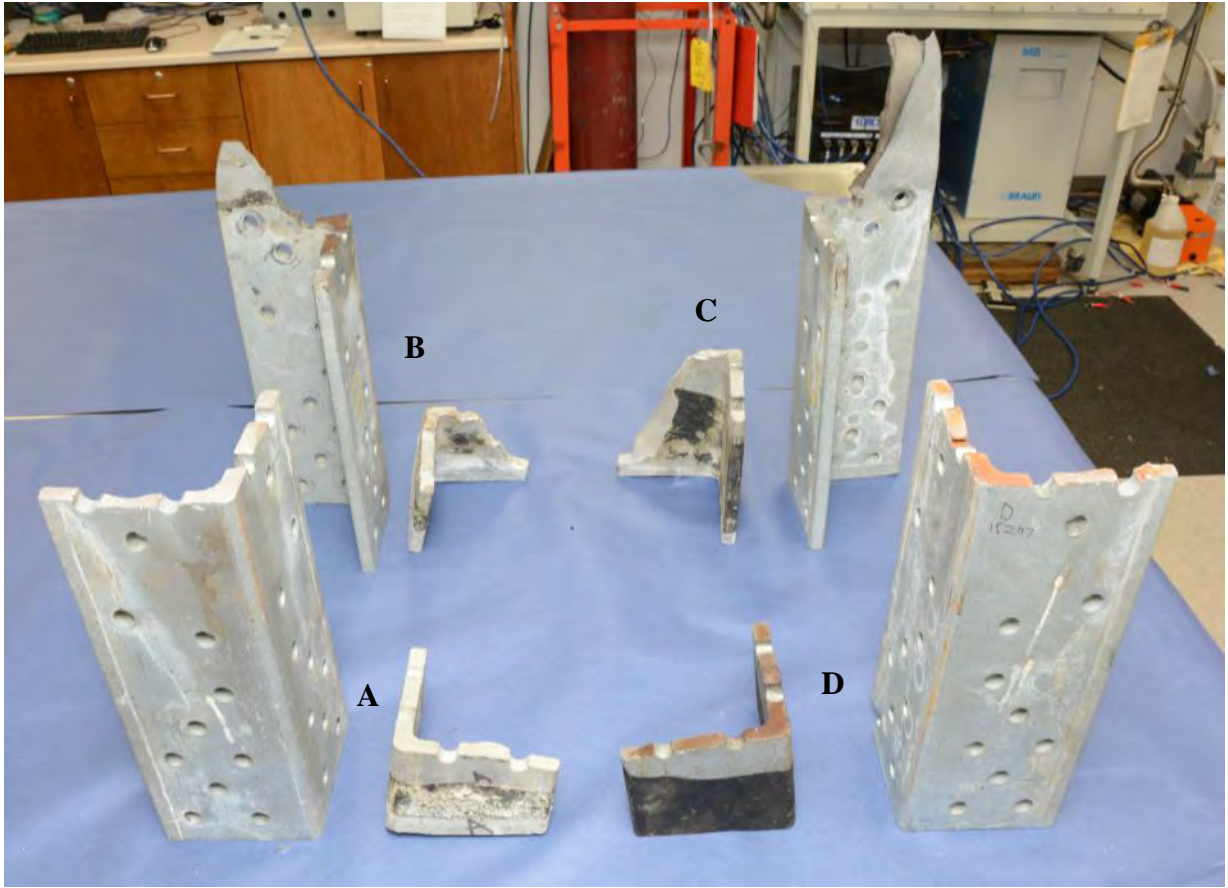
Exponent examined the fractured stubs within hours of the collapse; at that time, portions of the Stub B and D fractures exhibited significant corrosion (Figure 19, Figure 21, and Figure 23). Stubs A and C fracture surfaces exhibited no corrosion (Figure 19, Figure 20, and Figure 22), consistent with recent fracture. The extensive corrosion present on Stub B and D fracture surfaces indicates that these fracture areas likely existed for weeks prior to the October 18, 2015 collapse.

Figure 19. Photograph that shows both halves of each of the fractured incident stubs.

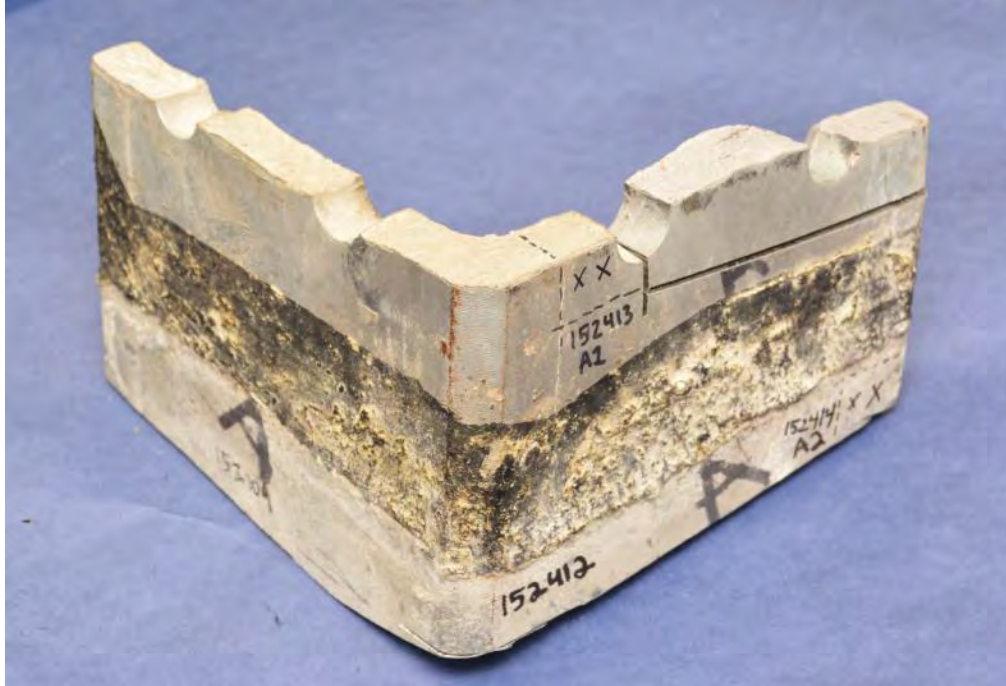
Figure 20. Photograph of the Stub A base fracture during visual examination.

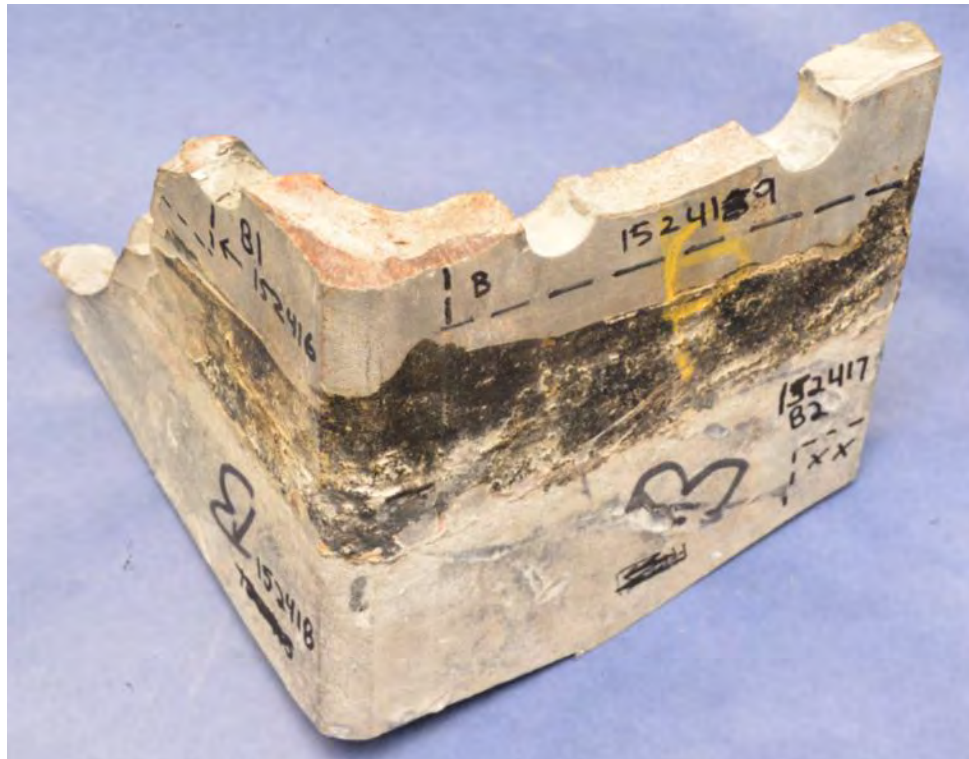
Figure 21. Photograph of the Stub B base fracture during visual examination.

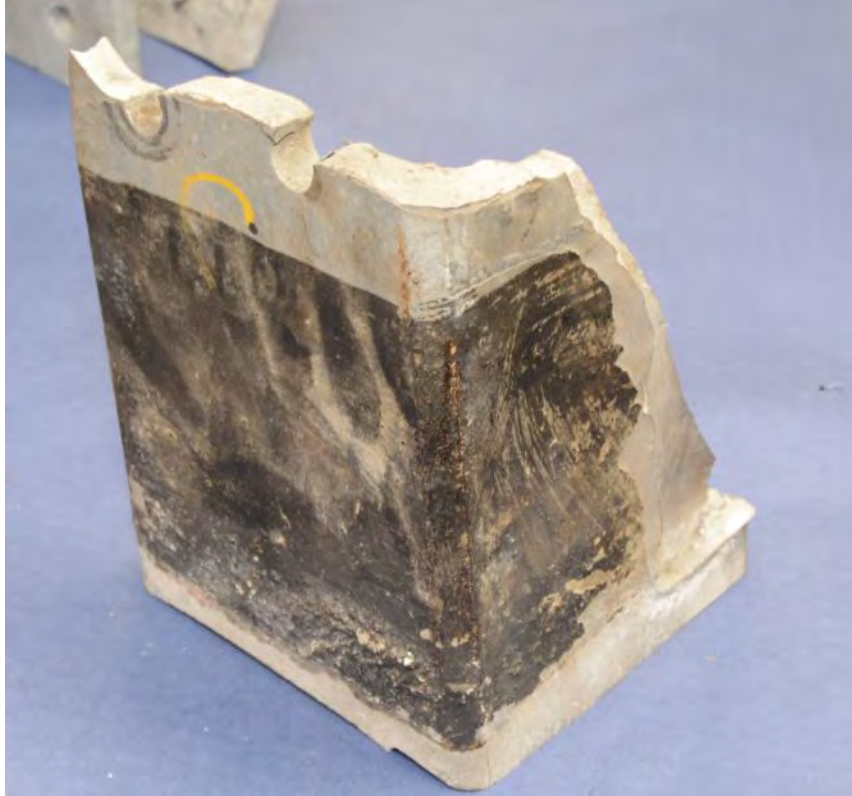
Figure 22. Photograph of the Stub C base fracture during visual examination.

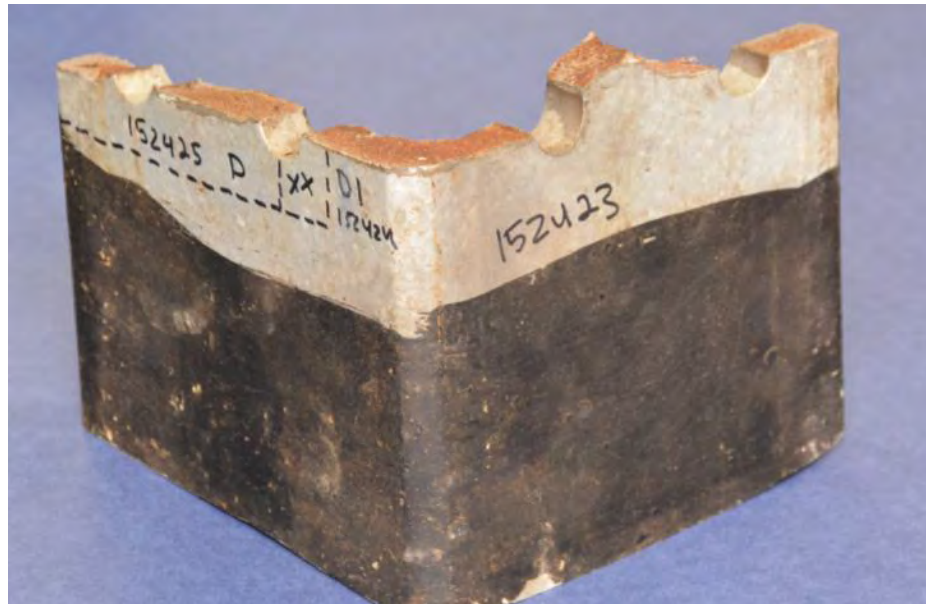
Figure 23. Photograph of the Stub D base fracture during visual examination.

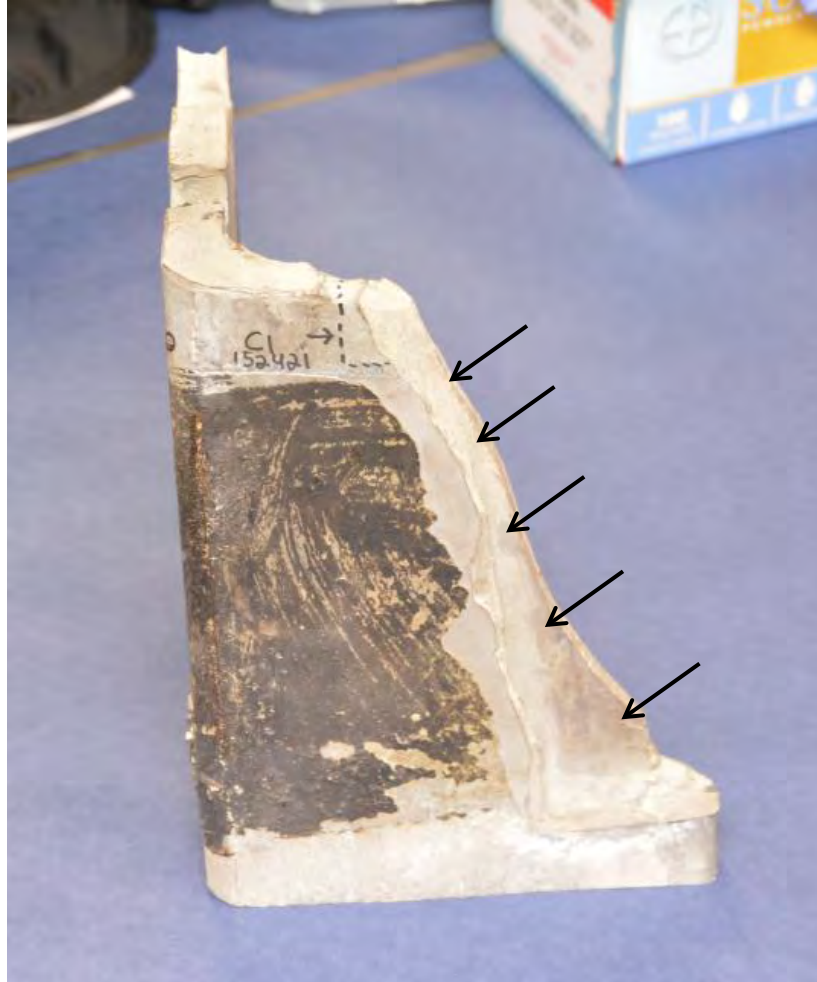
Figure 24. Laminar separation in the ductile overload portion of Stub C, shown by arrows.

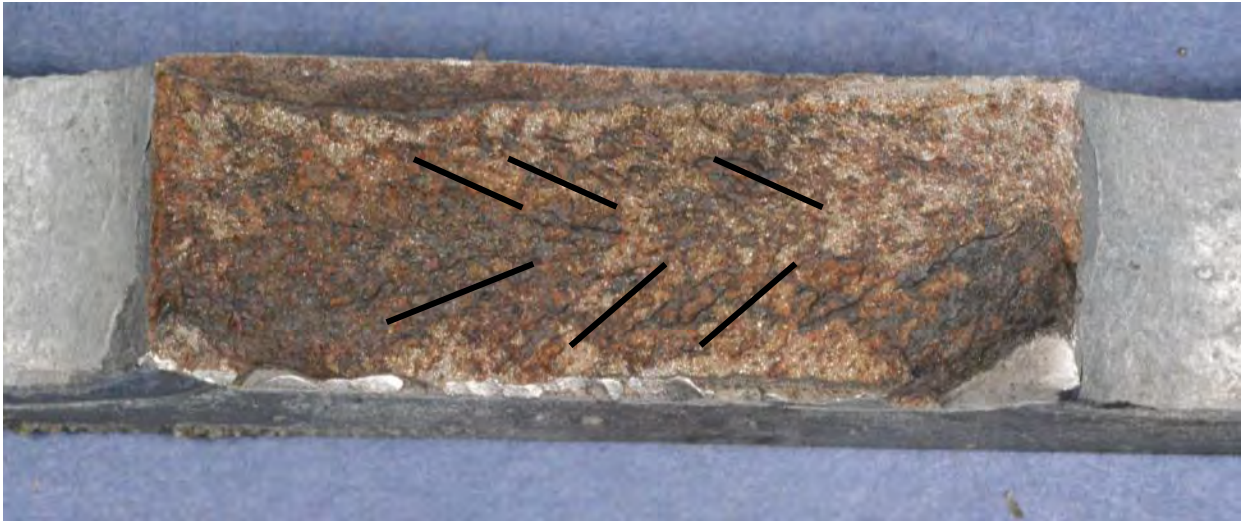
Visual analysis was sufficient to determine the fracture origins and direction of crack propagation for each of the four stubs. Chevron marks, as shown in Figure 25, point to the crack origins and indicate the direction of growth. The schematic shown in Figure 26 shows the fracture origins on the base-side of the subject tower stubs (viewed from above), crack propagation directions, and the portions of the fractures that pre-existed the October 18th, 2015 collapse. Each of the fractures initiated at bolt holes. Both Stubs B and D, which each exhibited fractures that pre-existed the collapse, contained two fracture initiation locations, one on each “leg” of the L-shaped cross section (shown in Figure 26). Stubs A and C, which fractured at the time of collapse, each had a single fracture origin. Photographic montages that show the tower-side fracture surfaces of Stubs A and D (the two stubs without large amounts of tearing/bending associated with final fracture) are shown in Figure 27 and Figure 28.

Figure 25. Photograph that shows representative chevron marks in Stub B. The dark lines help show the direction of the chevron marks.

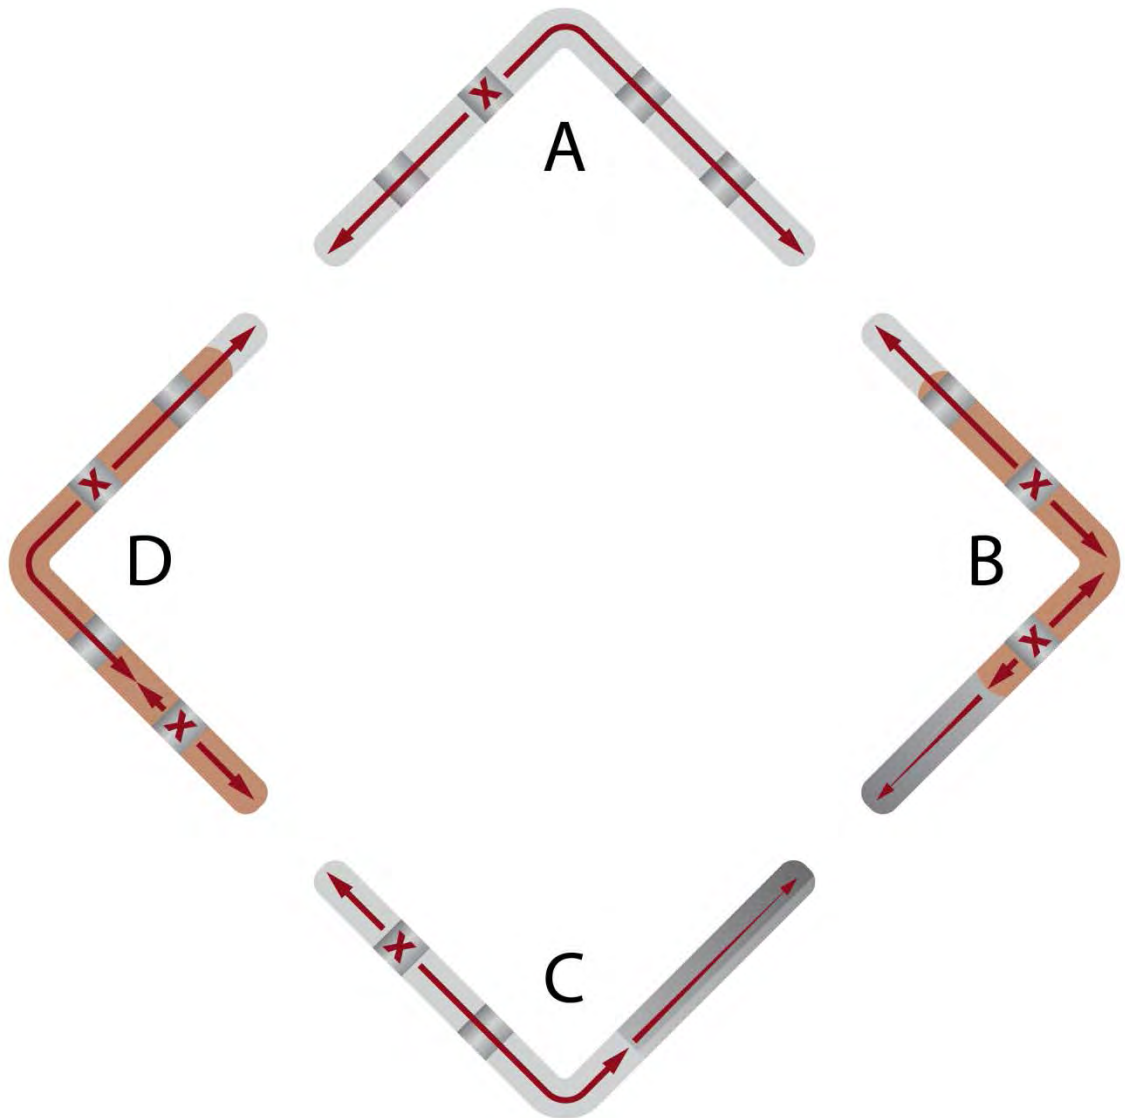
The fracture origins and trajectories, as described in a later section, suggest that failures of stub angles B and D generally initiated first near the outboard knee (heel) of the angles, then progressed toward the inboard toes. This implies that a bending moment was applied to legs B and D at the time that the stub angles of legs B and D had fractured. The orientation of that bending would be consistent with loads applied to the critical section had the tower legs been pulled inward. Inward displacement of the tops of the 17.5-ft tower leg extensions, as might be needed for fit-up during tower erection, was investigated as a possible failure load scenario.

Figure 26. Schematic that shows fracture initiation locations and growth directions in each of the four stub bases, when viewed from above. “X” indicates fracture origin hole locations, red arrows show crack growth directions. Gray-colored areas are fractures that were created when the tower collapsed; orange areas are those that exhibited corrosion at the time of the collapse.

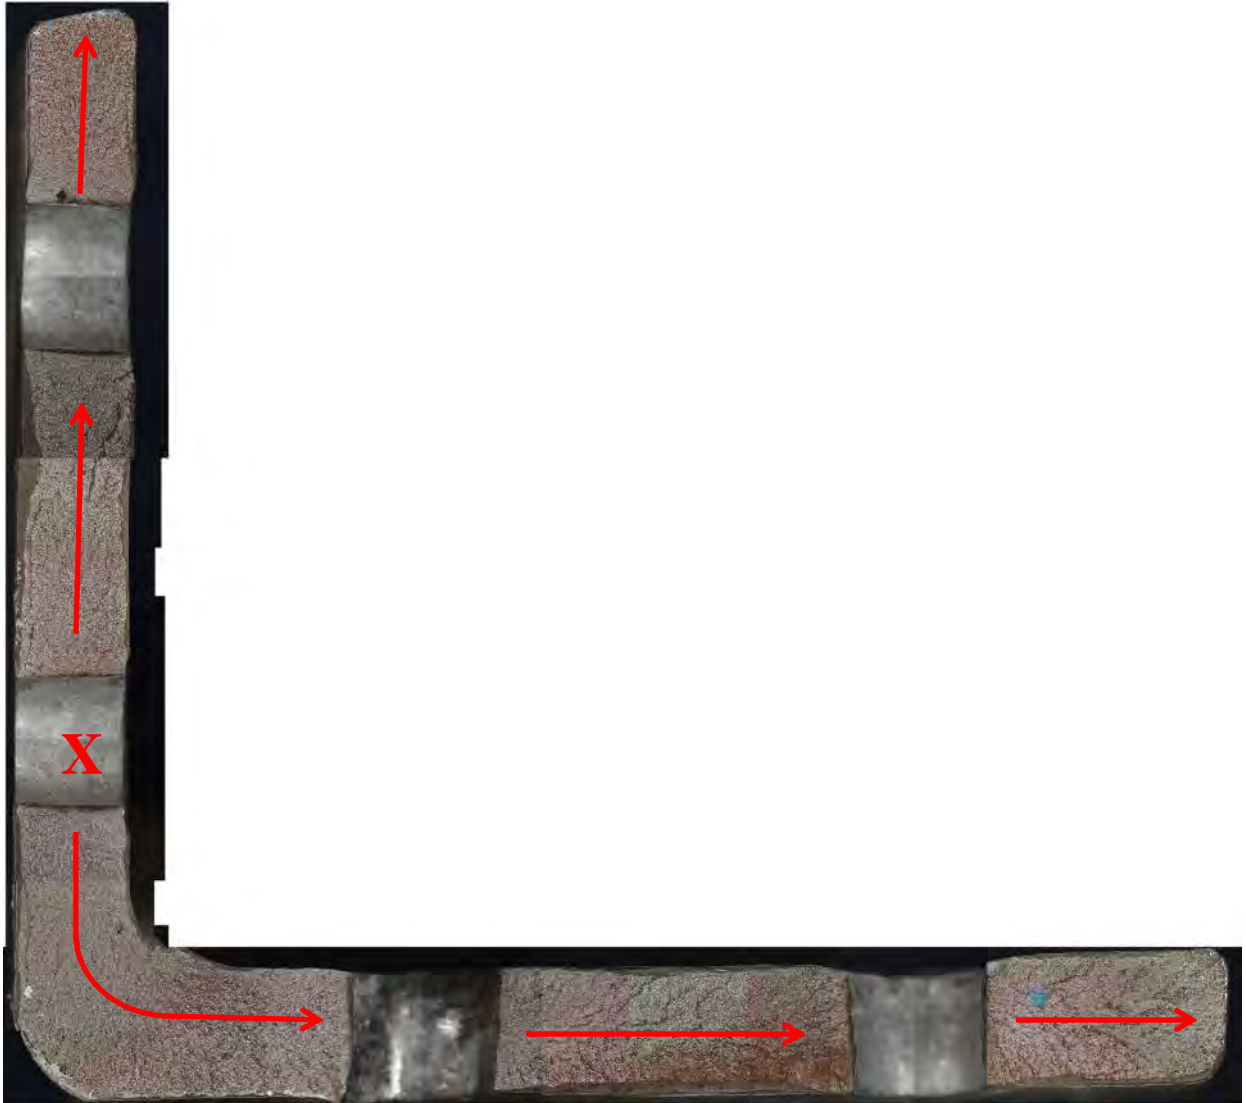
Figure 27. Stub A tower-side fracture surface montage, when viewed from below. "X" indicates the hole at the fracture origin, and red arrows show crack growth directions.

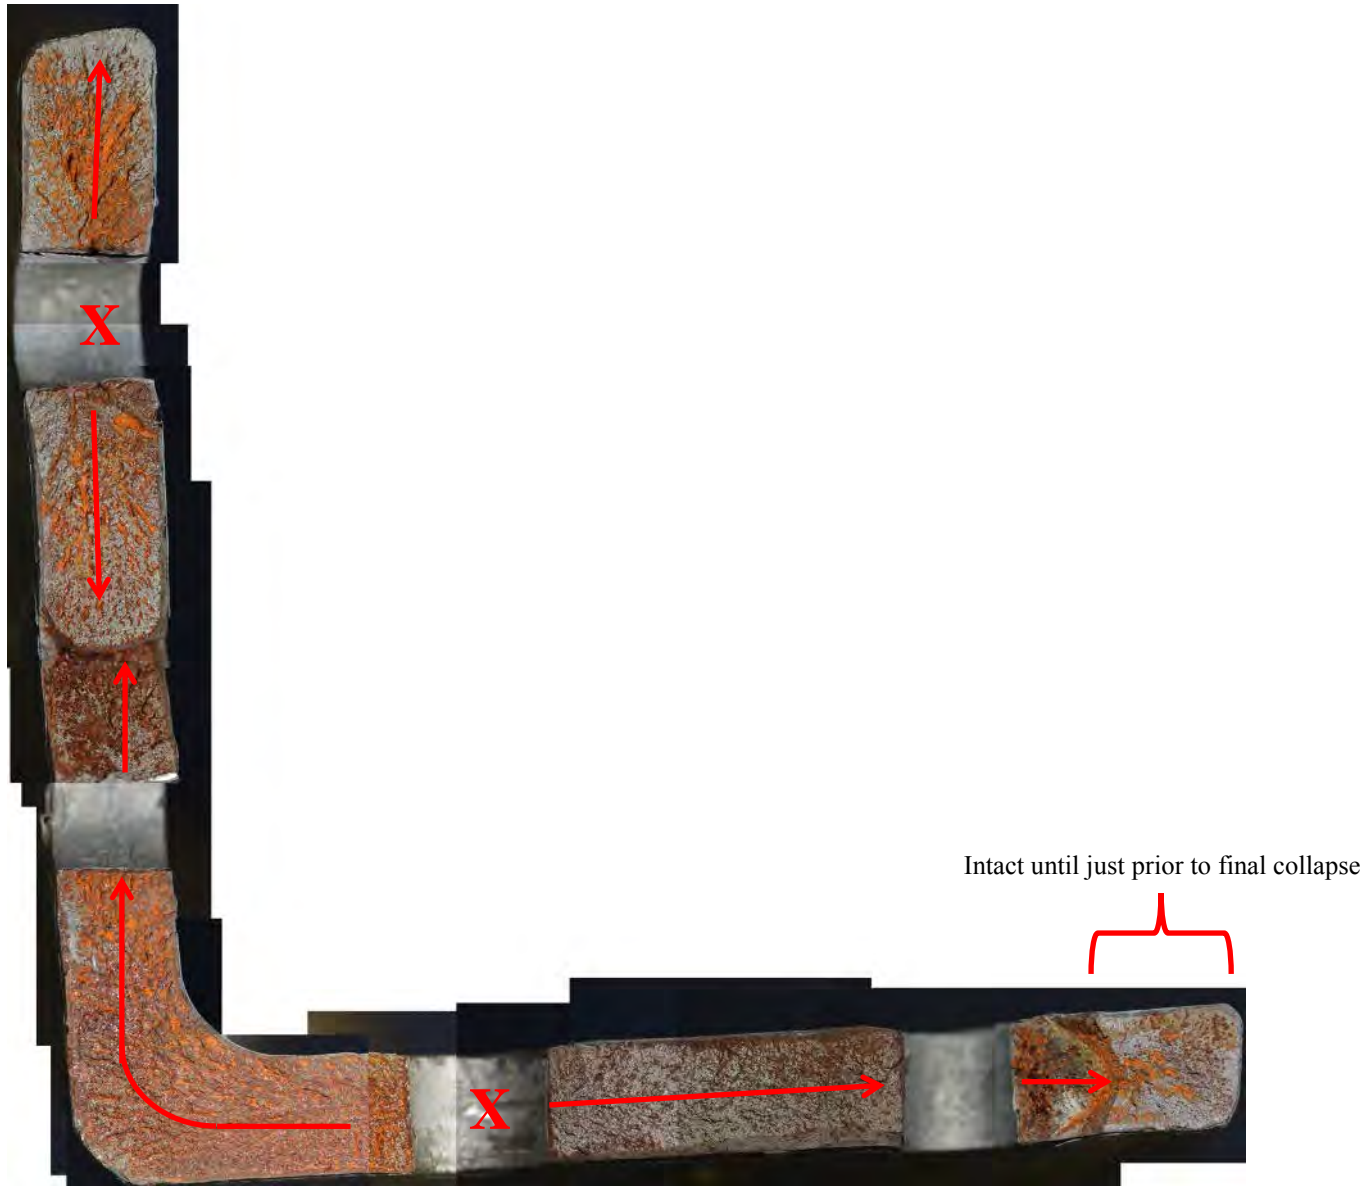
Figure 28. Stub D tower-side fracture surface montage, when viewed from below. “X” indicates the hole at the fracture origin, and red arrows show crack growth directions. The red bracket indicates the area that was intact until just before the final tower collapse.

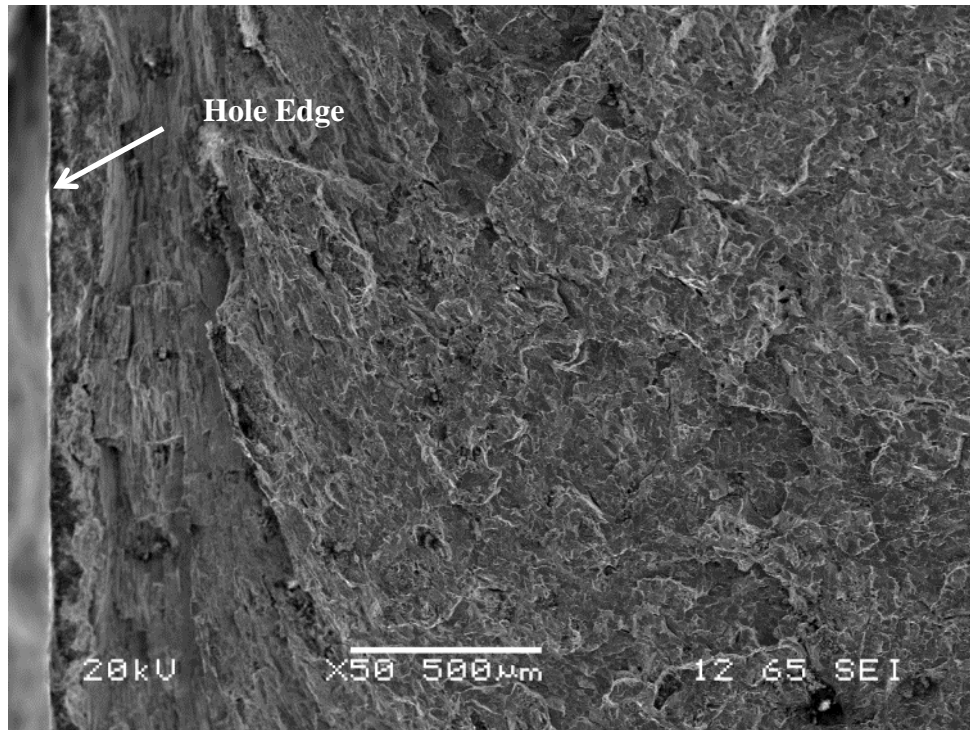
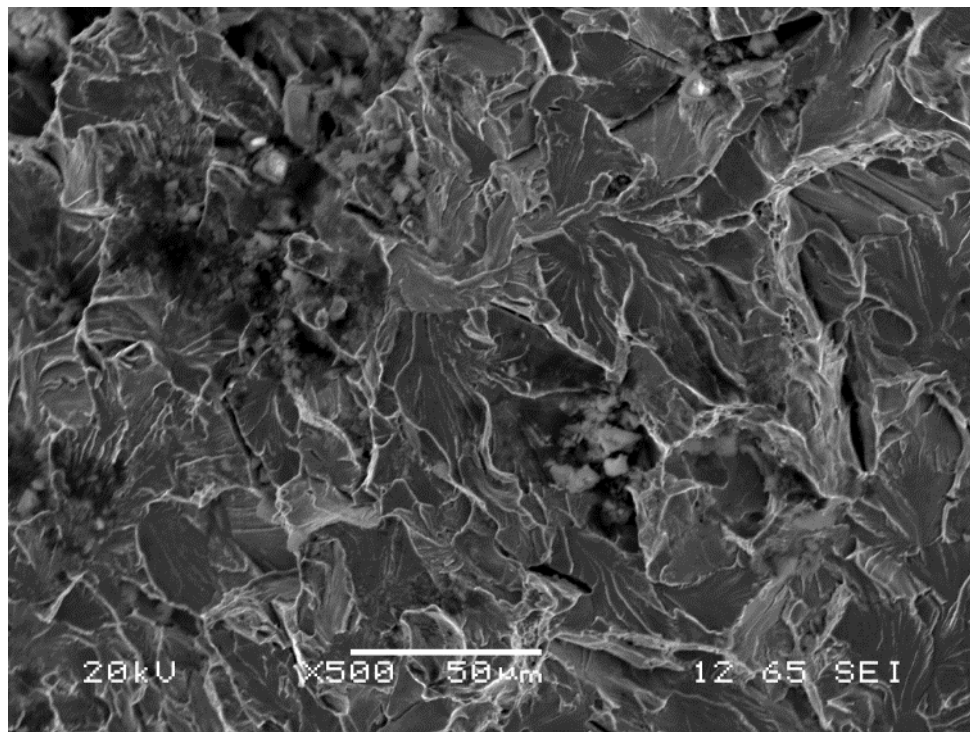
indicates that the fractures all occurred at temperatures below the ductile-to-brittle-transition temperature for the tower steel. No evidence of progressive cracking, such as fatigue crack initiation and growth or environmentally-assisted cracking, such as stress-corrosion cracking (SCC) was observed.

Figure 29. Representative SEM images from Stub A. Cleavage fracture morphology was observed throughout.

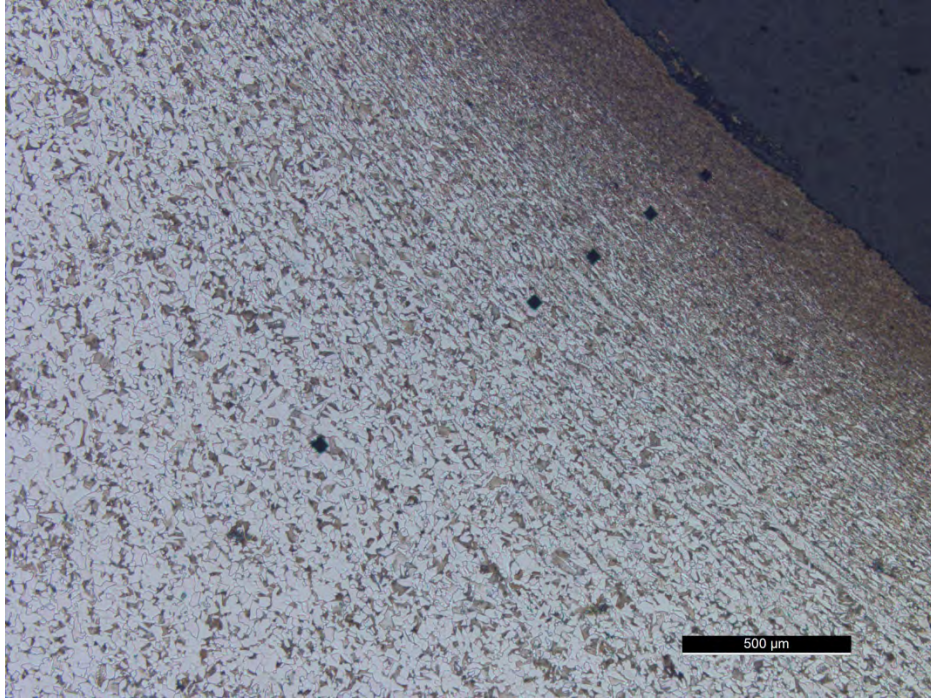
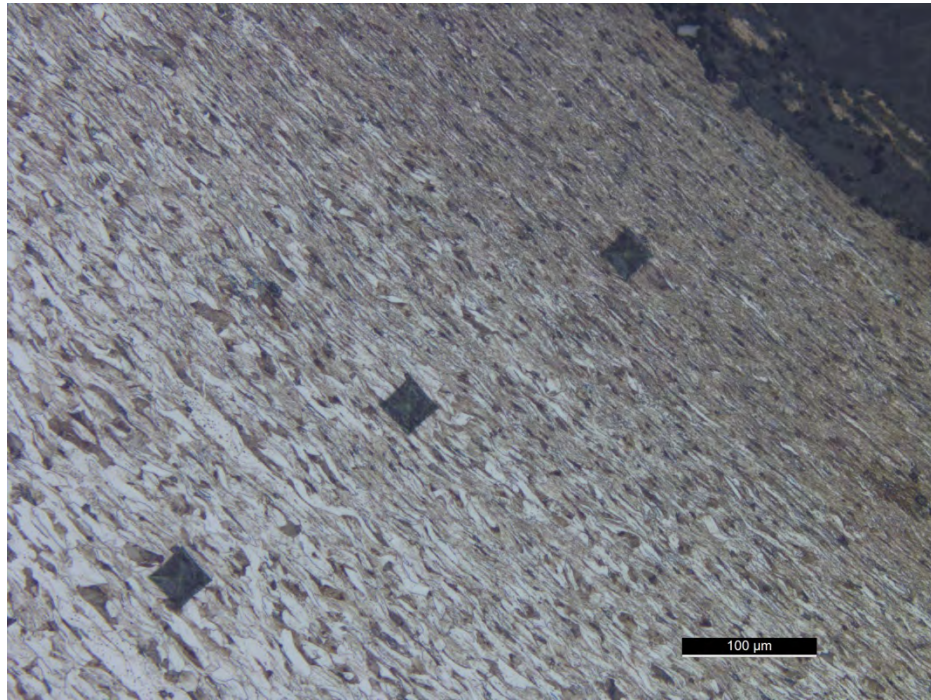
Figure 32. Metallographic image of the microstructure at a Stub D punched-hole fracture origin.

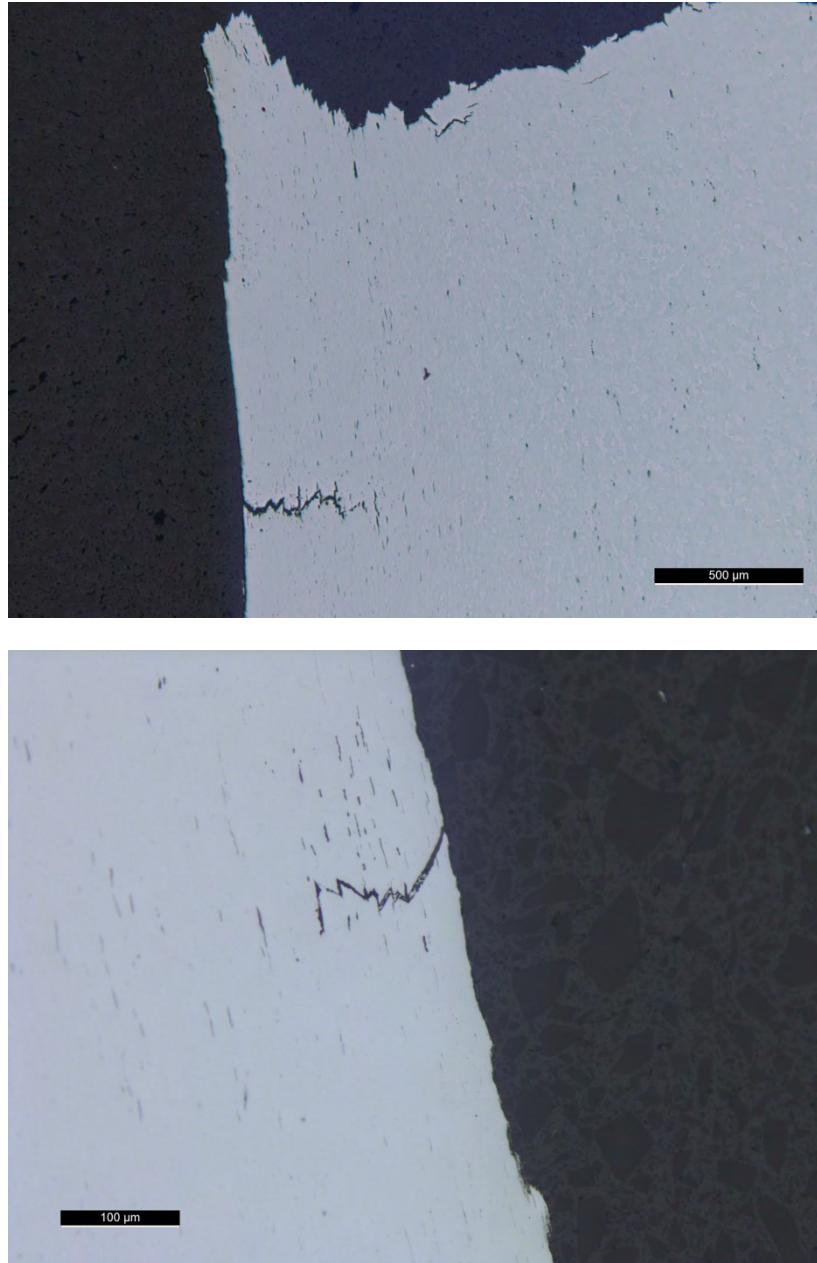
Secondary cracks were observed at some of the holes examined metallographically, as shown in for both Stubs A and D in Figure 35. These cracks were typically less than one-millimeter in length, within the zone of hardened material from the punching process.

Figure 35. Metallographic images of secondary cracks observed along the hole surface in Stub A (top) and Stub D (bottom).

2. Exponent recommends that PG&E consider updating material specifications for lattice tower construction to include minimum toughness requirements.
3. Exponent recommends that PG&E consider sub-punching and reaming any stub angles to be fabricated from recently purchased steel members unless they are shown to meet minimum notch toughness requirements.

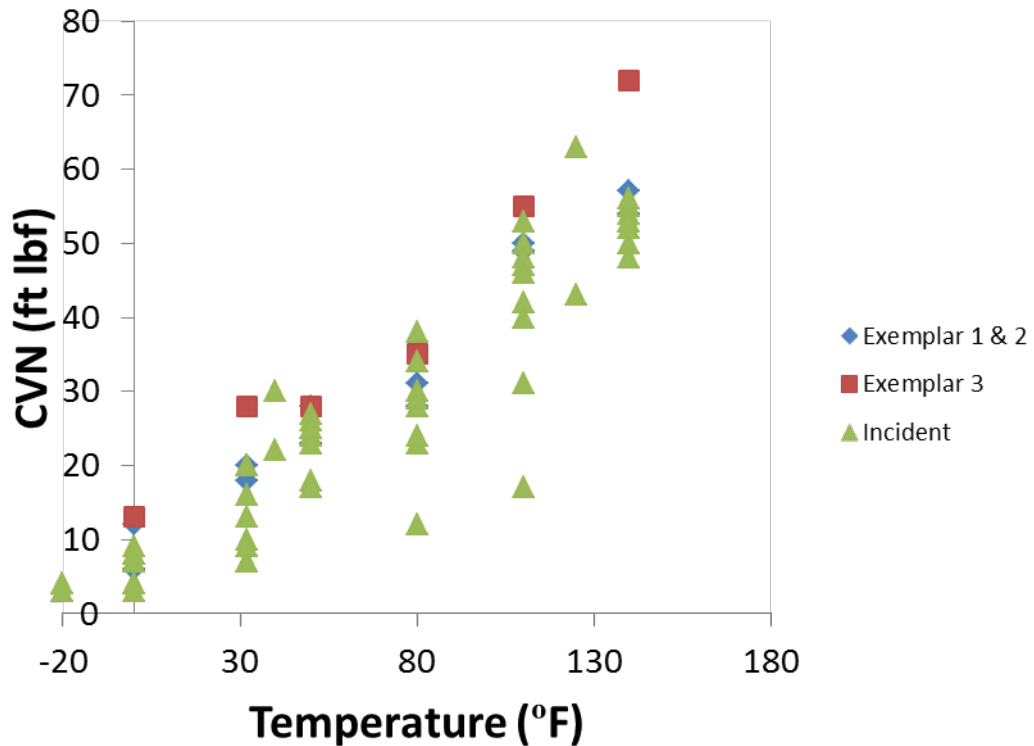
Figure 36. CVN data for each of the Incident stubs (A, B, C, D) and the three exemplar stubs.
