PUBLIC UTILITIES COMMISSION

CPUC File No.: EA2010-16

SUBJECT: Audit of LADWP's Northridge District

Audit Summary

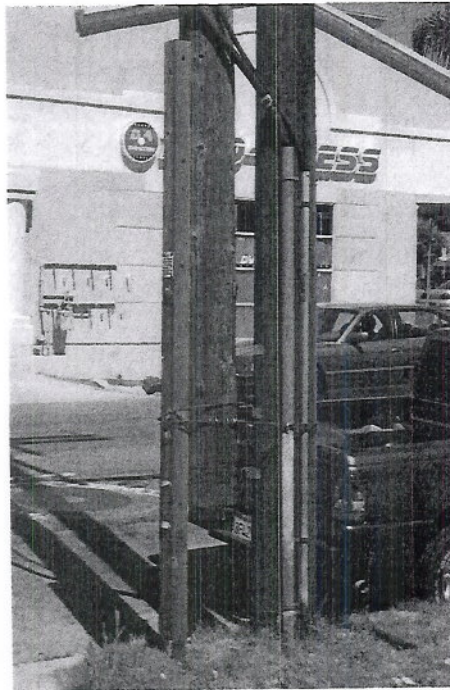
While inspecting pole number 402410M at 10246 Owensmouth Ave. in Chatsworth, I observed an adjacent pole that was topped at the communication level and supported by a piece of lumber at the ground level. This pole was last patrol inspected on November 11, 2009 and the inspector did not notify the other company and/or facility owner of the safety hazard.

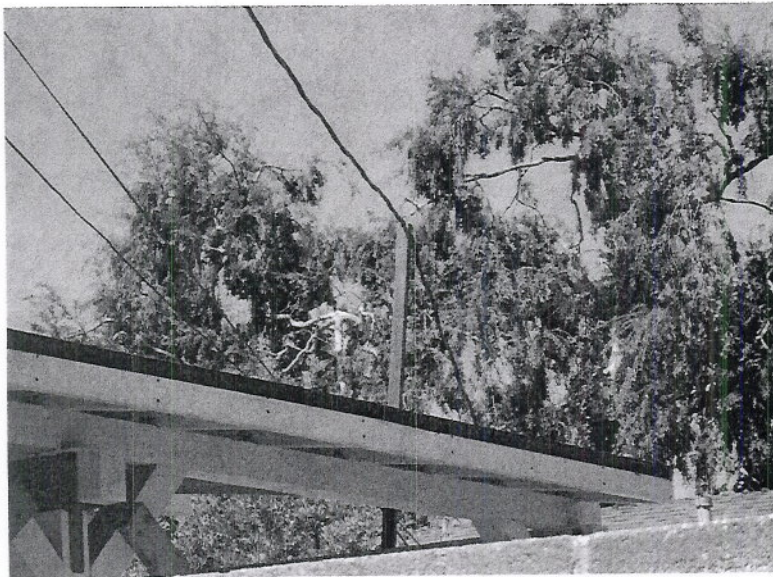
Pole number 250695M located in an alley near Loma Verde Ave. and Strathern St. in Canoga Park had a piece of wood supporting a service drop above a roof.

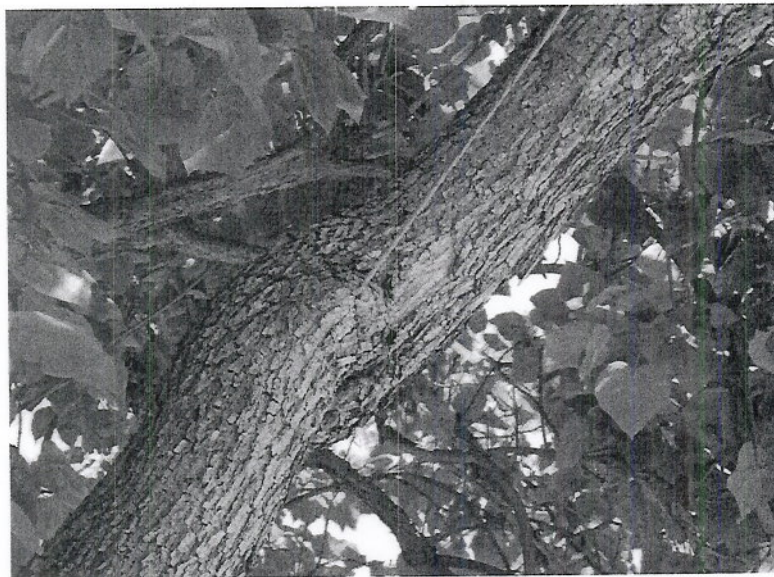
Pole number 70045M at 7849 De Soto Ave. in Canoga Park was found to have a span guy wire in a tree branch.

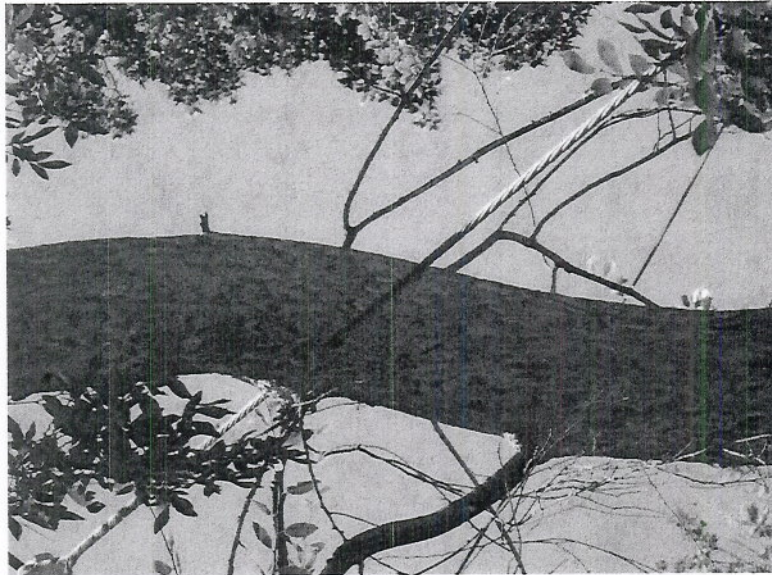
Pole number 335958M located near Saltillo St. and Castillo St. in Woodland Hills was found to have a down guy wire in a tree branch.
