Aliso Canyon RCA Phase 4 Protocol for Metallurgical Investigation of the SS-25 Failure

RCA SS-25: CPUC, DOGGR, SoCalGas

February 15th, 2018

SCG-16-001

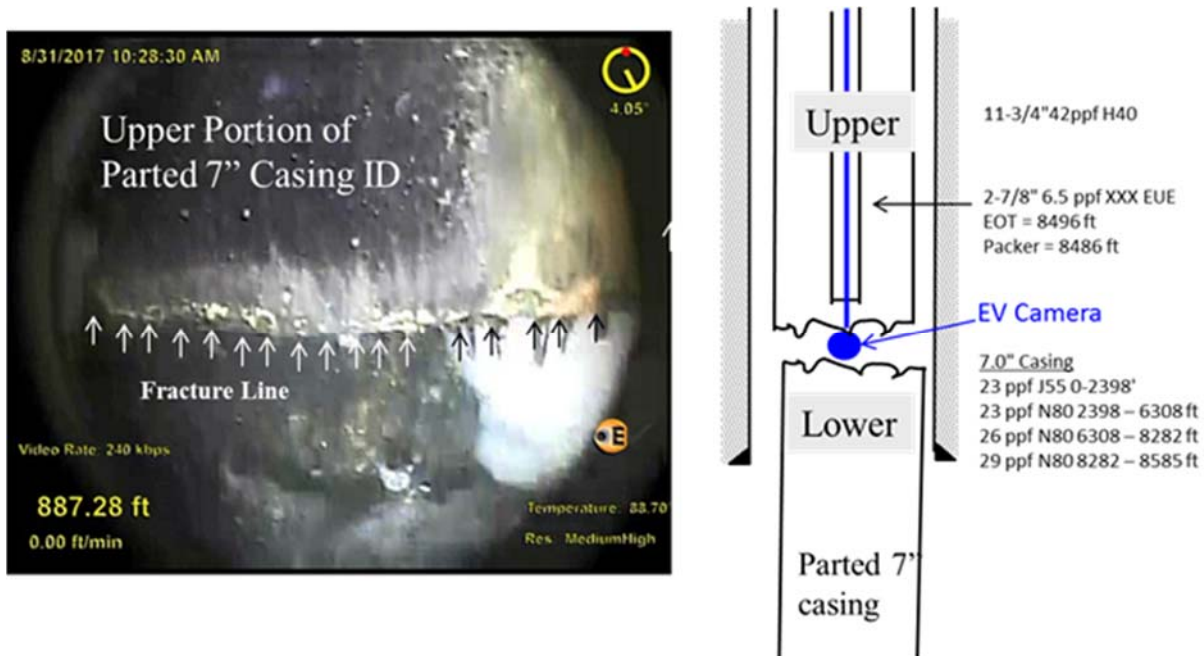
The 7" casing was inspected with an EV downhole video camera on August 30th, 2017. The inspection identified a fully parted casing at an approximate depth of 887' WLM (wireline measurement). Figure 1 shows a snapshot taken from the downhole camera video showing the upper portion of the parted 7" casing. The joint associated with the parted casing was identified as joint 22.

Figure 1: An EV video camera image showing the parted casing located at 887.28 ft WLM

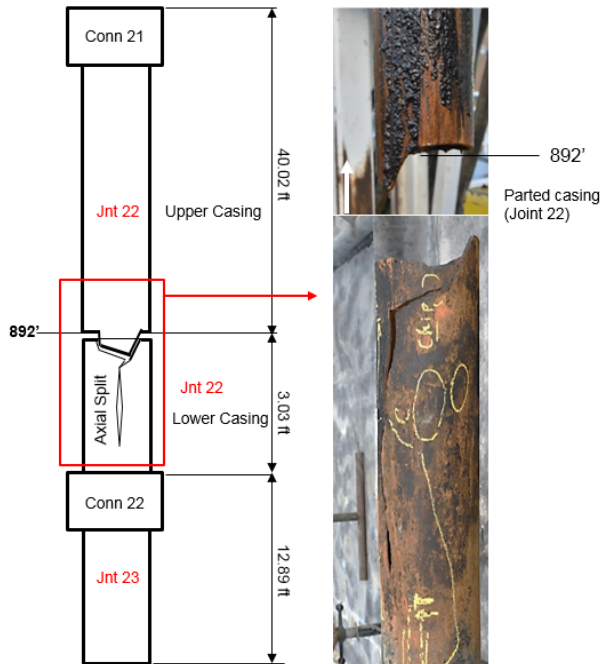
Figure 3: Sketch and field photo showing the upper and lower fish of the parted 7” casing (Joint 22)

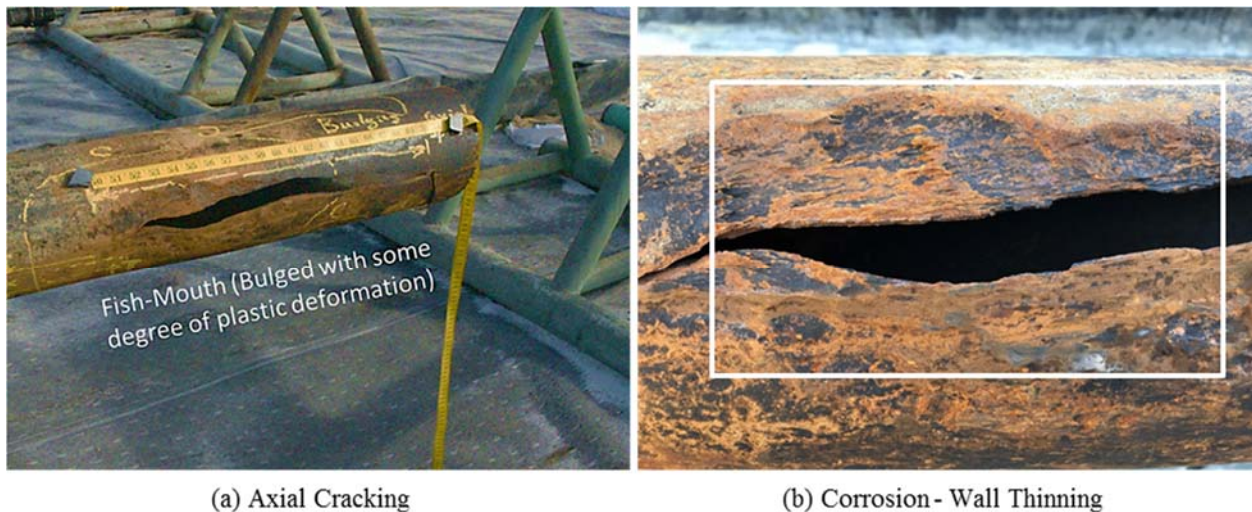
On-site examination of the failure indicated that the circumferential parted-failure of Joint 22 was brittle with little plastic deformation such as necking or shear (Figure 3). The axial split (cracking) exhibited some degree of bulging (i.e., plastic deformation), Figure 4a. Severe external corrosion (i.e., OD corrosion) was observed in the failure areas; indicating the axial split that is associated with wall thinning due to corrosion, Figure 4b.

Figure 4: Images of the axial split showing the (a) fish-mouth appearance with some degree of bulging and (b) failure associated with corrosion/wall thinning

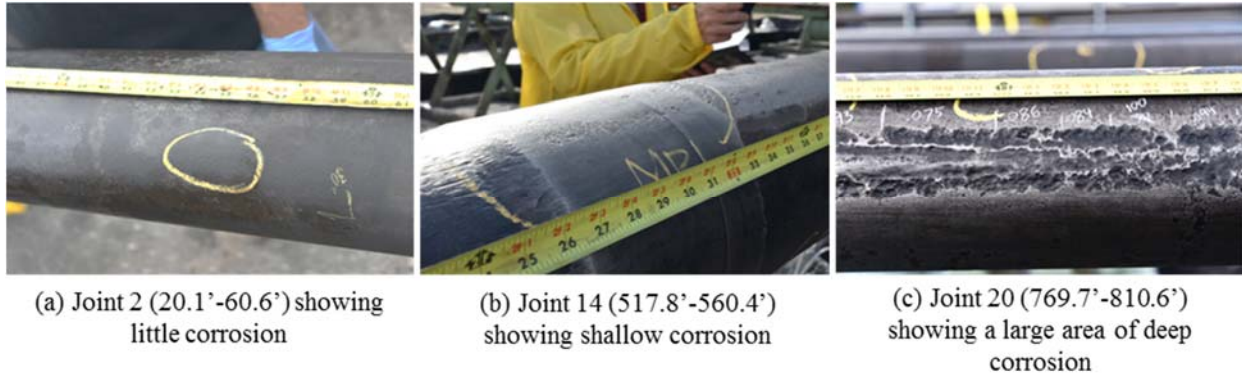
The severity of corrosion appears to increase with increasing depth, with the most severe corrosion seen at failed joint 22. Figure 5 shows examples of the observed corrosion trend. The

images show that Joint 2 (at the depth of 20.1'-60.6') and Joint 14 (at the depth of 517.8'-560.4') contain increasing amounts of shallow corrosion while Joint 20 (at the depth of 769.7'-810.6') contains severe corrosion.

Figure 5: Severity of 7" casing external corrosion as a function of joint depth

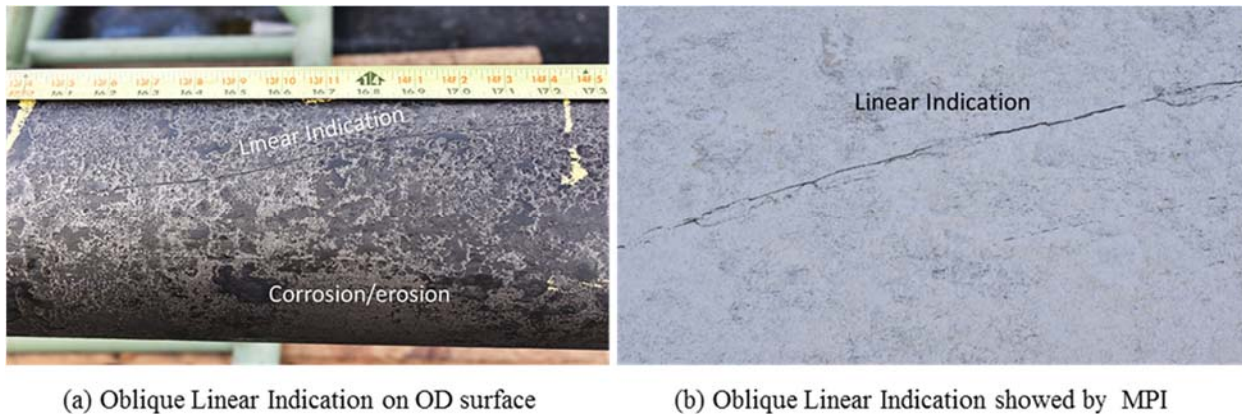
Another type of indication found during the field investigation was oblique, shallow crack-like features. The angle of the crack-like features was slightly deviated from the longitudinal axis of the casing. The features were identified by visual examination and confirmed by field magnetic particle (MPI) and ultrasonic inspection. Figure 6 shows an example of this type of indication on the casing OD surface from joint 19 both before and after white paint MPI. In addition, areas of mechanical damages such as gouges, tong marks, slip marks, and possibly erosion/corrosion marks were also observed. Figure 7 provides examples of these types of mechanical damage.

Figure 6: Images of joint 19 showing an oblique crack-like feature (a) before and (b) after MPI

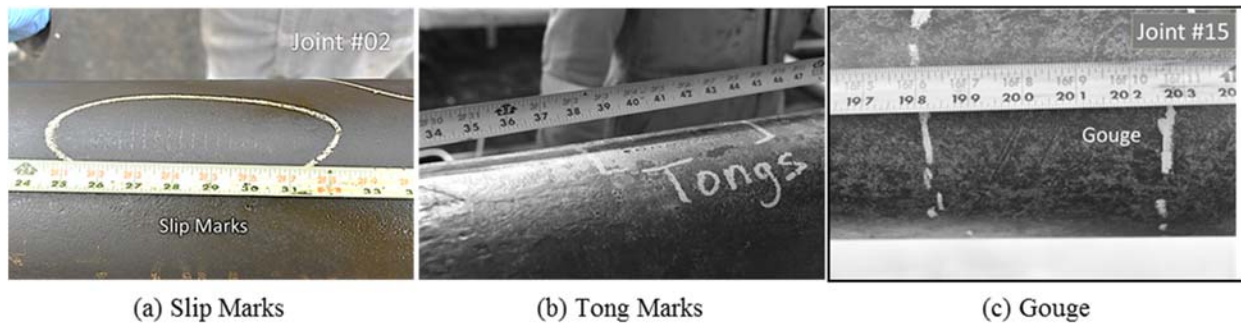
Figure 7: Type of mechanical damages seen on the 7” casing (a) Slip Marks, (b) Tong Marks and (c) Gouge

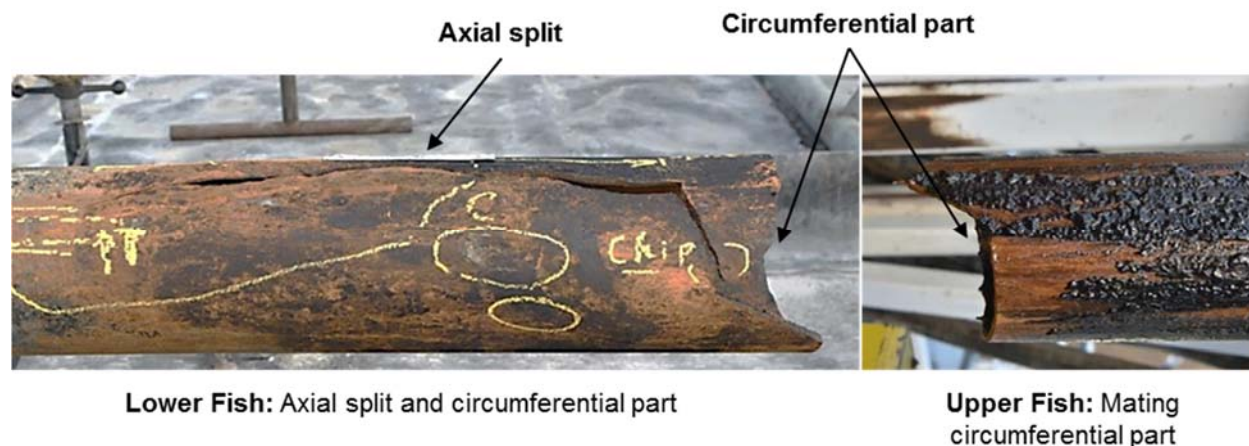
Figure 27 shows an image of the upper and lower fish of the 7" parted casing. The images illustrate the axial split and circumferential part. The origin of the failure will be determined by investigating the fractures surfaces of the axial split and circumferential part. This will be accomplished using visual examination, macro photography and stereo microscopy. Fracture surface features identified during the investigation will assist in determining the origin of the fracture. Once identified, the origin will be clearly marked and sized (for example, length, depth and width for corrosion). The remaining areas of the fracture surface will also be further examined and sized for zones of fracture. This will also be accomplished using macro photography and stereo microscopy. Each unique zone will be clearly marked for future investigation.

Figure 27: Lower and upper fish (parted 7" casing Jnt 22)

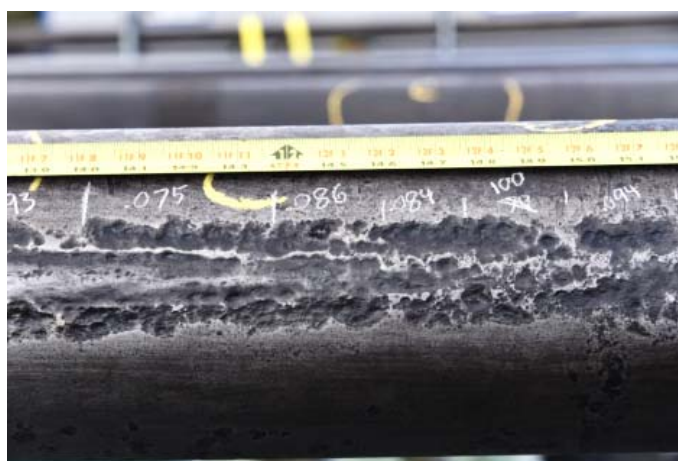
Corrosion features were identified during the field examination of the 7" casing. The severity of the corrosion appeared to increase with depth. The observation is qualitative in nature. Attempts will be made to quantify the observations using 3D laser scanning techniques as is described in Section 5. Figure 28 shows an example of a more severe corrosion feature. The main goals of the corrosion investigation are as follows:

Figure 28: Example of erosion/corrosion feature (Jnt 20)

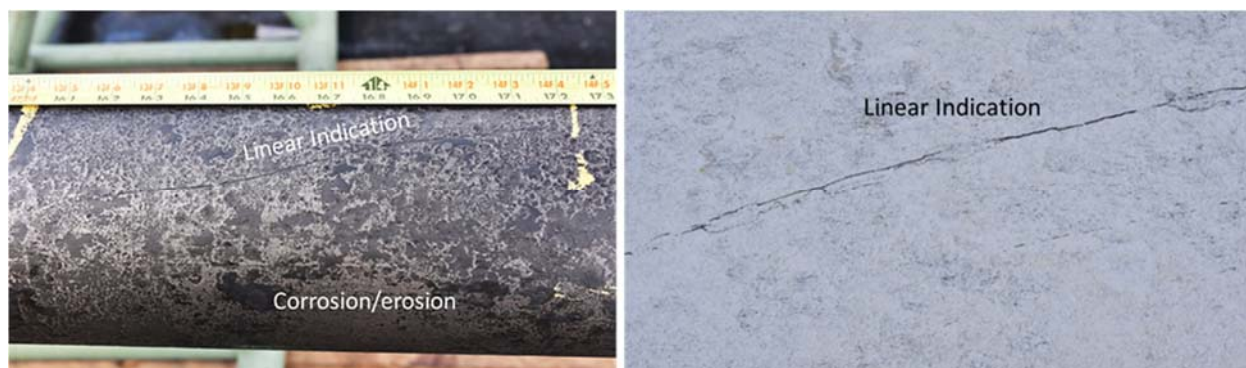
Oblique crack-like features were identified during the field visual examination of the 7” casing. The features were visible after cleaning, but were more apparent after black and white magnetic particle inspection (MPI). The features were oblique to the axial orientation of the casing. The crack-like features appeared straight and tight. The main goals of the oblique crack-like feature investigation are as follows:

Figure 29: Example of oblique crack-like feature
