CALIFORNIA PUBLIC UTILITIES COMMISSION

Incident Investigation Report

Incident Number: G 20171127-2428

Utility: Pacific Gas and Electric PG&E

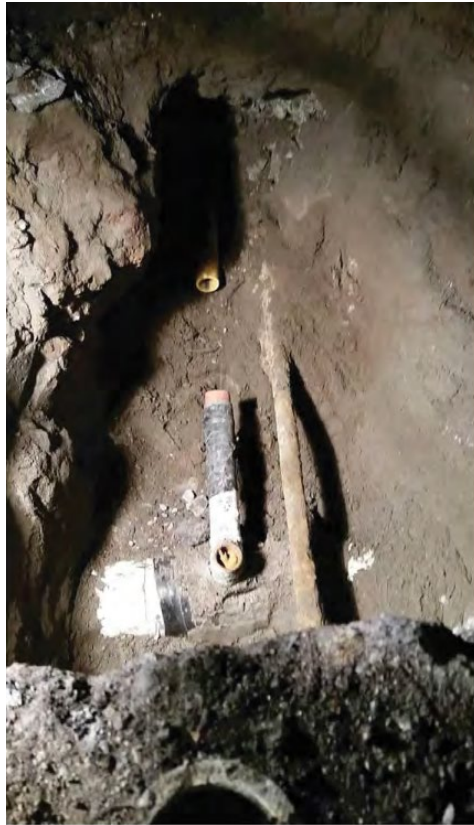
abandoned service tee shown in Figures 1 and 2. Figures 1 and 2 show that the service tee was not capped by a mechanical fitting, fusion fitting or weld cap.

Figure 1. Source of the gas leak¹

PG&E failed to properly abandon the service line to 3976 Mission Street during project 30267522X. The failure to permanently seal the still live service tee resulted in the X-Pando plug being used for longer than its typical temporary application, as well as being subject to pressures higher than the component is designed for, especially after the uprate project in 2013. Therefore, SED finds PG&E in violation of Title 49 CFR § 192.621(a)(1).

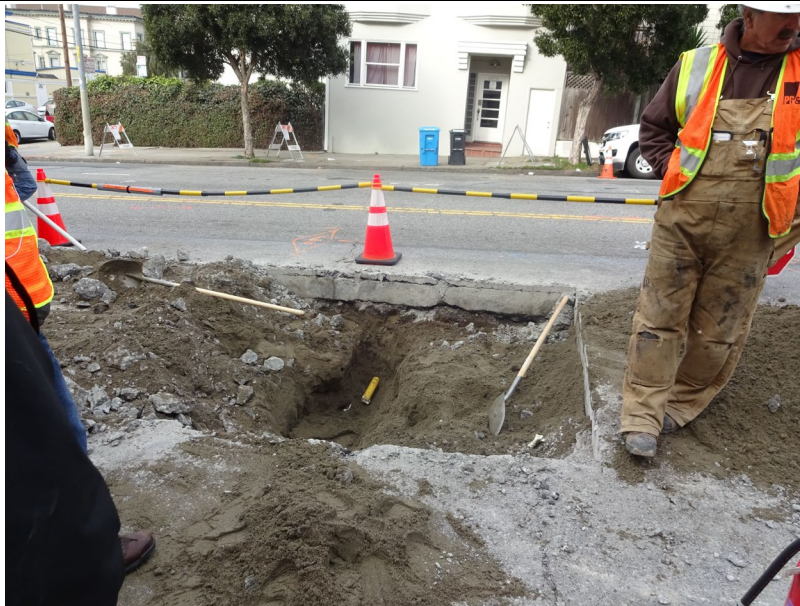
Figure 2. Photo of abandoned service tee location looking northwest towards [REDACTED]

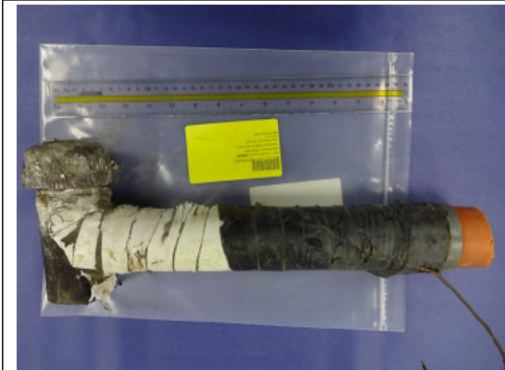
PG&E hired Exponent to investigate the root causes of the incident. PG&E removed the service tee and transferred it to Exponent's lab. Figures 3-6 are photographs of the service tee at Exponent's lab. Figures 5 and 6 show closeups of the expander plug from the top and the bottom in a dislodged state similar to Figure 1.

Figure 3. Photograph of Mueller Tee after removal from scene.³

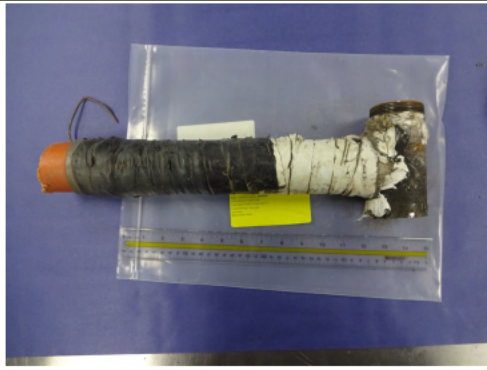
Figure 4. Mueller Tee after removal from scene.³

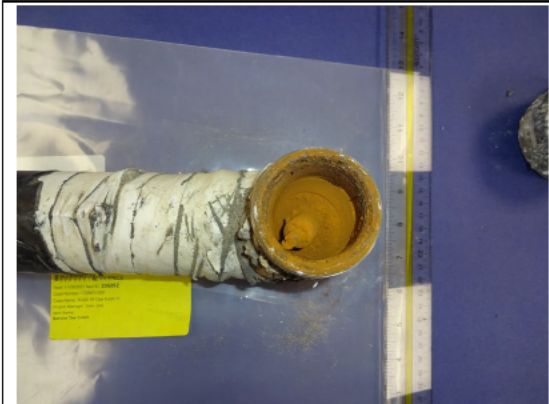
Figure 5. Top view of Mueller Tee showing top of X-Pando Plug.³

PG&E failed to follow Procedure C-36.1 Rev #00 Gransky Bag Method for Stopping Off Low Pressure Service Tees when it failed to remove the X-pando plug from the service tee. PG&E also failed to follow A-93.2 for failing to use approved mechanical or fusion end caps to seal the cut end. Therefore, SED finds PG&E in violation of Title 49 CFR §192.605(a).

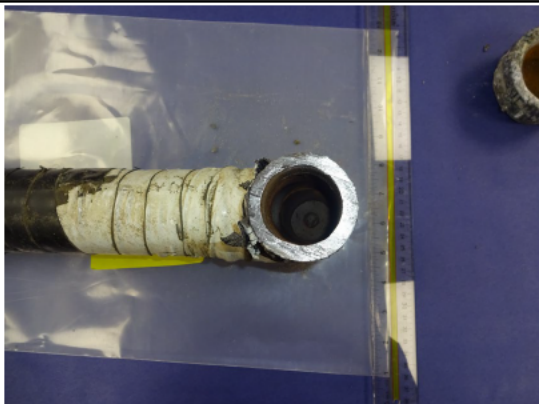
Figure 6. Bottom view of Mueller Tee showing bottom of X-Pando Plug.³

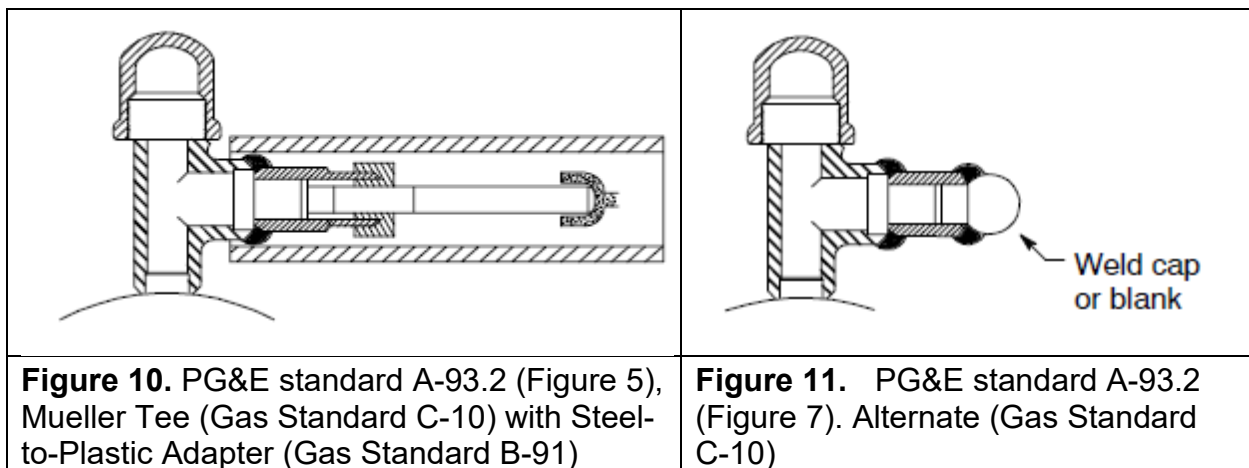
Figures 5 and 7 from the procedure illustrate examples of how the service connection can be deactivated.

- B. Cut the plastic service pipe 4" to 5" downstream from the service tee connection. Use approved mechanical or fusion end caps to seal the cut end.

- (3) If cutting the service 2' or more beyond the tee, follow the requirements listed in Item 4.
 - (4) Steel punch tee alternative: remove the comp.... Place wet rags around the tee if using a rubber stopper, and weld a cap or blank over the outlet....
