Exponent[®]

Failure Analysis Associates

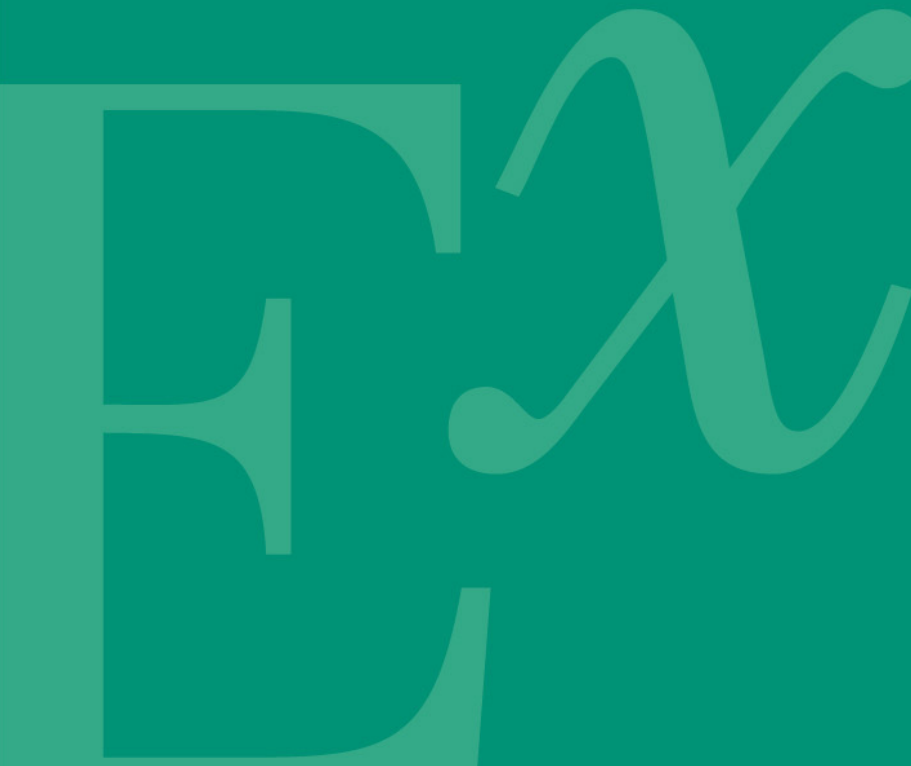
**PG&E Line 118B Fresno
In-Service Rupture Analysis**

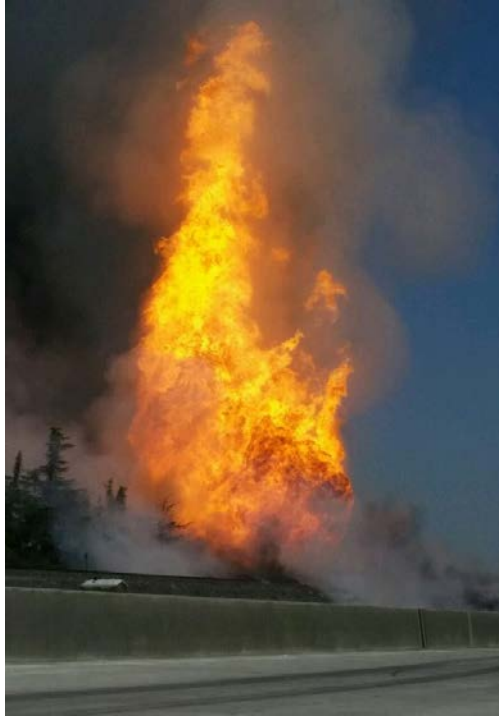
Figure 1. Photograph of the fire associated with the rupture taken from Highway 99.
Photo: Kevin Ling / Associated Press.

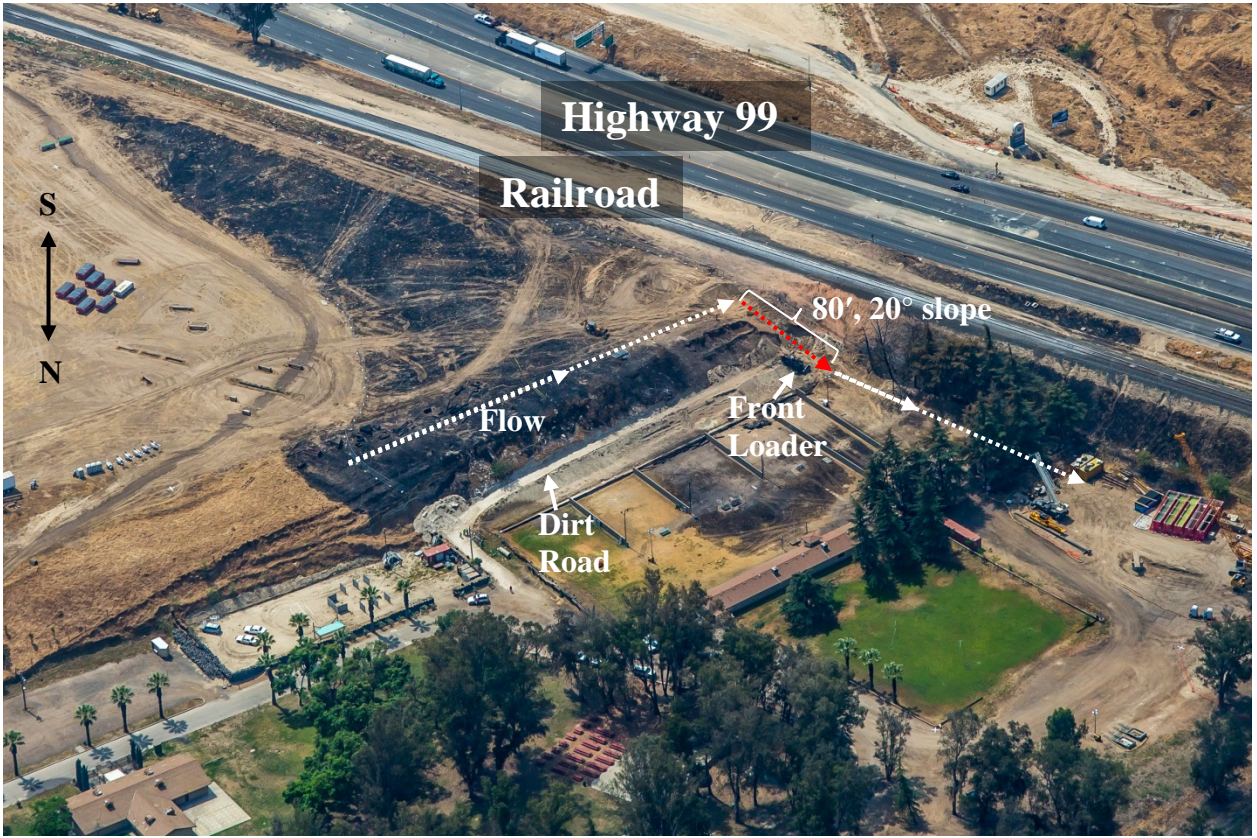
Figure 2. Aerial photograph of the incident site after the incident and pipe excavation. The area of pipe rupture is shown by a dotted red line.

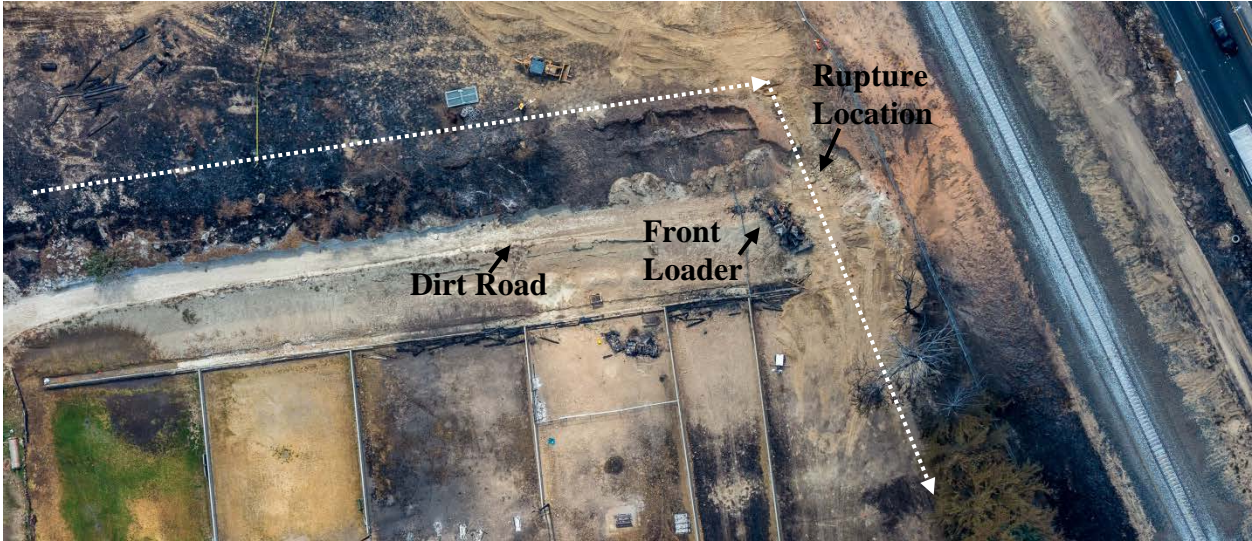
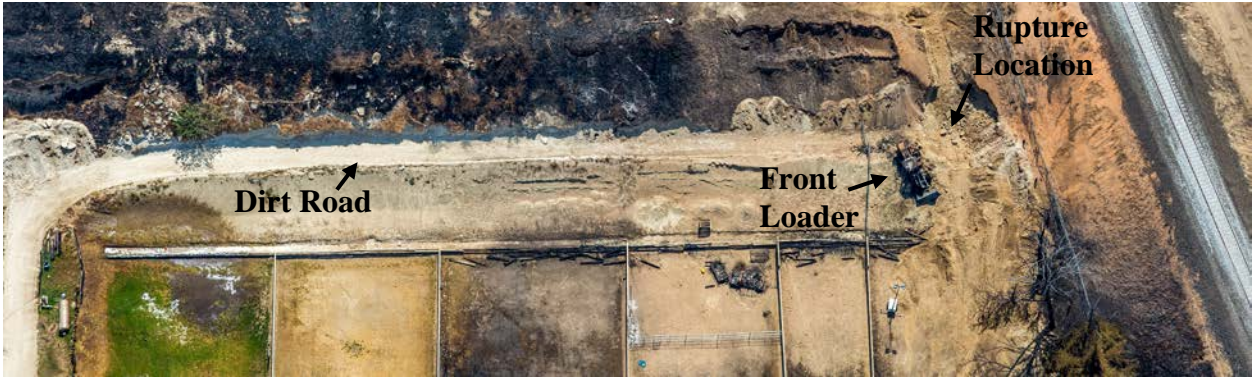
Figure 3. Aerial photographs of the incident scene taken after the incident and pipe excavation.

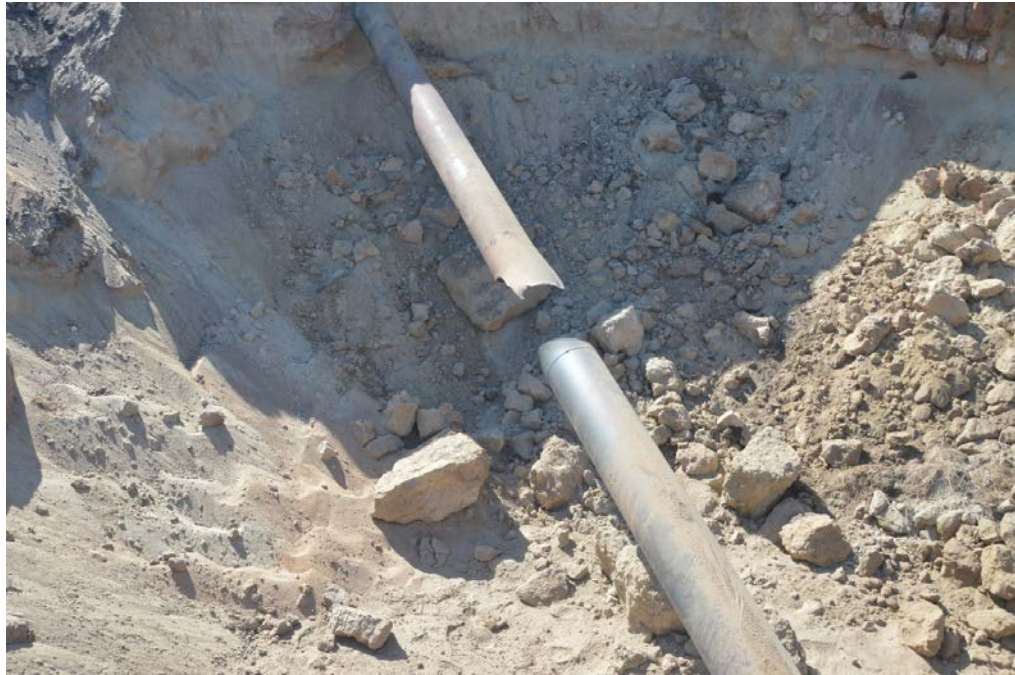
Figure 4. Photograph of the ruptured pipe segments taken looking upstream (southeast).

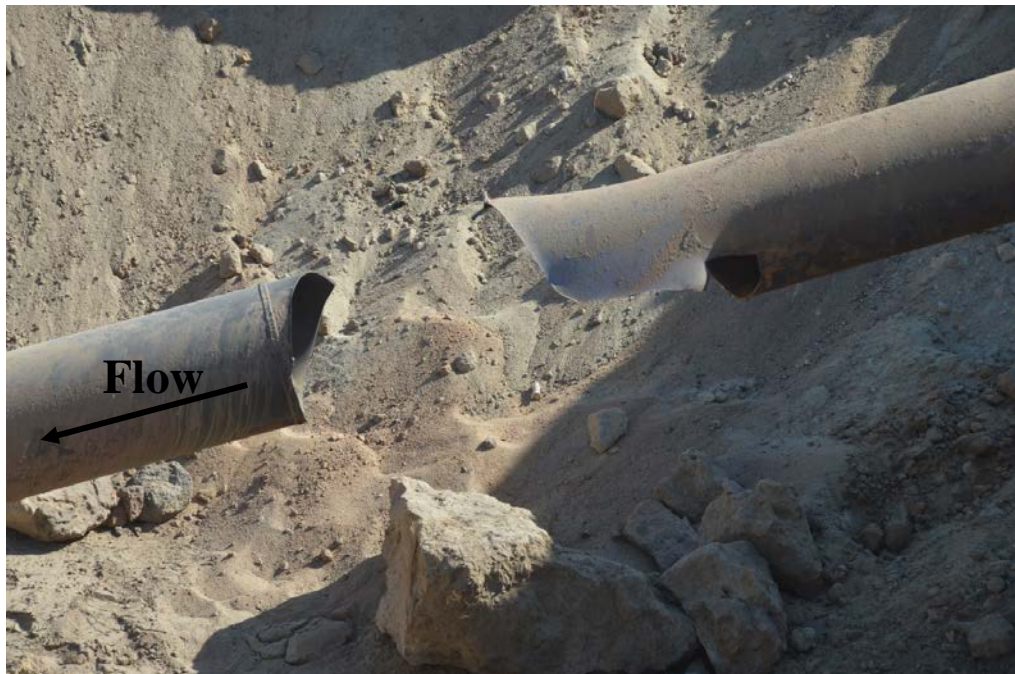
Figure 5. Photograph of the ruptured pipe segments looking northeast toward the dirt road and away from the railroad and Highway 99.

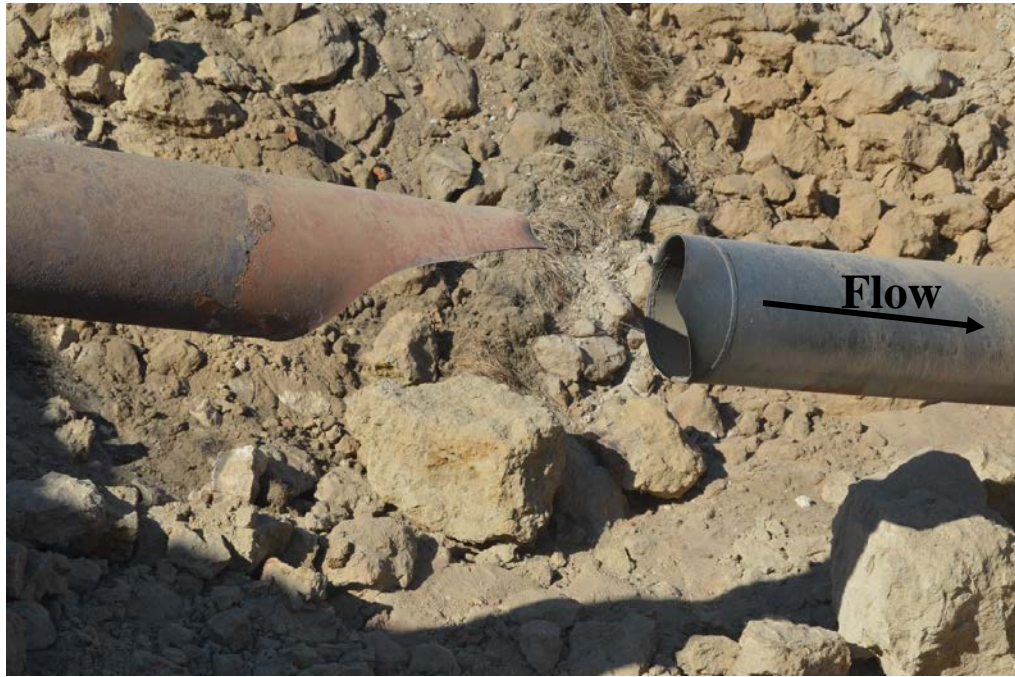
Figure 6. Photograph of the ruptured pipeline looking southwest toward the railroad and Highway 99.

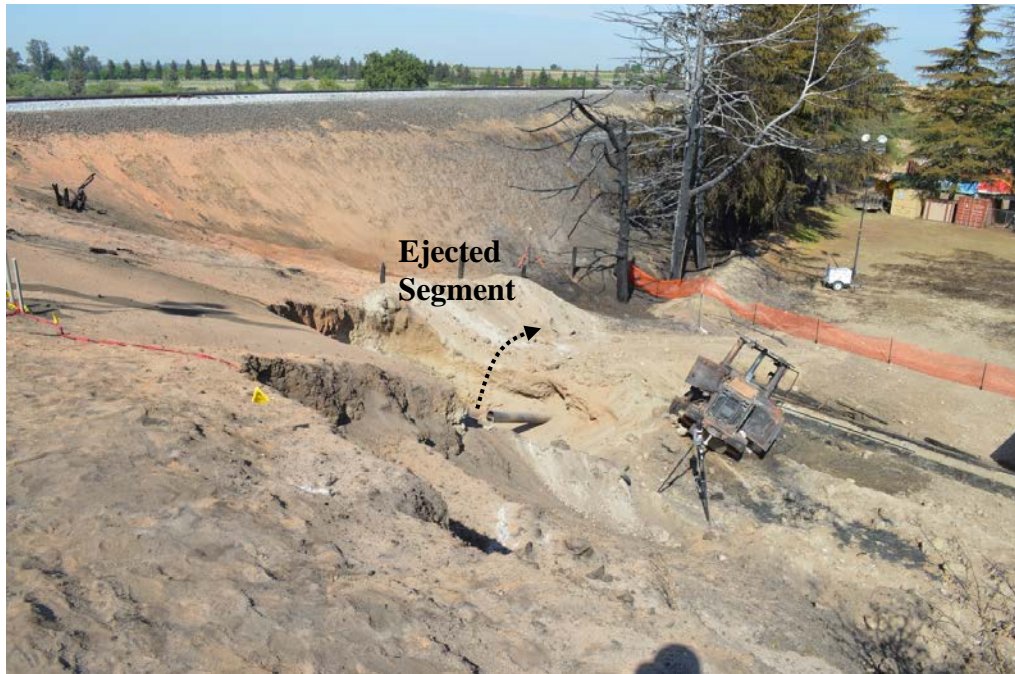
Figure 7. Photograph looking west toward the rupture crater from the top of the slope. The Ejected Segment is visible northwest of the crater.

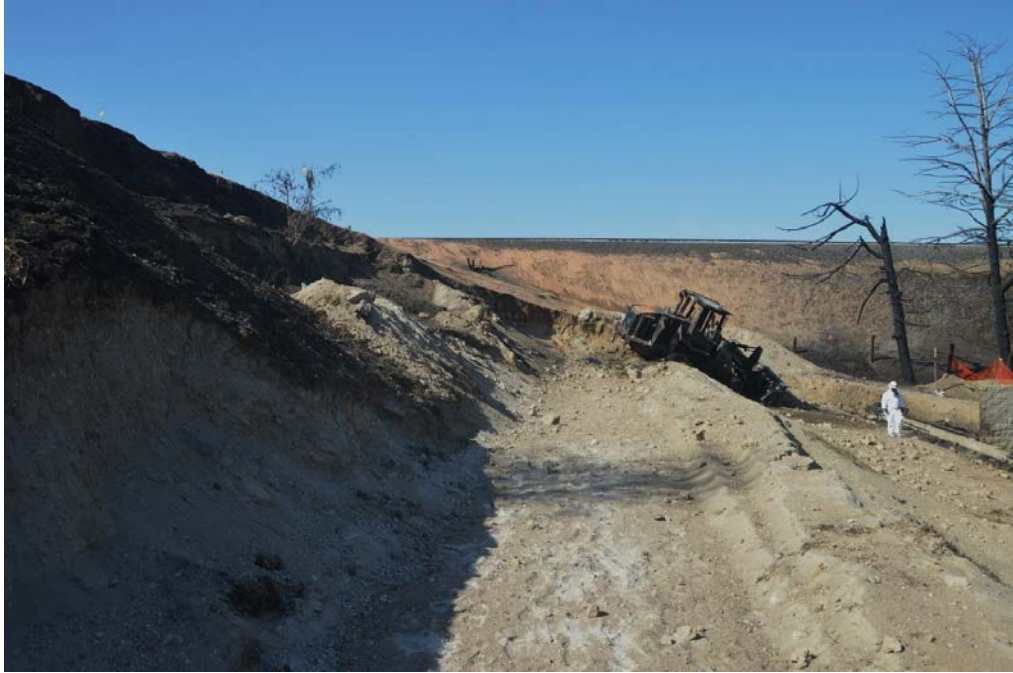
Figure 8. Photograph of the incident site taken from the dirt road looking southwest toward Highway 99 and the railroad.

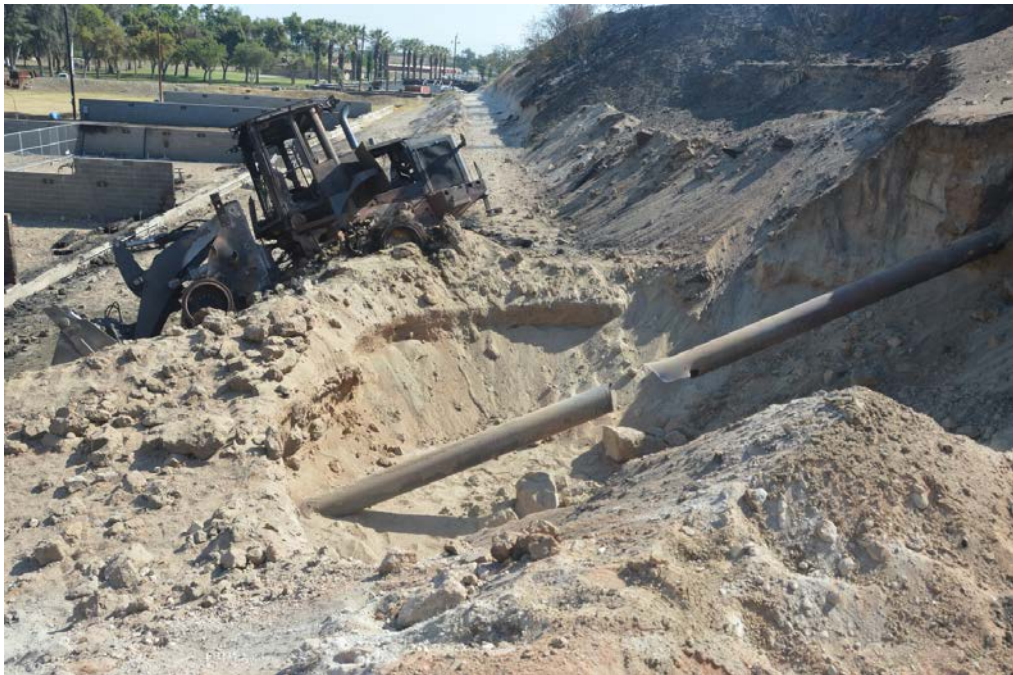
Figure 9. Photograph looking northeast at the ruptured pipeline and crater with the dirt road in the background. The uphill side of the road is coincident with the rupture location.

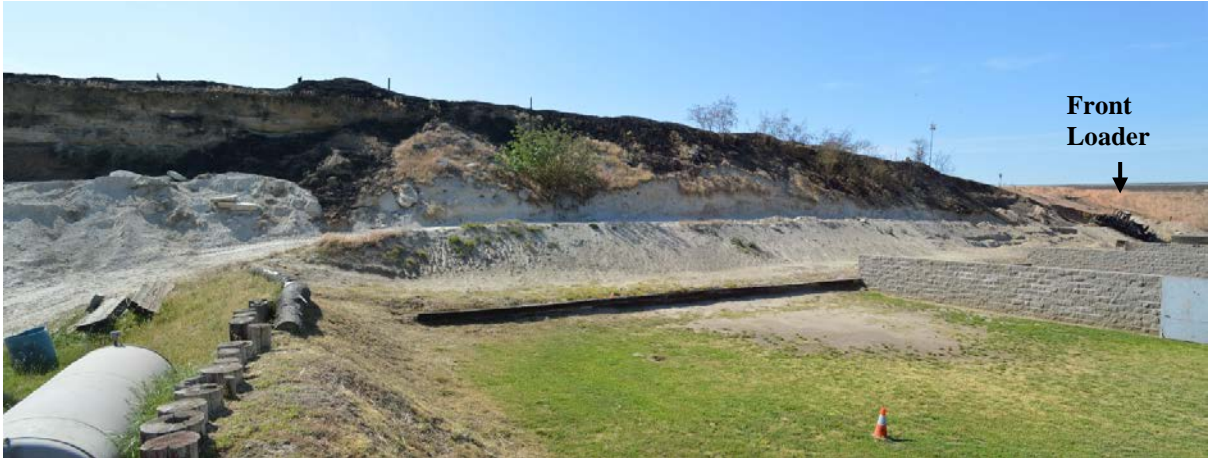
Figure 10. Photograph looking south from the shooting range toward the slope behind the range. This image, taken after the rupture occurred, shows the dirt road cut into the slope and extending from the near left toward the far right, where the front loader is visible.

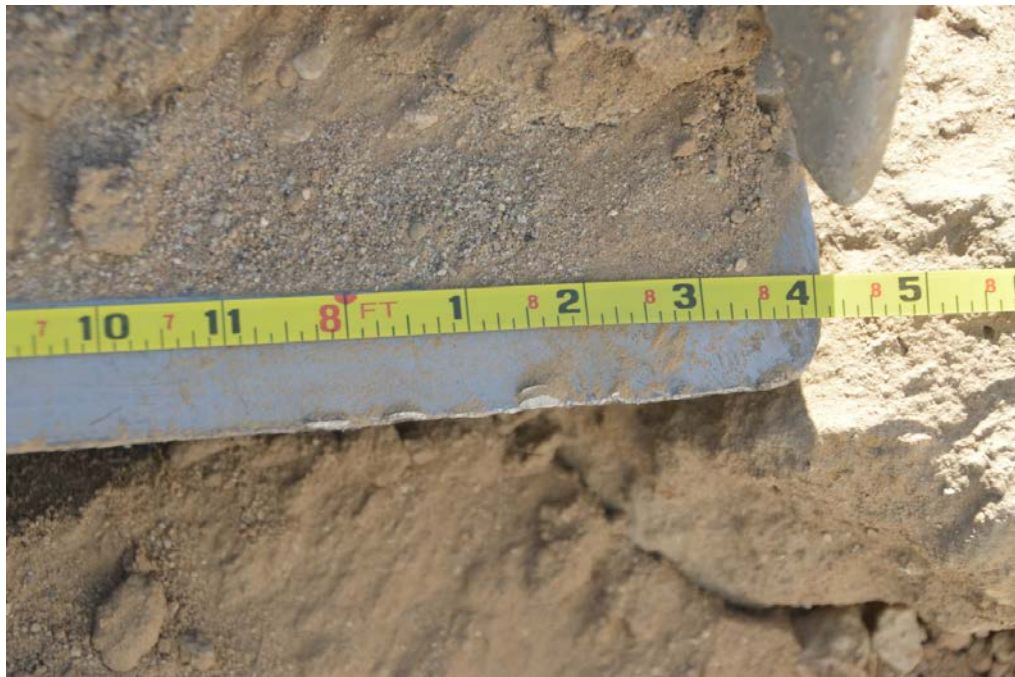
Figure 11. Photograph showing the left front corner of the bucket blade of the front loader.

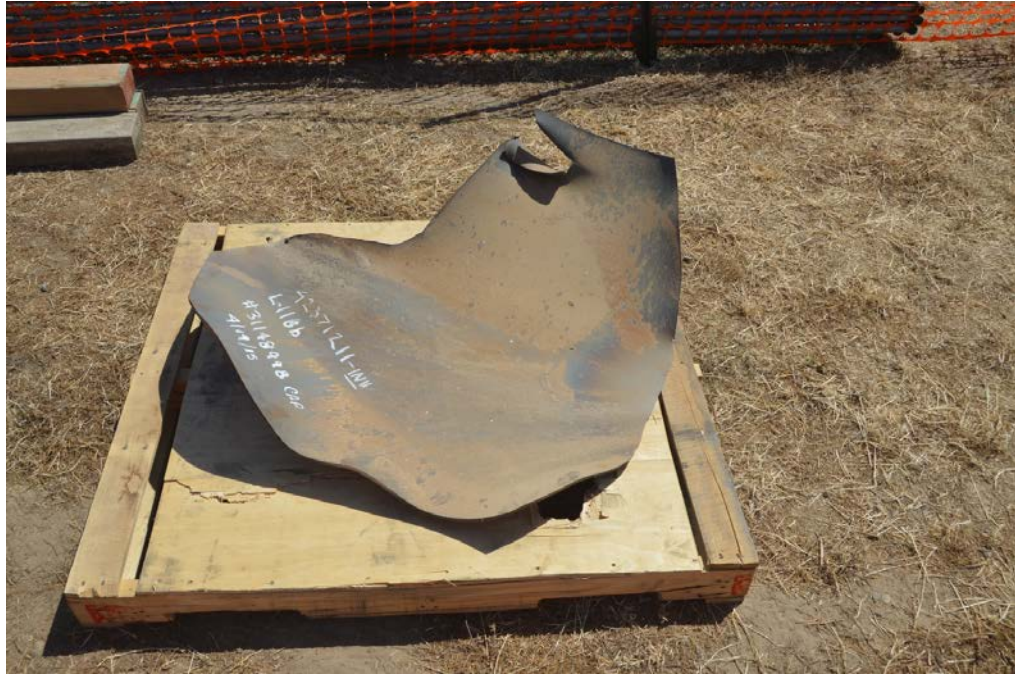
Figure 12. Photograph of the Ejected Segment. The piece was found approximately 20 feet from the nearest edge of the rupture crater.

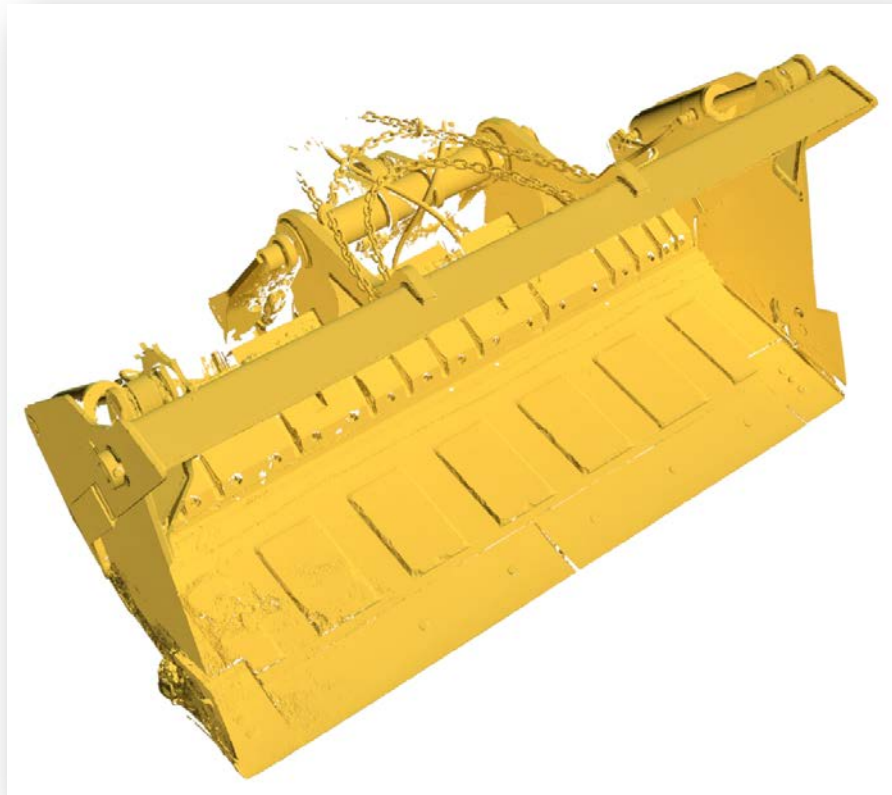
Figure 13. Laser-scan image of the front-loader bucket.

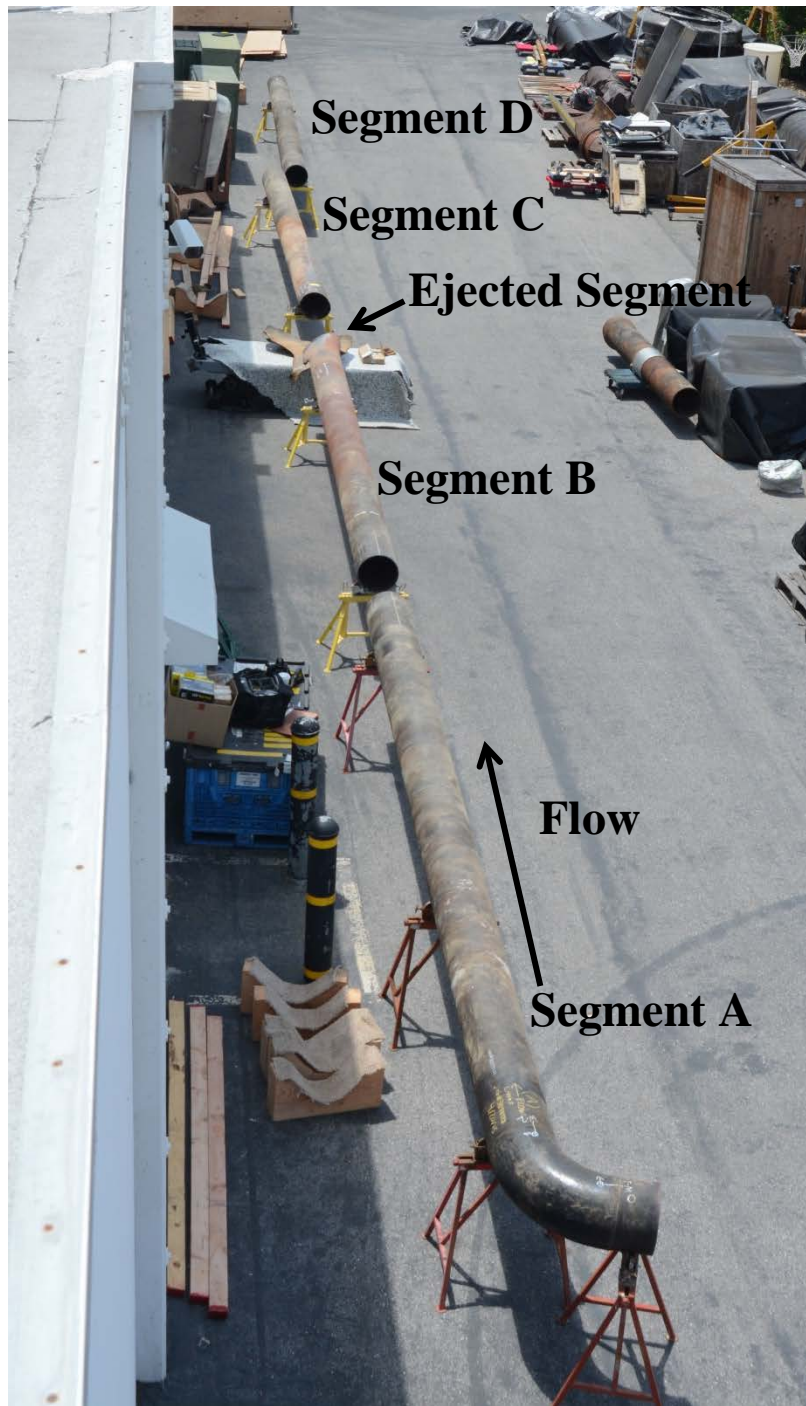
Figure 14. Photograph showing the five pipe pieces shipped to Exponent for analysis. From upstream to downstream, they include Segment A, Segment B, the Ejected Segment, Segment C, and Segment D.

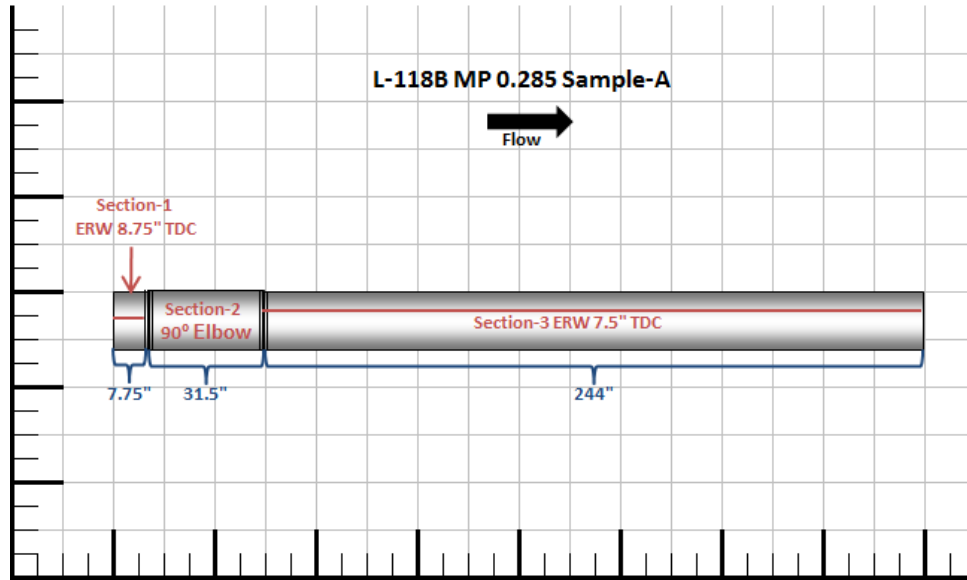
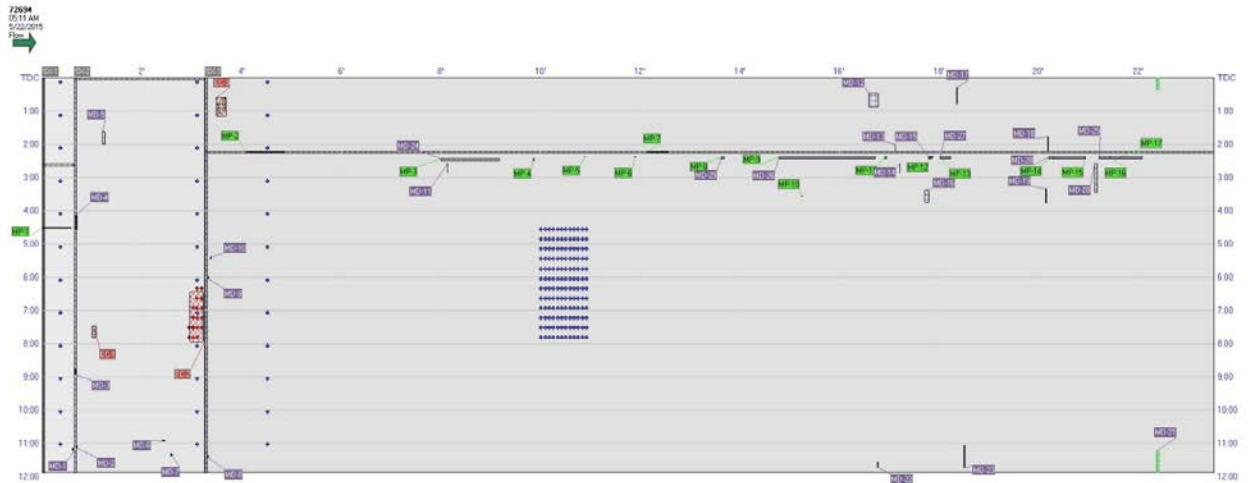
Figure 17. Overview of pipe Segment A. Indications are shown on the bottom image, with full details contained in Appendix A.

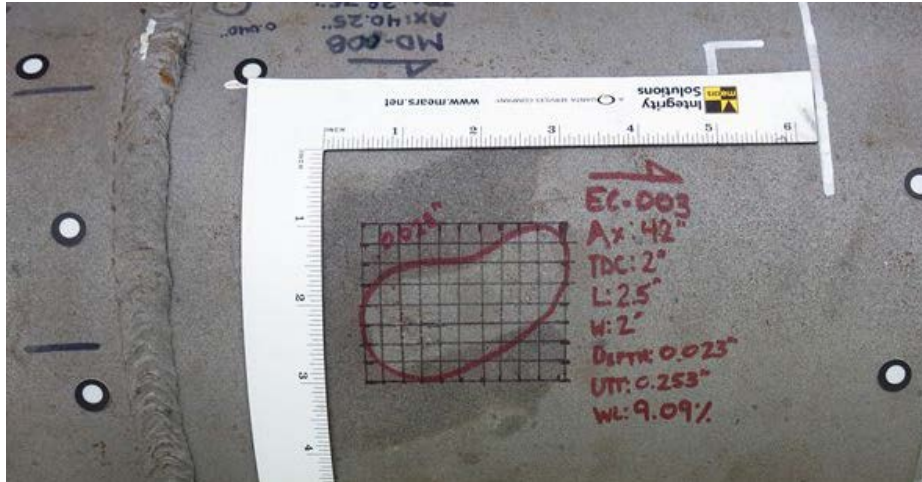
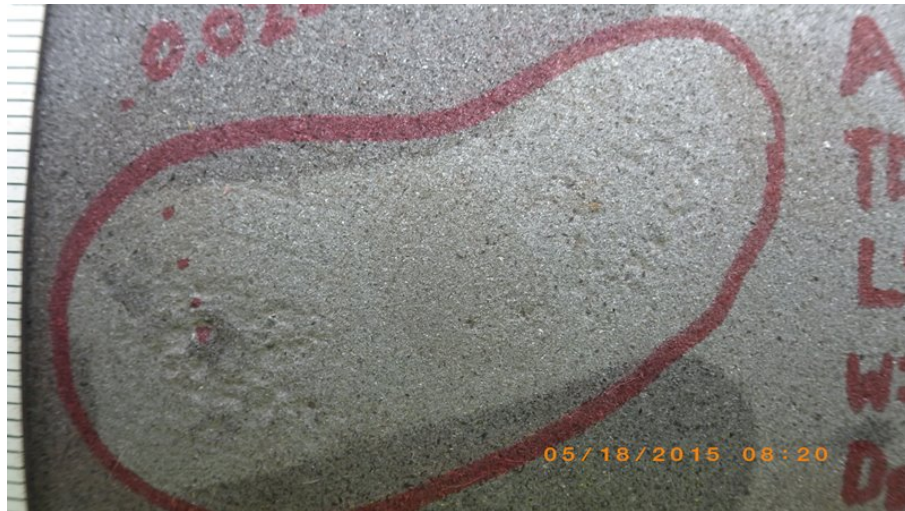
Figure 21. A representative example of minor external corrosion from Segment A (A-EC3).

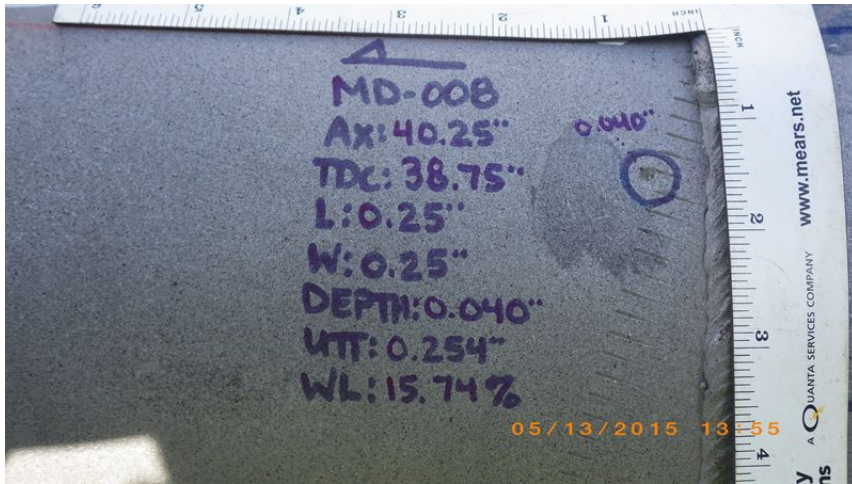
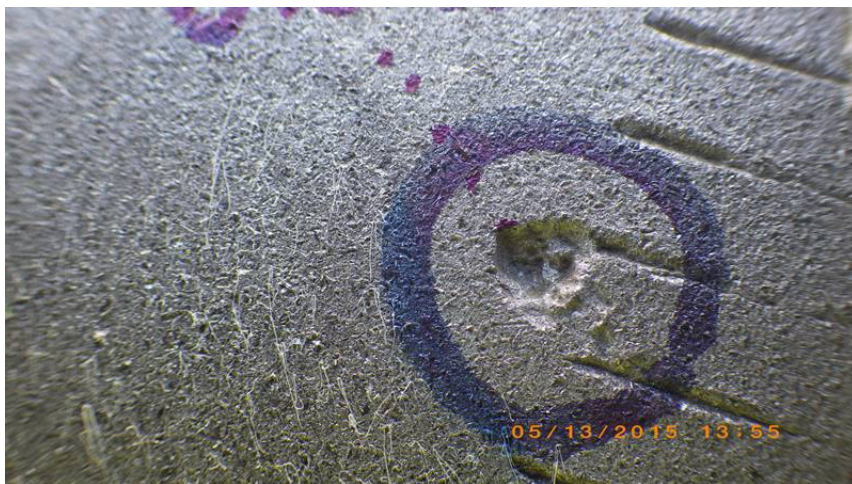
Figure 22. Arc-weld damage A-MD8 exhibited the greatest wall loss of any MD or EC at 16 percent.

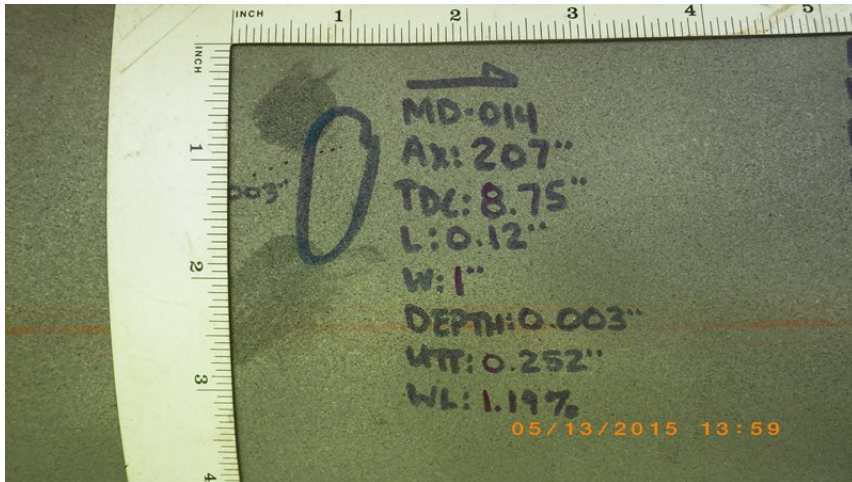
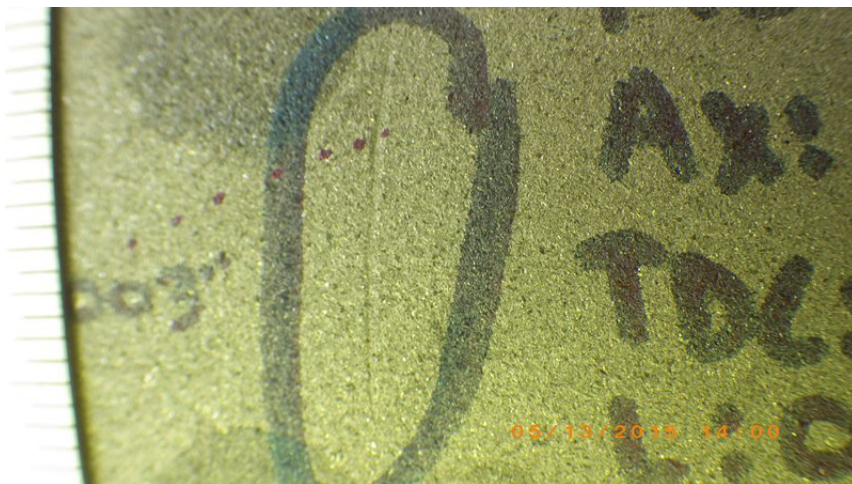
Figure 23. A representative instance of mechanical damage (A-MD14).

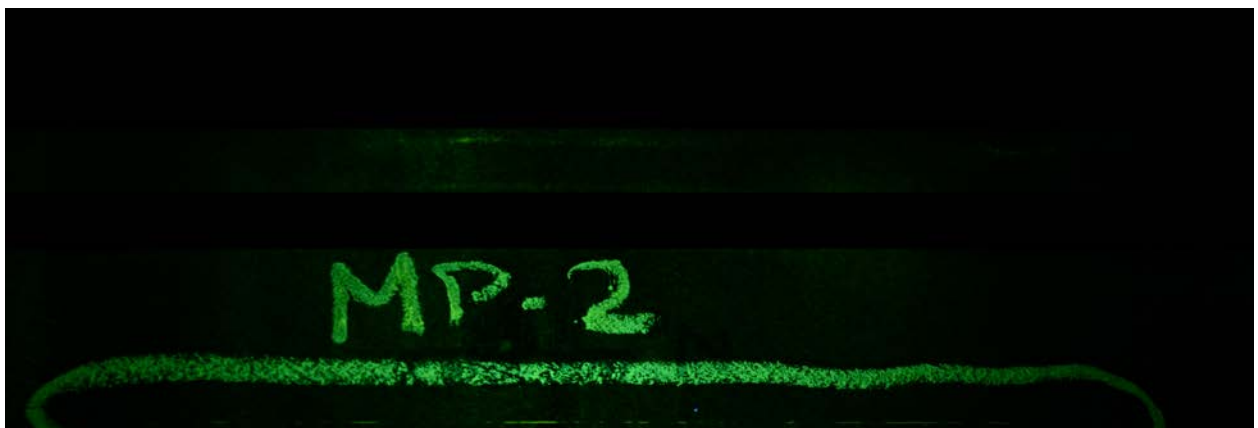
Figure 24. Magnetic particle indication A-MP2.

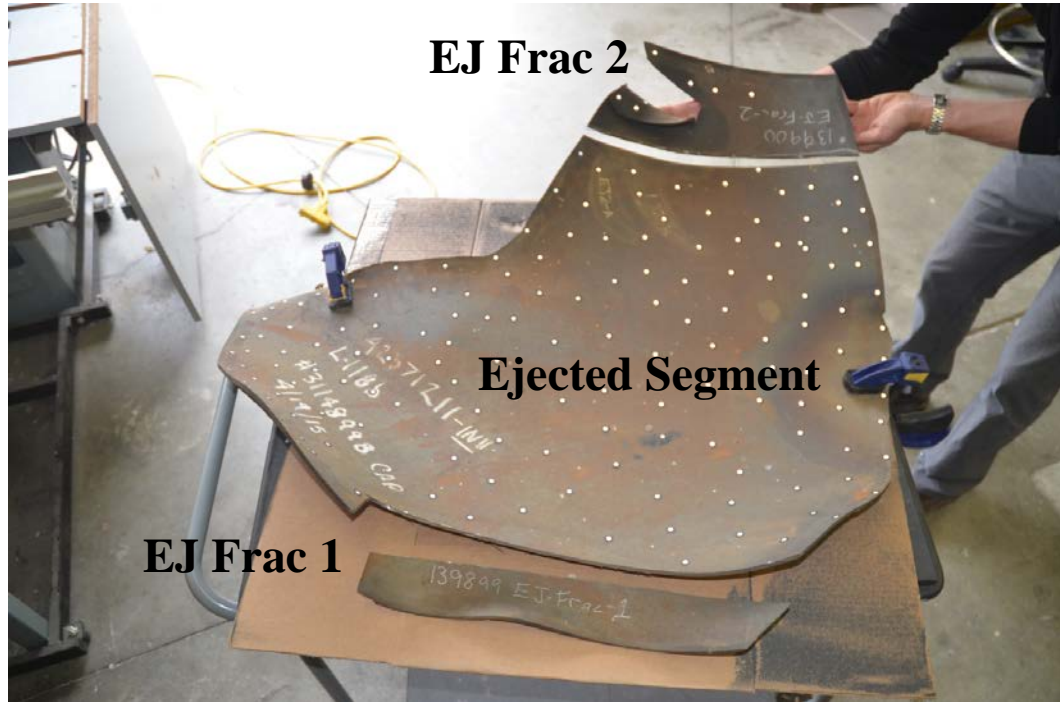
Figure 31. Initial sectioning of the Ejected Segment (center) to remove fractographic samples EJ Frac 2 (top) and EJ Frac 1 (bottom).

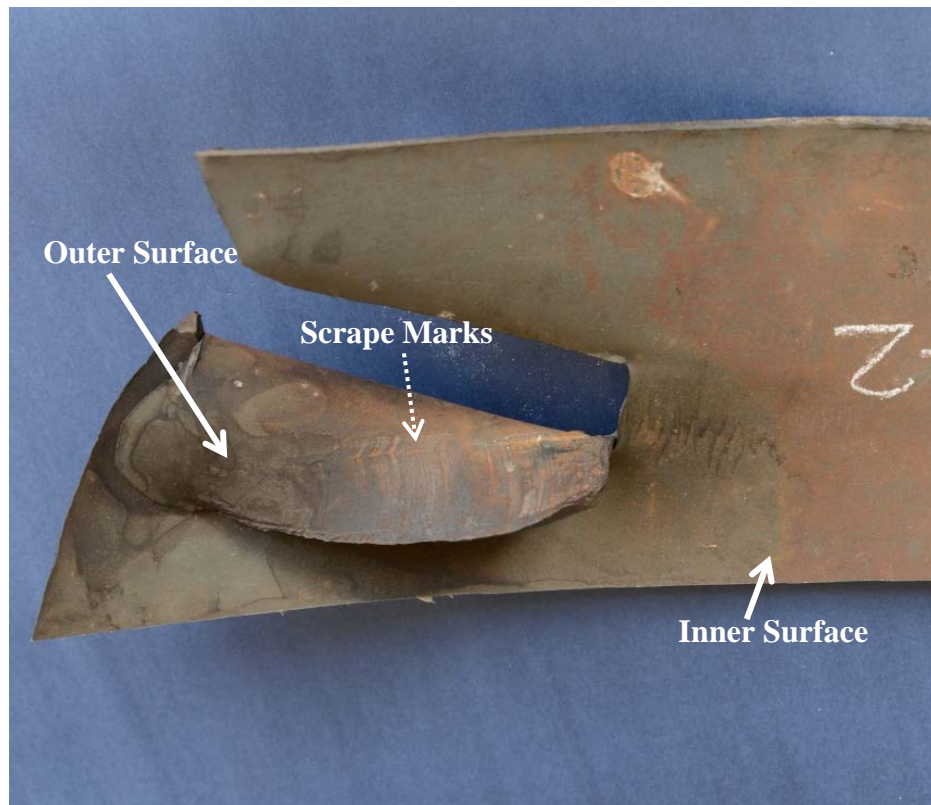
Figure 34. Photograph of the apparent puncture location that exhibits scrape marks on the outside surface of the inward-folded flap. The flap is approximately 5 inches long.

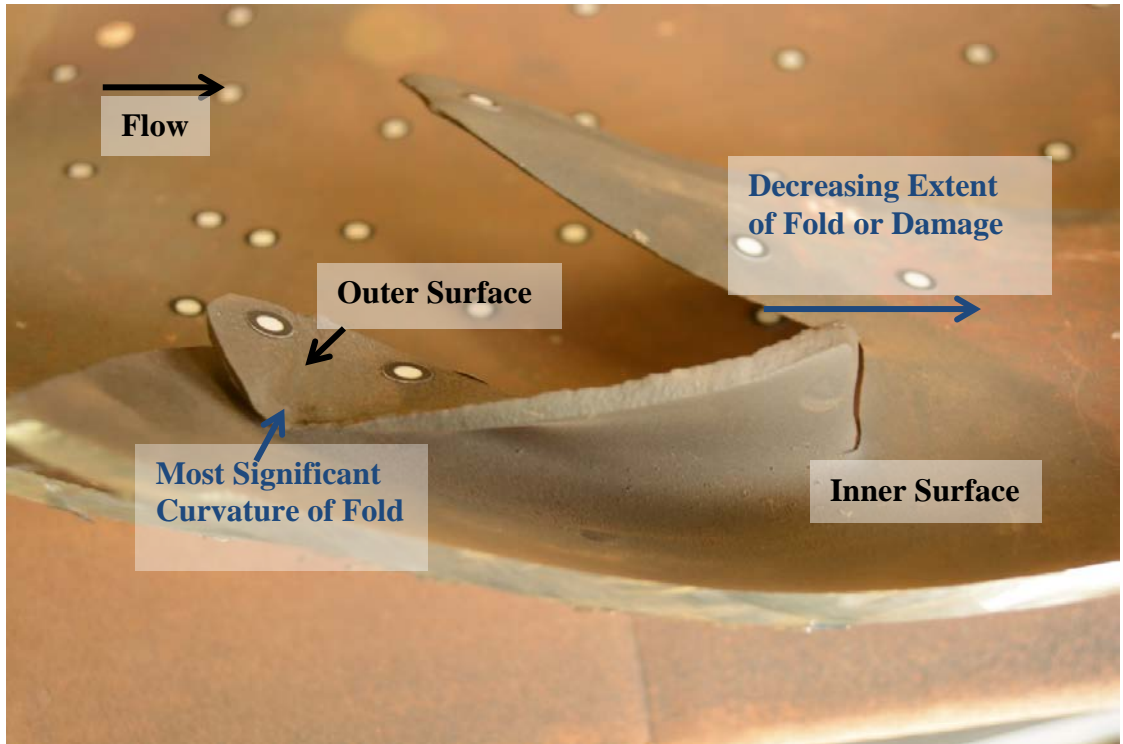
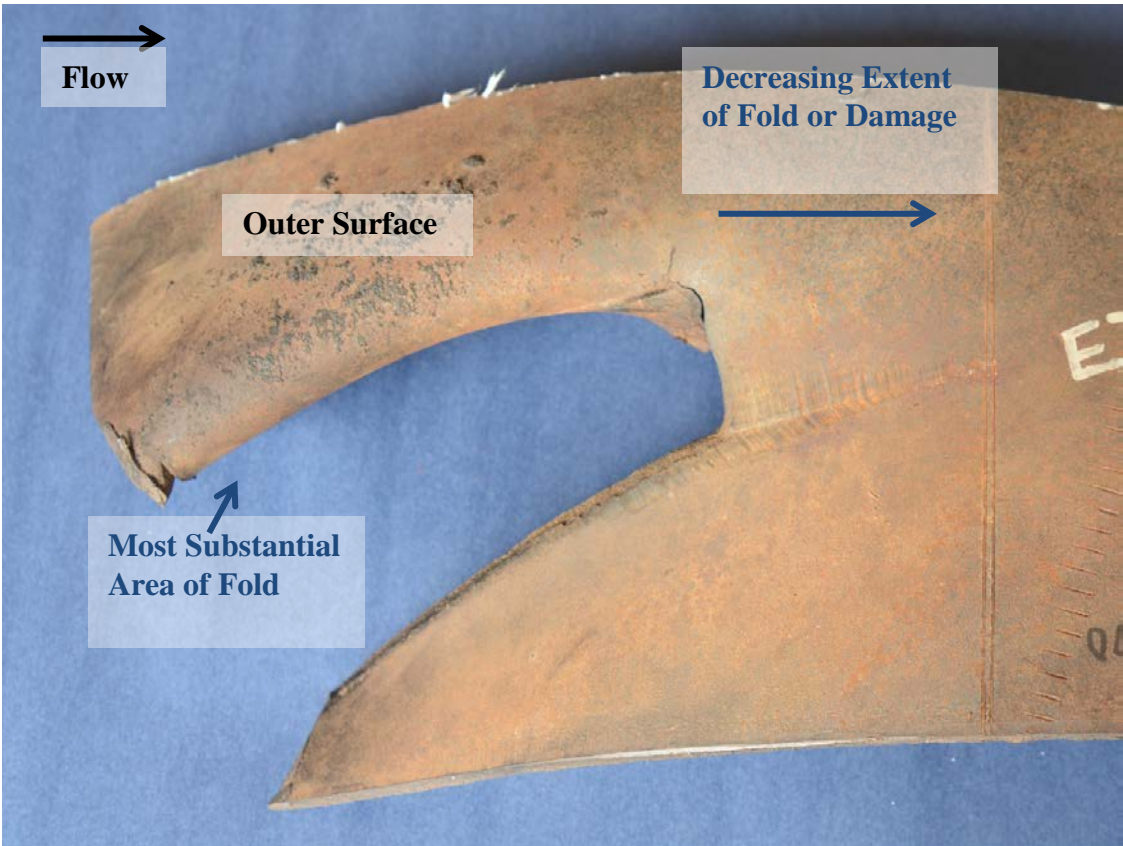
Figure 35. Photographs of the fold showing a decreasing extent of damage in the downstream direction.

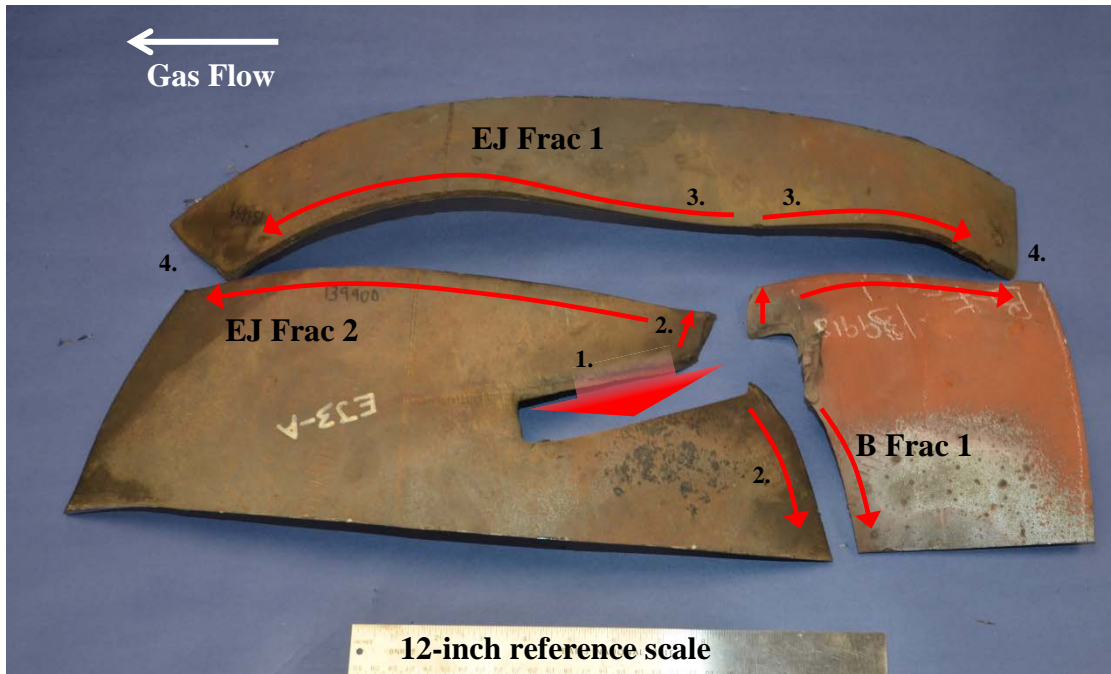
Figure 36. Fracture occurred in four stages: (1) initial puncture, (2) crack bifurcation in a circumferential orientation away from initial puncture in both directions, (3) crack propagation along the long seam for 19 inches in total, and (4) final ductile tearing (not shown).

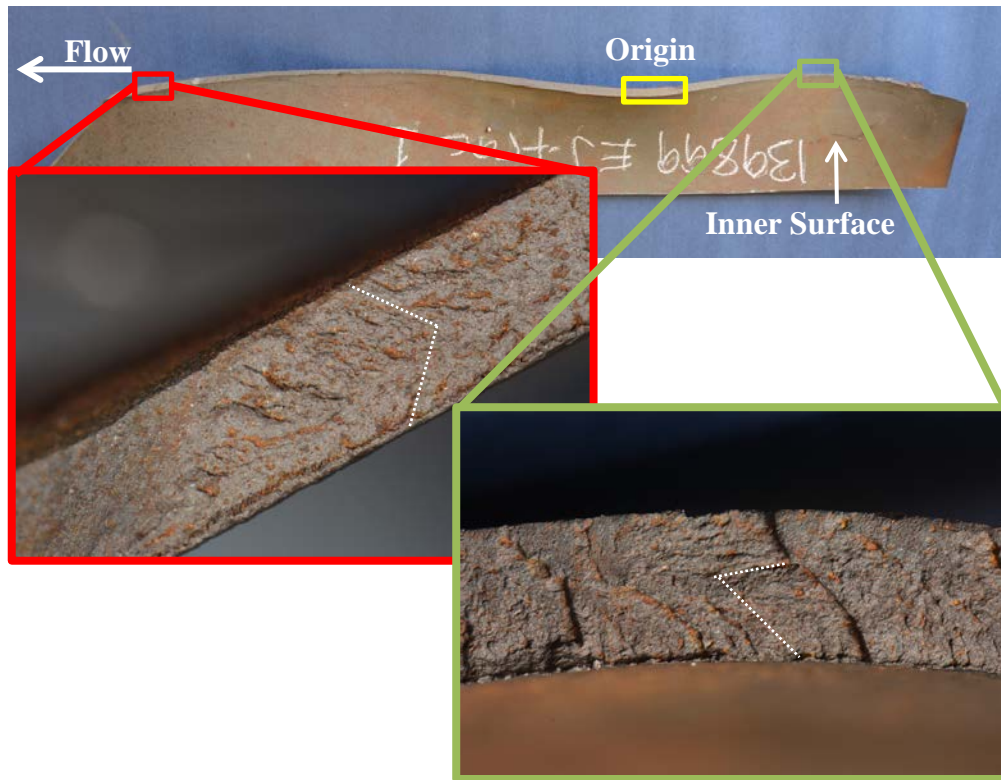
Figure 37. Chevrons on the long seam fracture of EJ Frac 1.

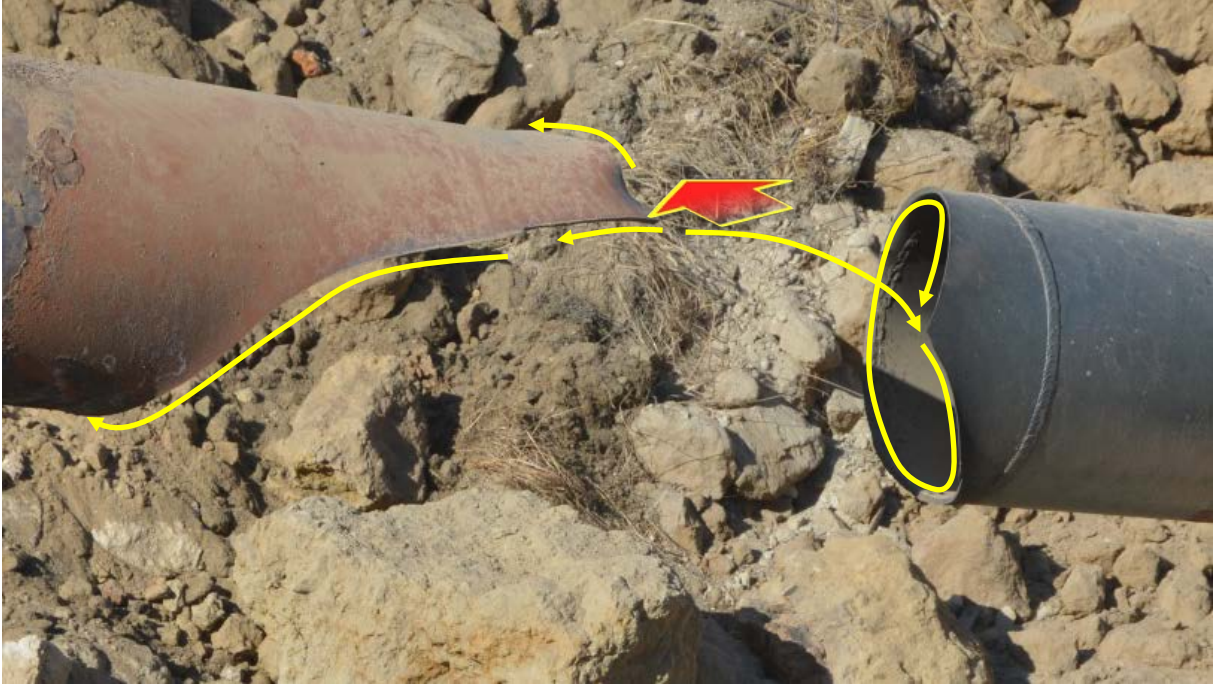
Figure 38. Photograph of the pipeline rupture location prior to removal from the incident site. The yellow arrows trace the likely fracture path following initial puncture (shown by the red arrow).

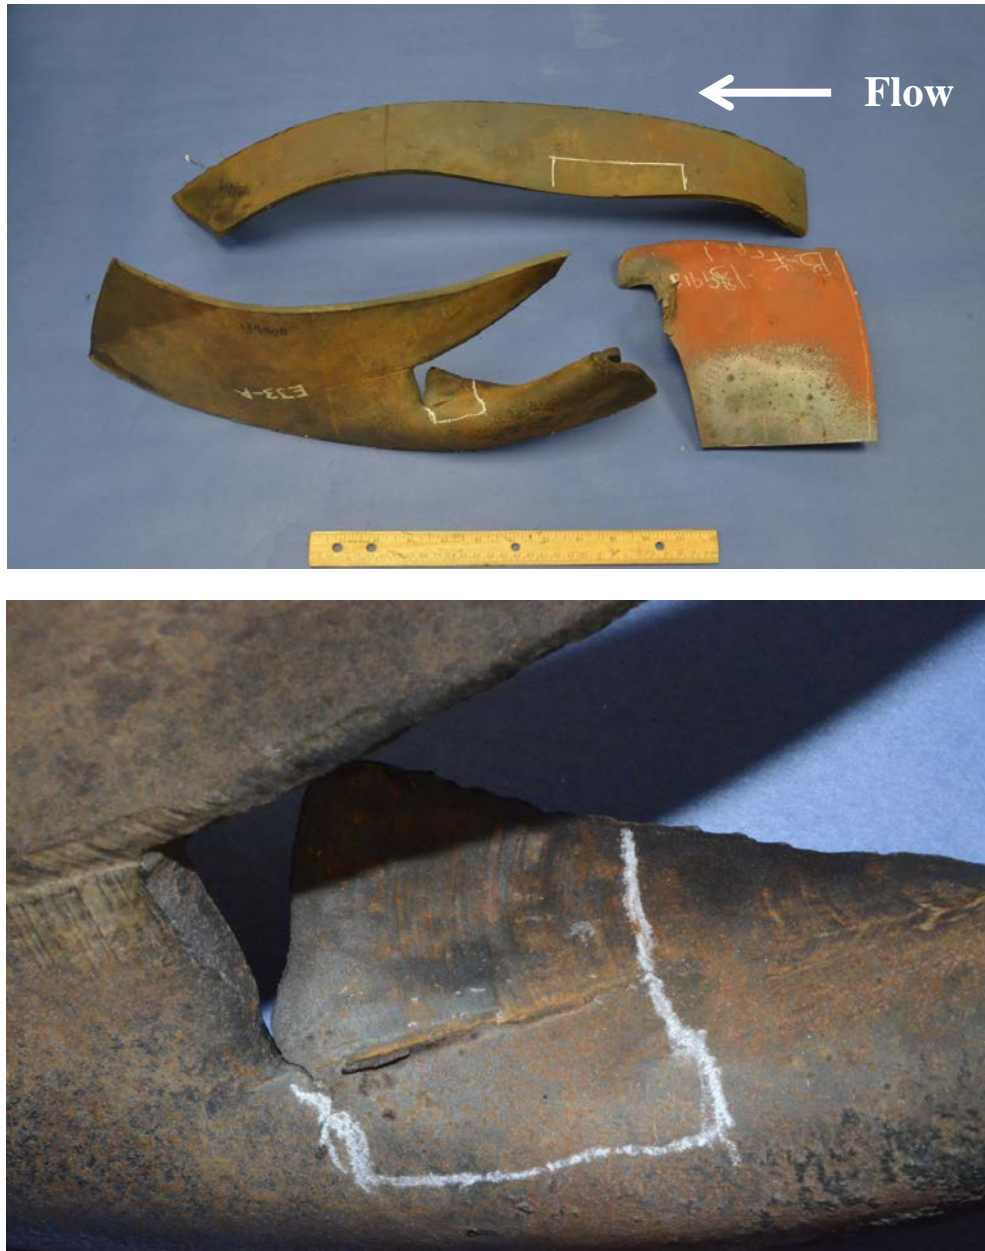
Figure 39. Sample extraction for sample labeled: EJ Frac 2-2. The piece was removed from the Ejected Segment.
