Exponent[®]

Failure Analysis Associates

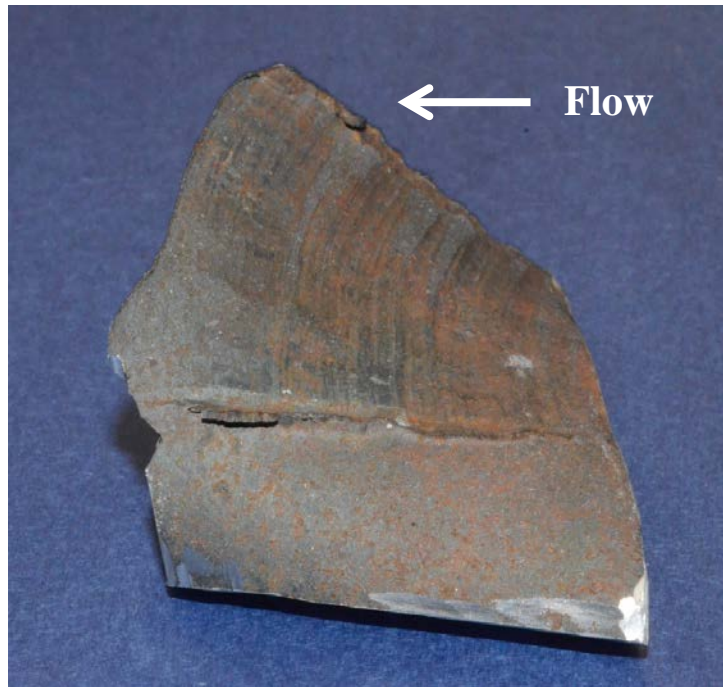
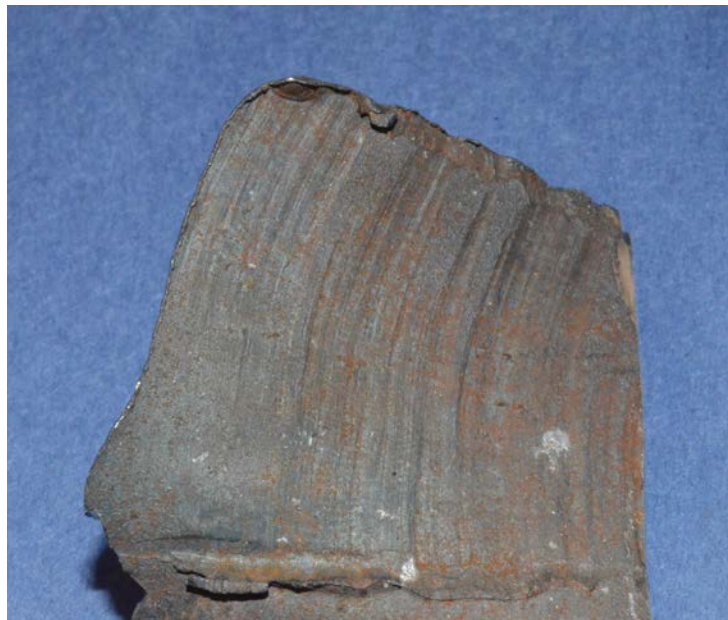
Figure 40. Photo documentation of EJ Frac 2-2 showing scrapes from third-party damage along the outer diameter of the pipe.

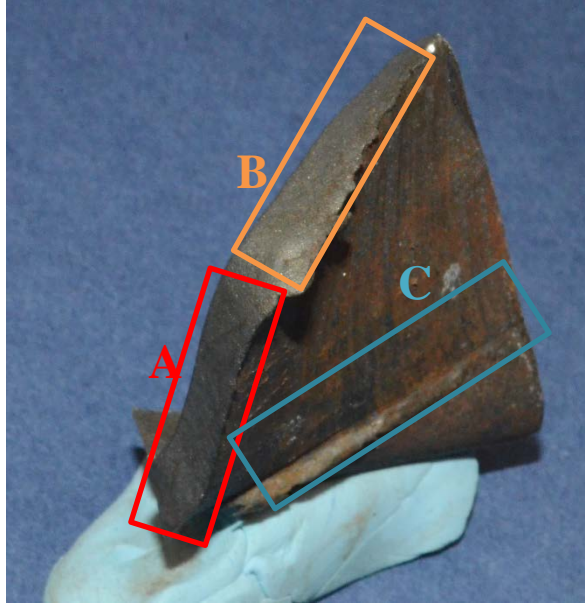
Figure 41. Photo documentation of EJ Frac 2-2 showing areas of further analysis (Figure 42).

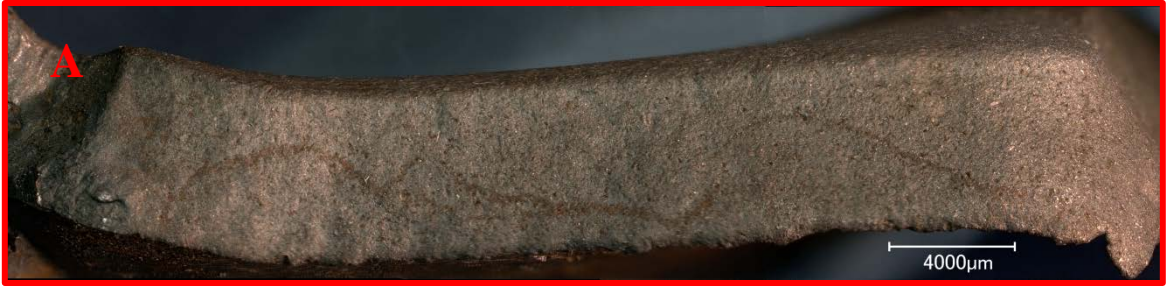
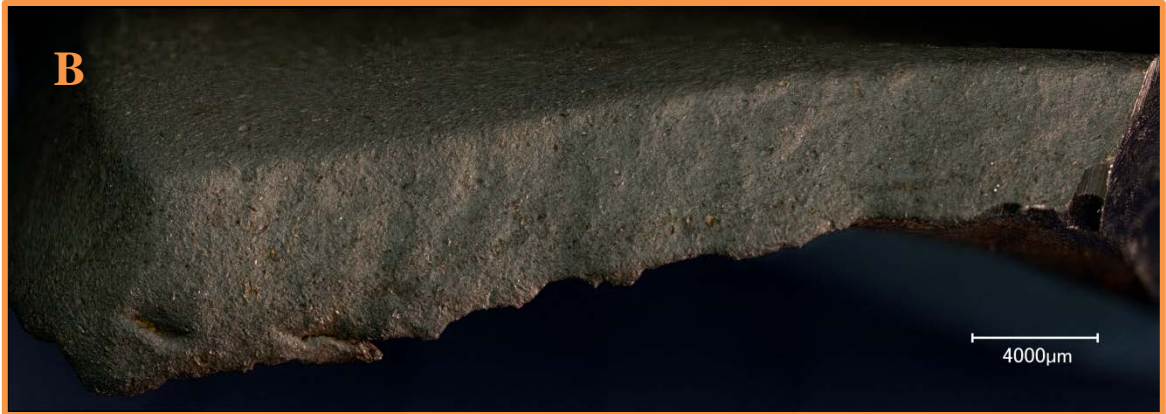
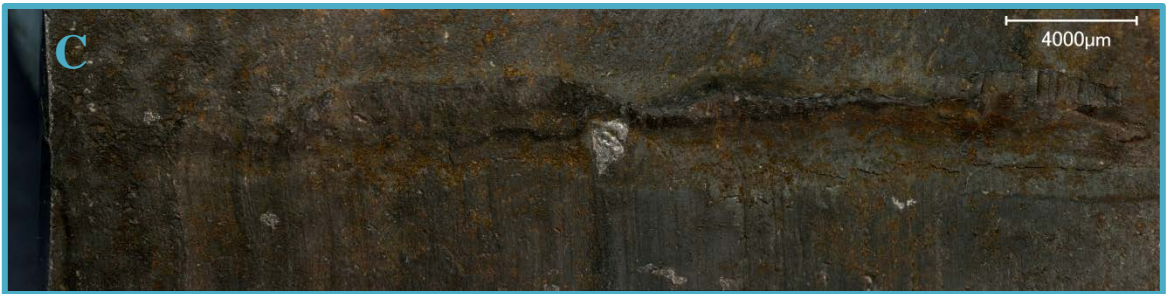
Figure 42. Detailed light images of the fracture surfaces (A) and (B) of EJ Frac 2-2, and mechanical damage on the outer diameter (C).

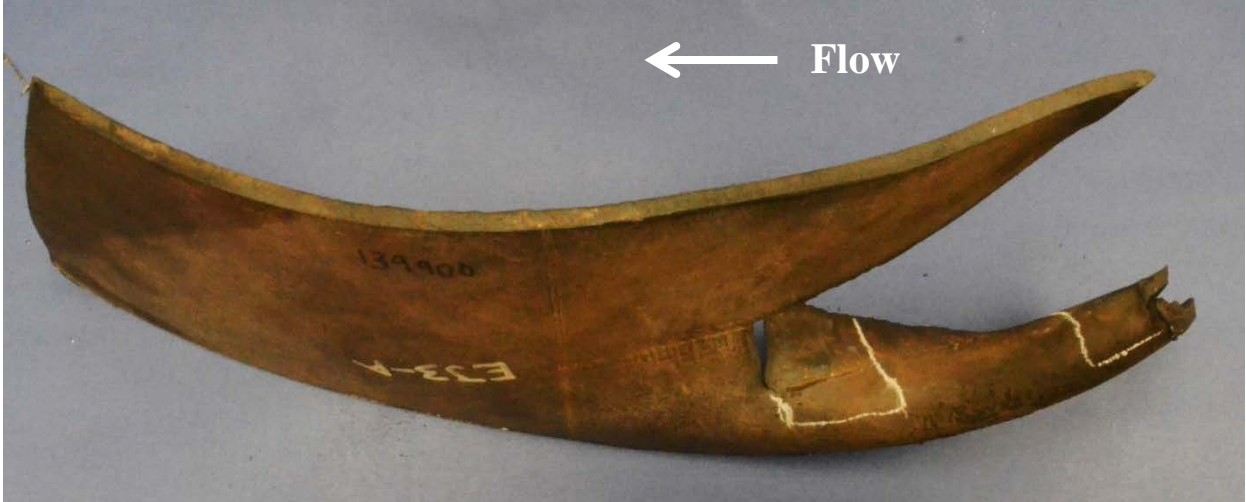
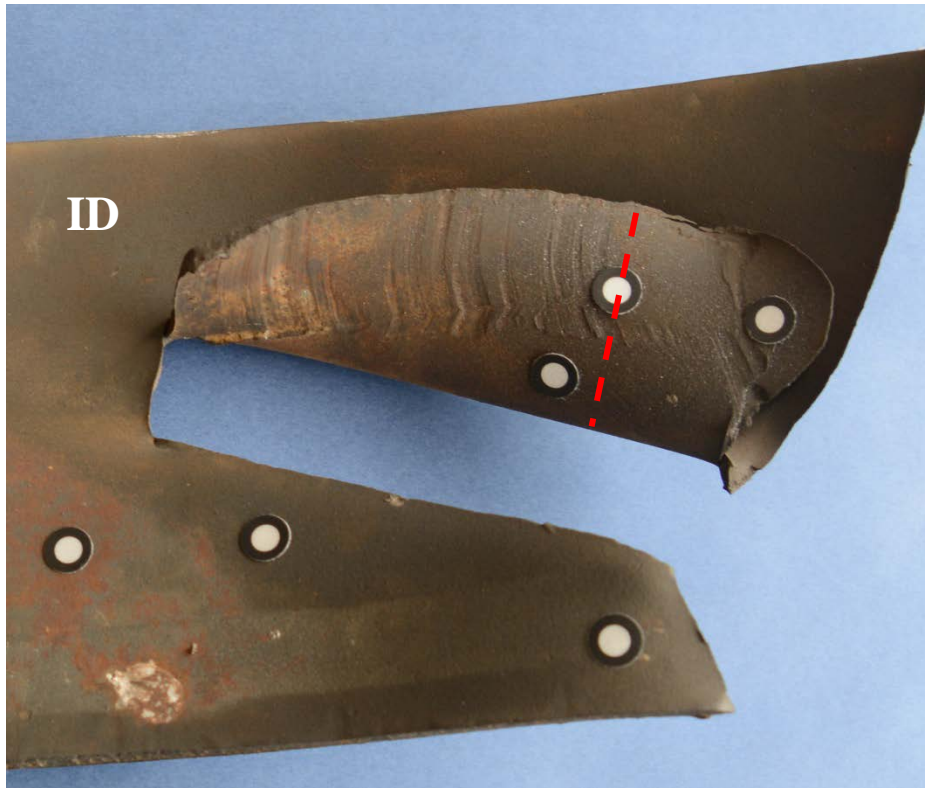
Figure 43. Extraction of sample EJ Frac 2-3. Sample was cut from the Ejected Segment.

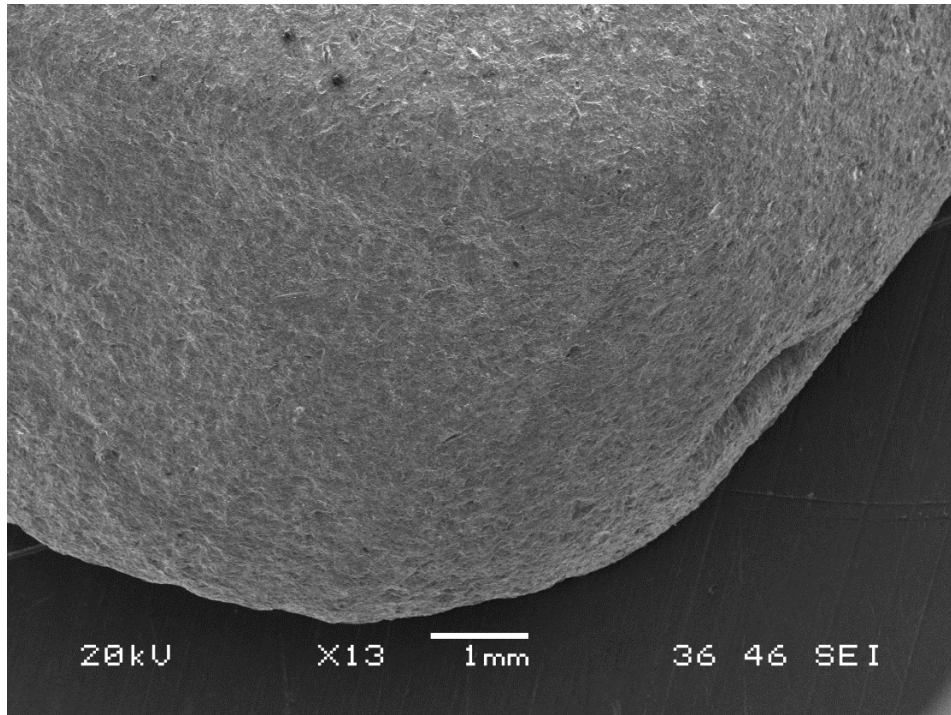
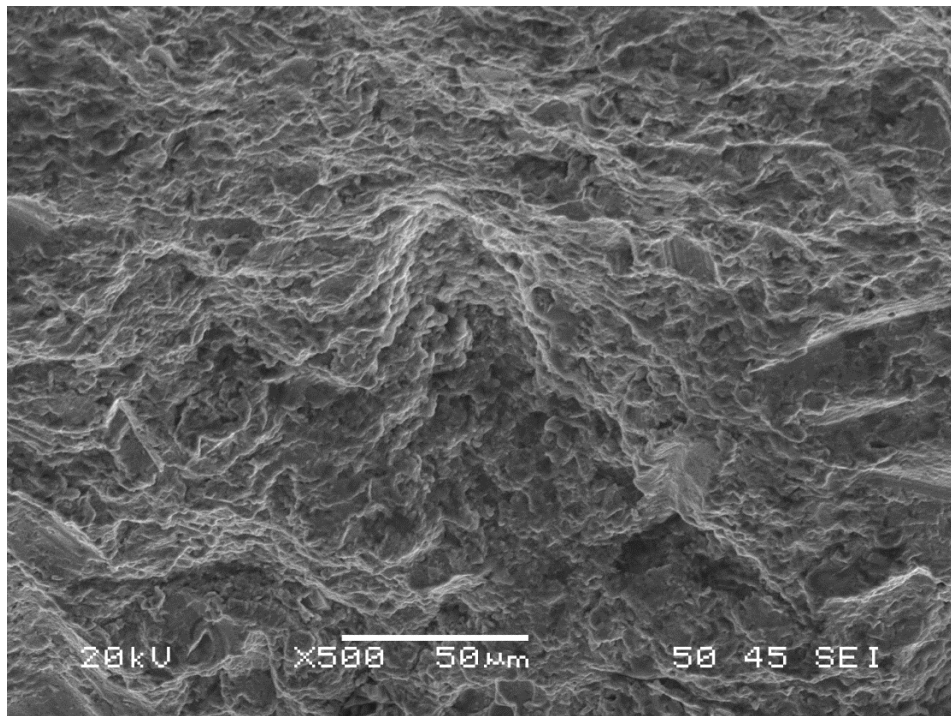
Figure 46. SEM images of the fracture surface of sample EJ Frac 2-2.

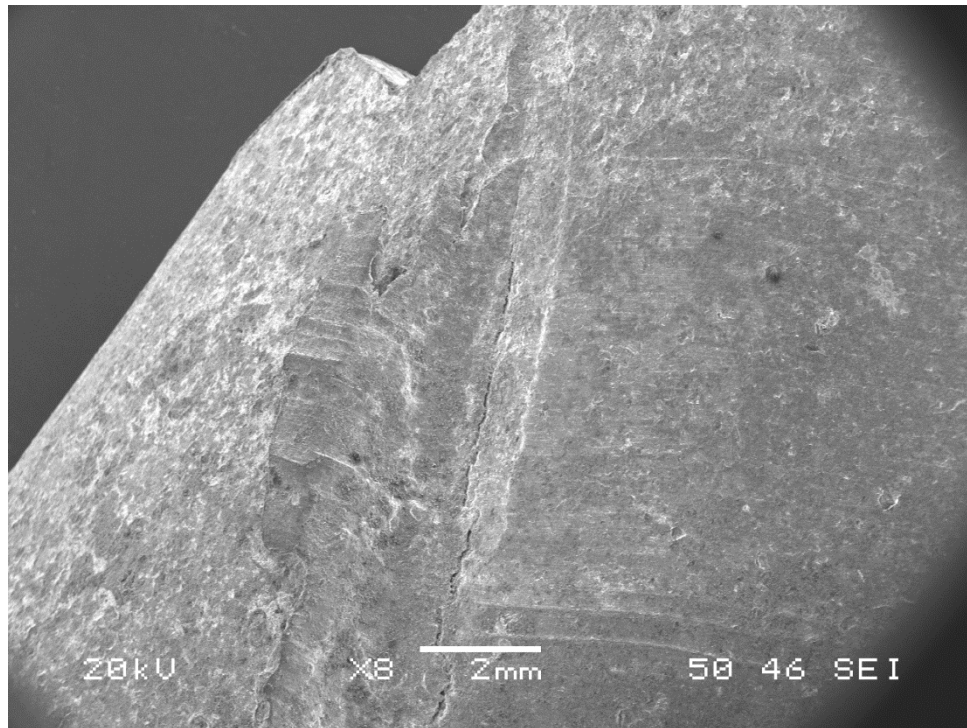
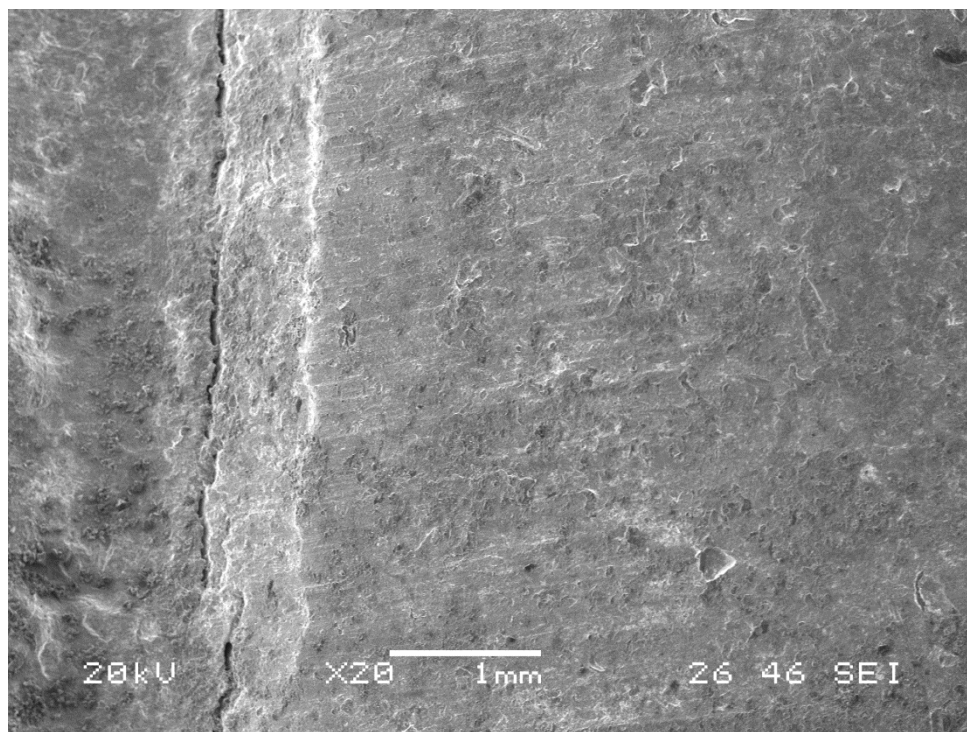
Figure 47. SEM image of the outer diameter of EJ Frac 2-2 showing scrapes and damage from mechanical contact.

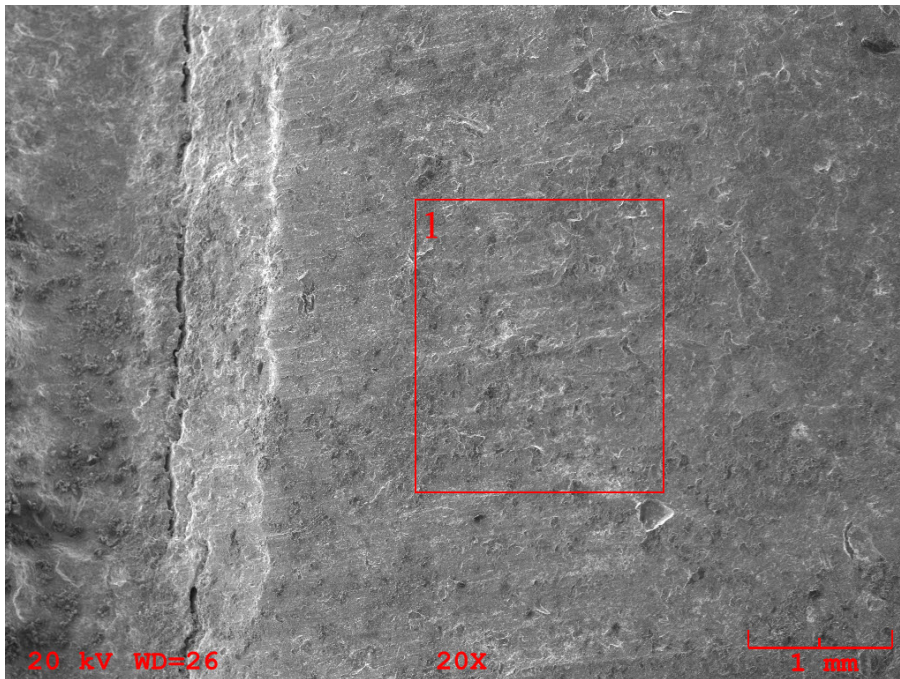
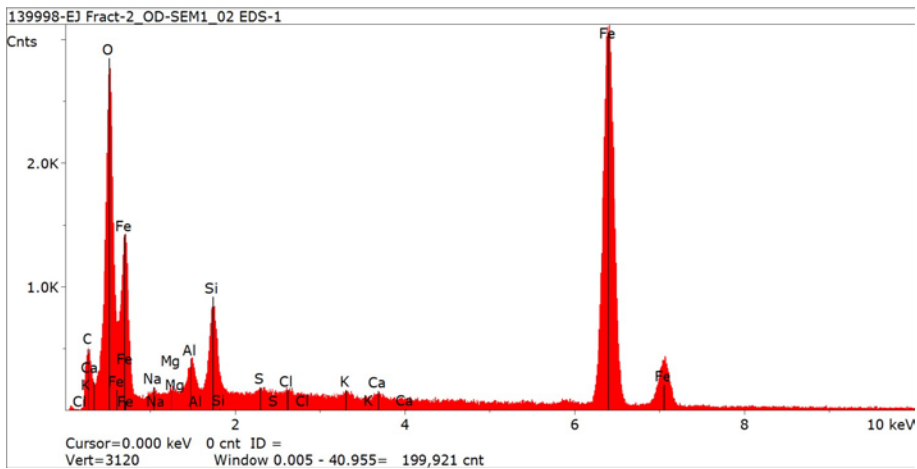
Figure 48. Area EDS scan of the outer diameter of EJ Frac 2-2.

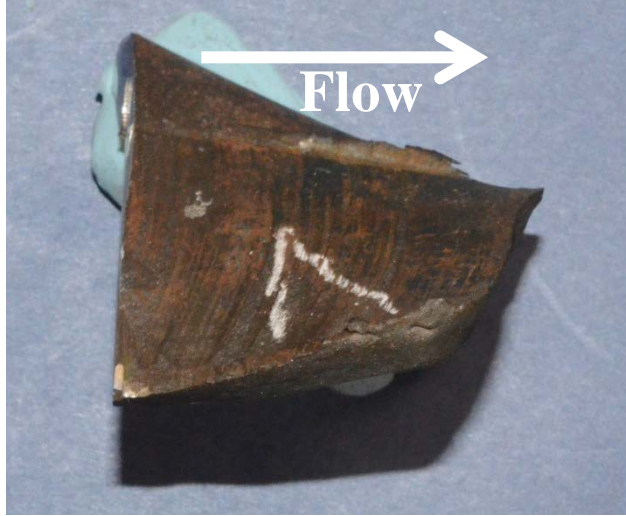
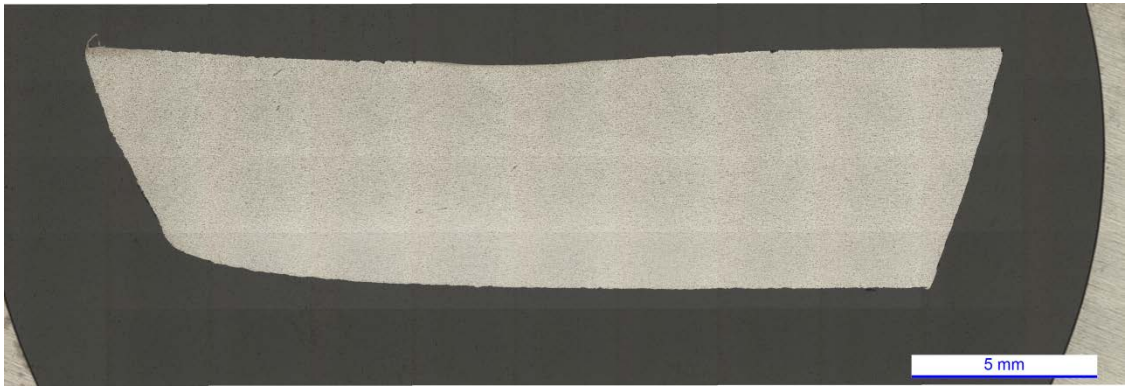
Figure 49. Metallographic sample extraction and mount from EJ Frac 2-2. The outer diameter is at the top of the sample, the inner diameter is at the bottom, and the fracture surface is on the left.

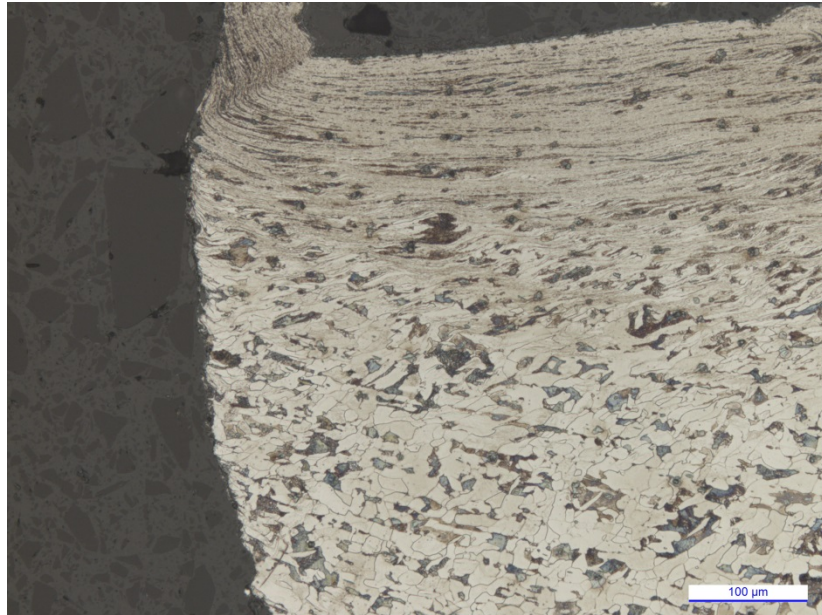
Figure 50. Metallographic image of EJ Frac 2-2 that shows significant plastic deformation on the outer diameter, evident by the highly-deformed grain structure along the top of the sample.

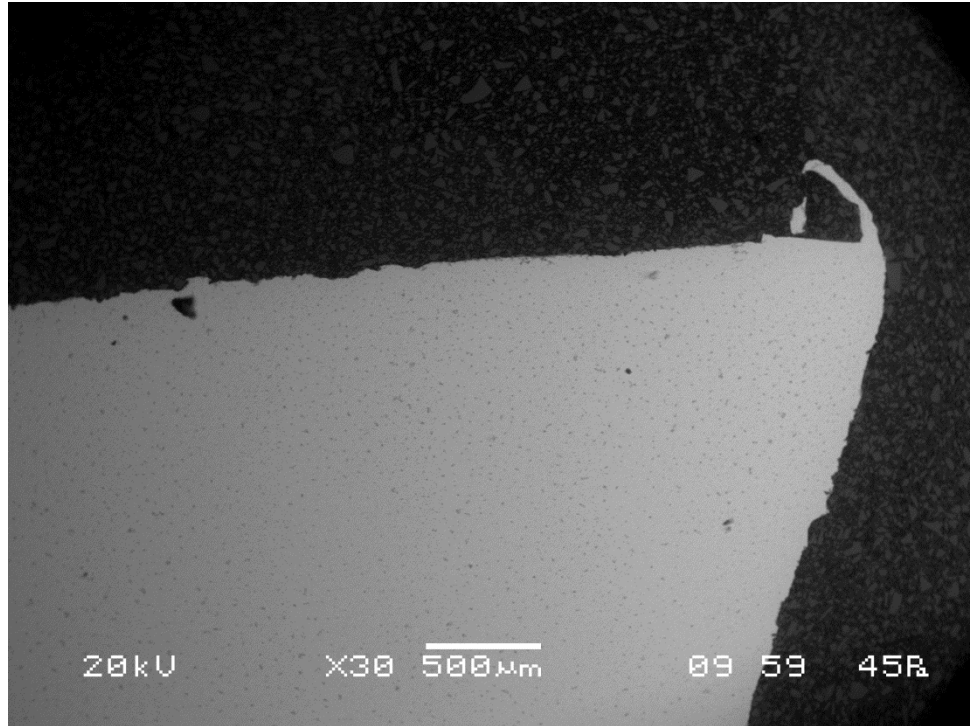
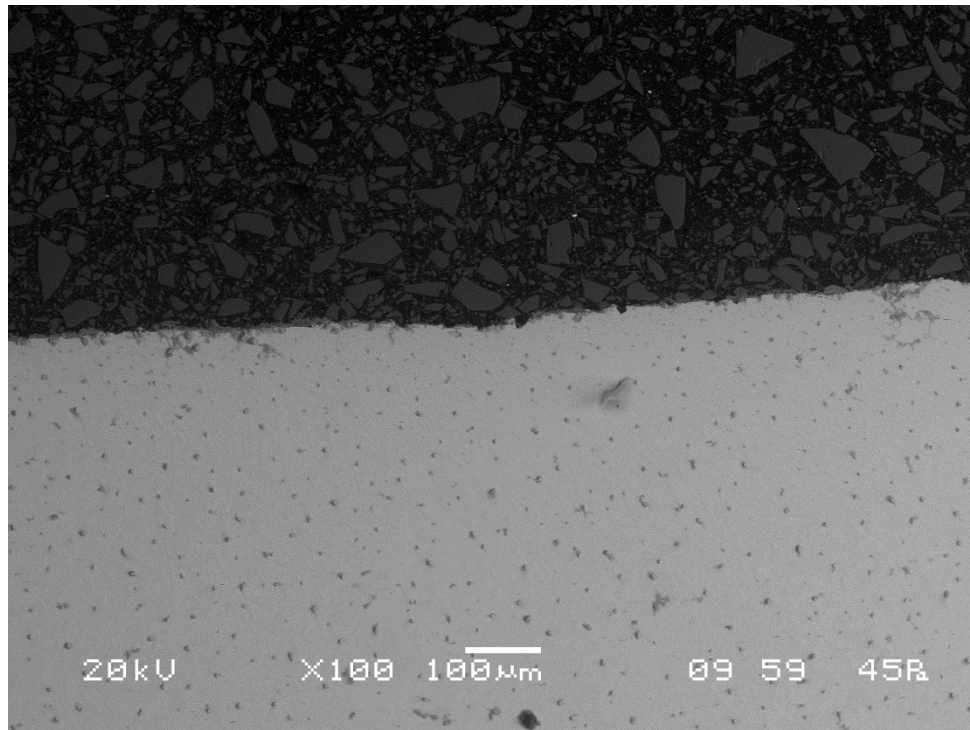
Figure 51. SEM images of EJ Frac 2-2. The top image shows the outer diameter on the top and the fracture surface on the right. The bottom image shows the outer diameter along the top.

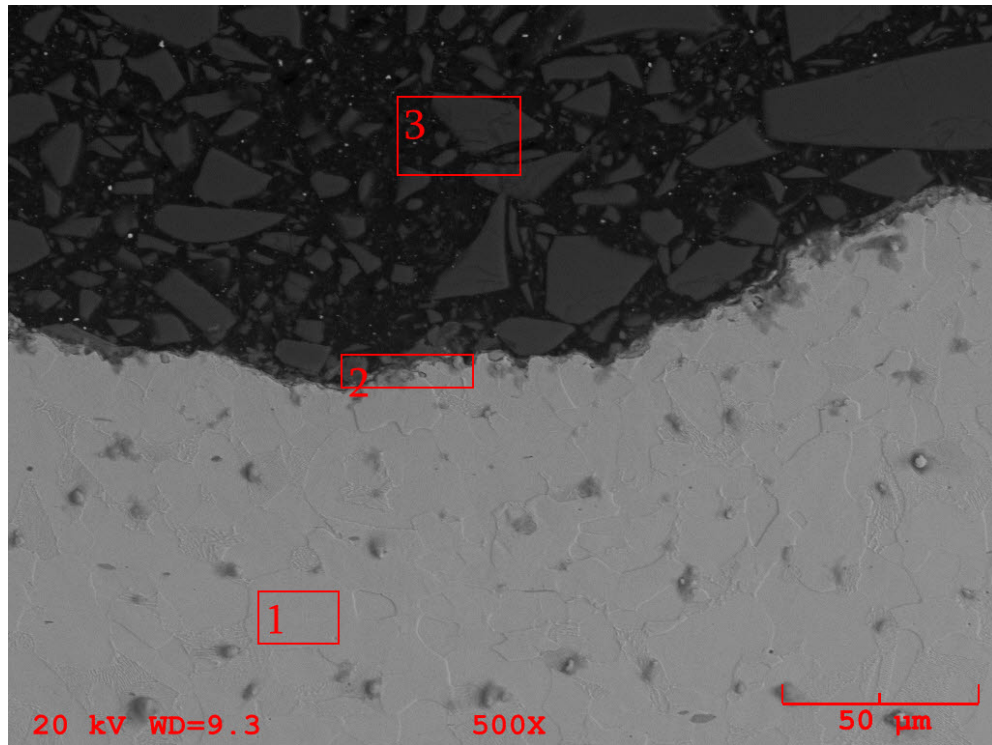
Figure 52. SEM image of EJ Frac 2-2 showing areas of EDS spectra presented in Figure 53. The black area at the top is the mounting medium.

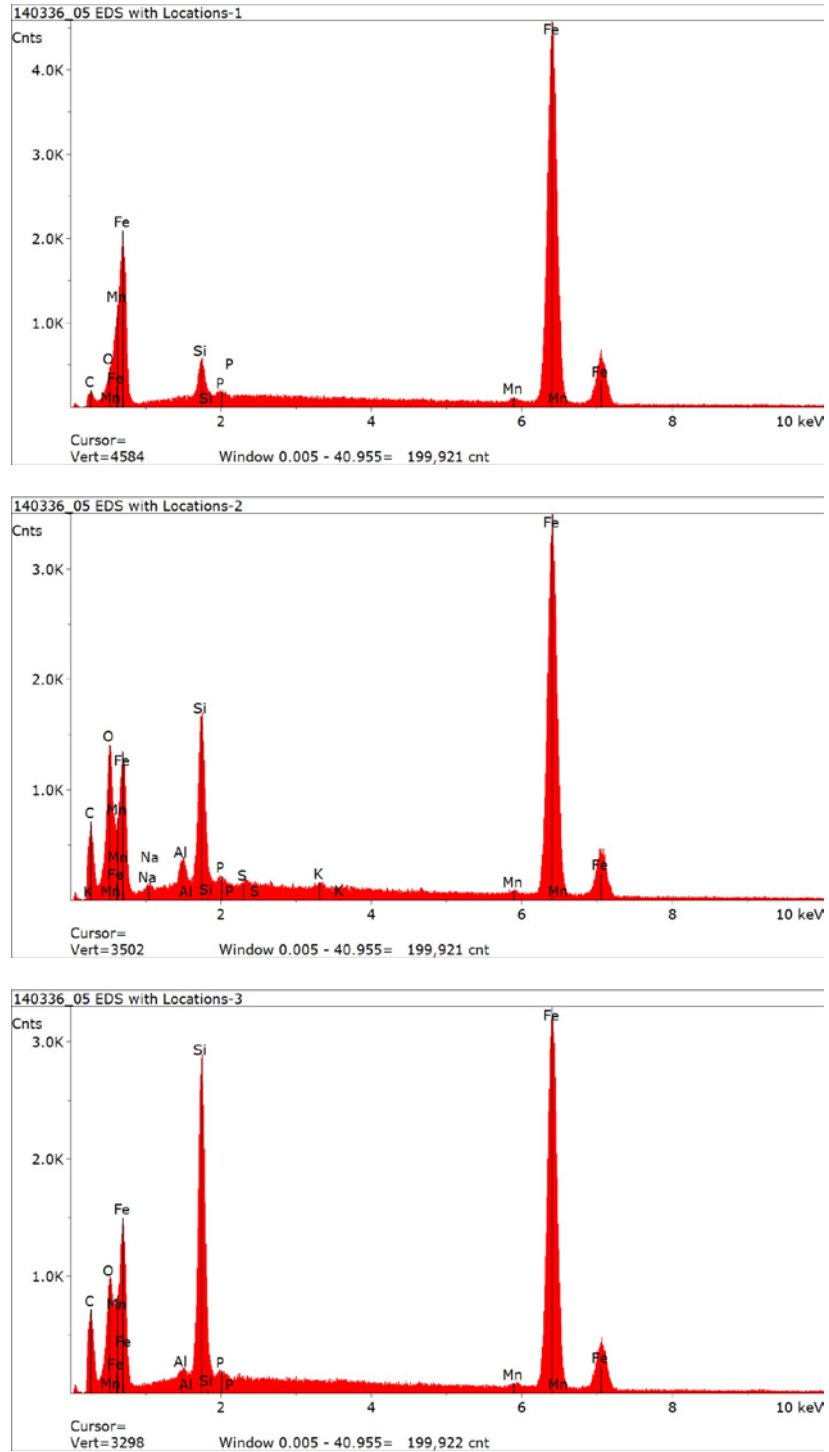
Figure 53. EDS spectra corresponding to the locations of EJ Frac 2-2 shown in Figure 52.

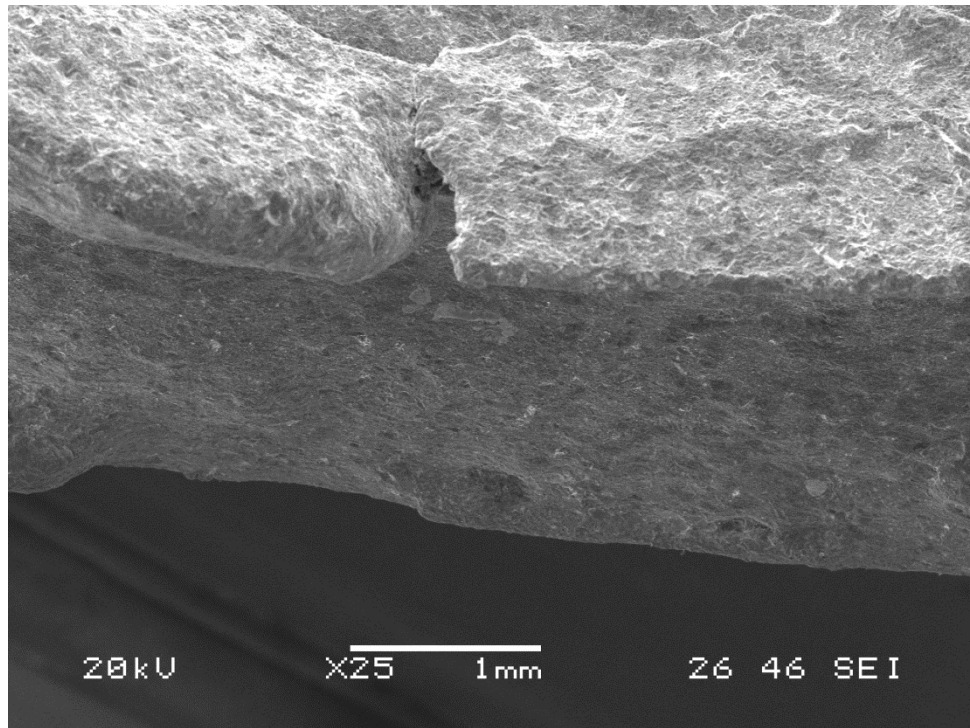
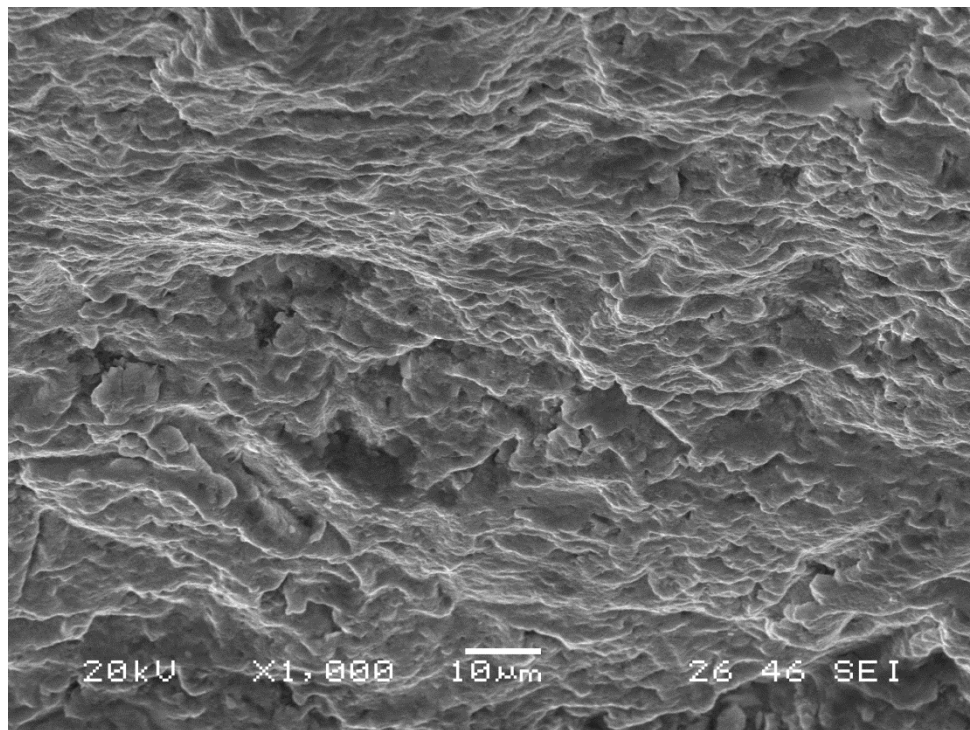
Figure 54. SEM images of EJ Frac 2-3.

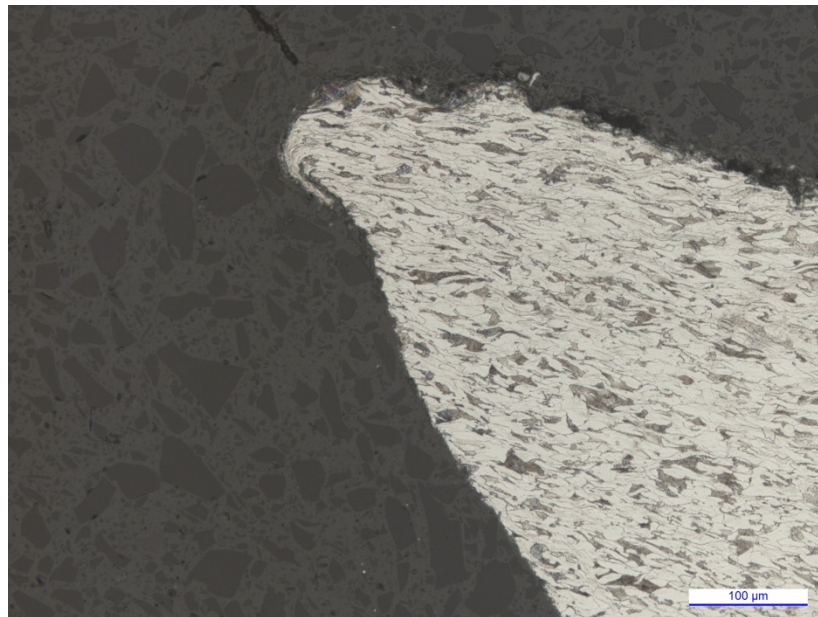
Figure 57. Light optical image of EJ Frac 2-3 showing the outer diameter along the top, and the fracture surface on the left. Grain deformation is visible along the outer diameter of the pipe, indicative of mechanical damage.

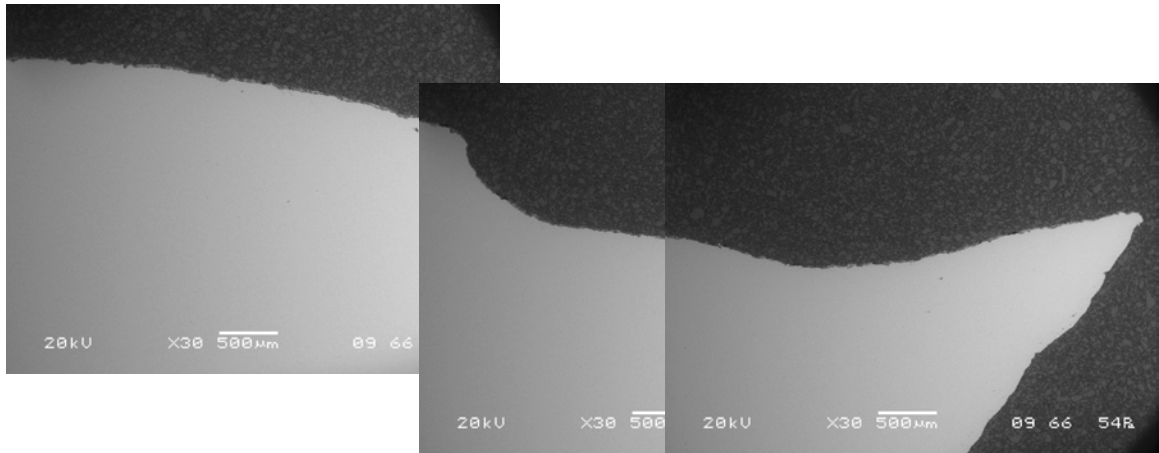
Figure 58. SEM images of EJ Frac 2-3 showing the outer diameter of the pipe along the top and the fracture surface on the right. Significant dents are observed along the outer diameter.

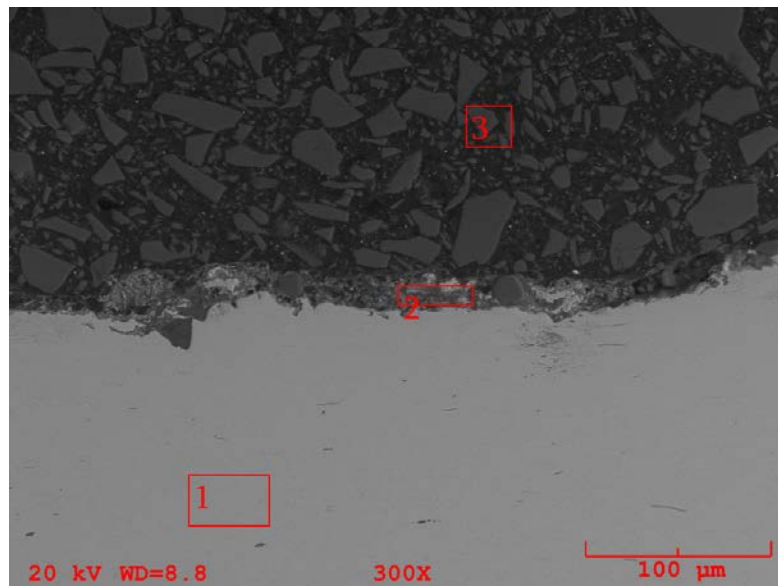
Figure 59. SEM image showing areas of EDS spectra identified in Figure 60.

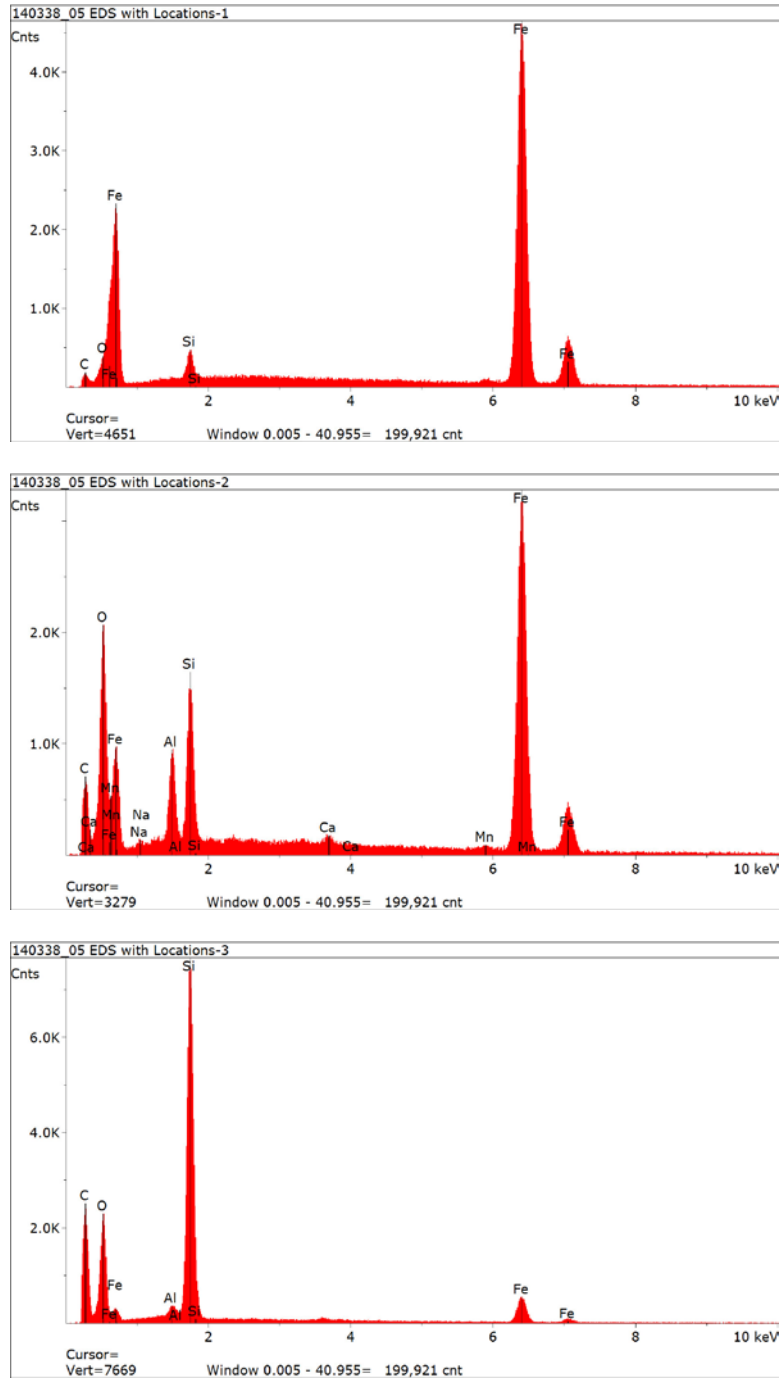
Figure 60. EDS spectra of the EJ Frac 2-3 metallographic mount for locations 1, 2, and 3 shown in Figure 59.

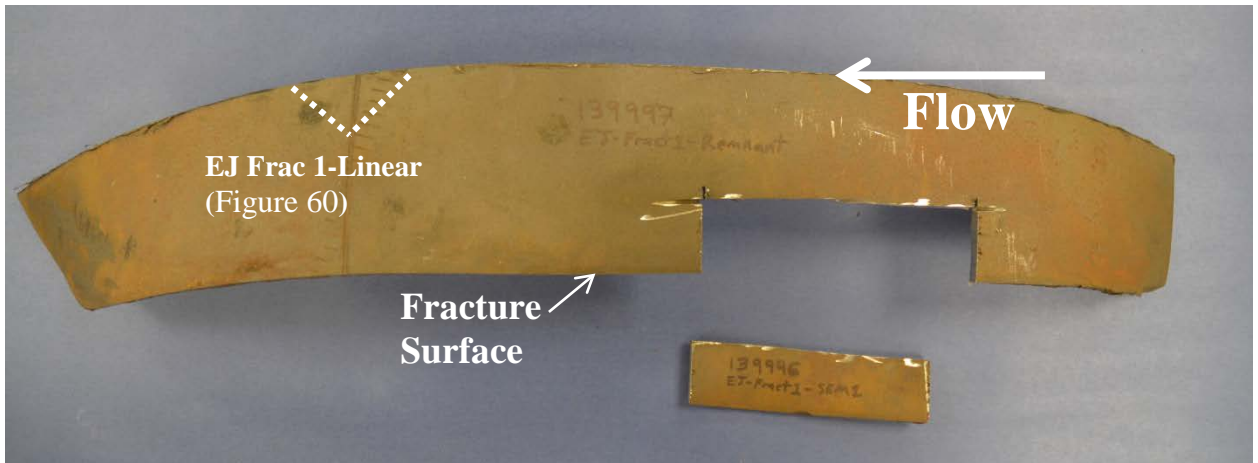
Figure 61. Photo documentation showing the area of the long seam fracture extracted for further analysis. This piece was labeled EJ Frac 1-SEM.

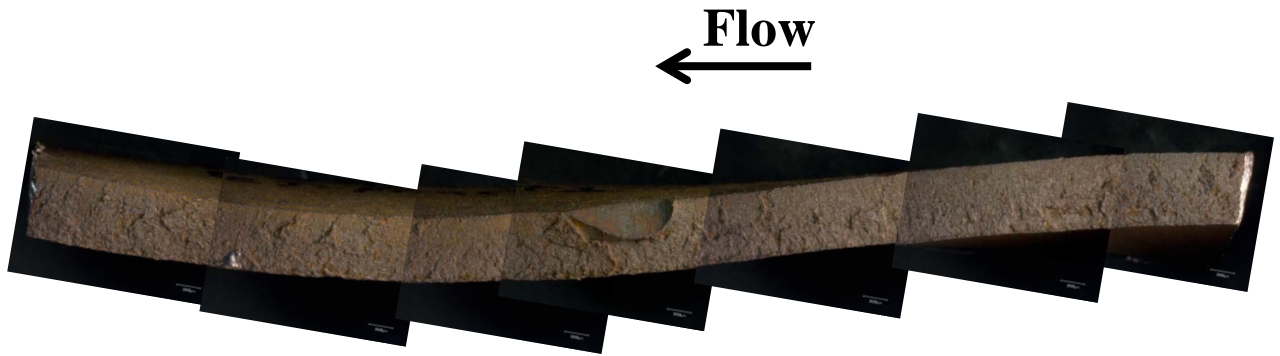
Figure 62. Light optical images stitched together to complete the fracture surface for EJ Frac 1-SEM. The large dent in the center along the outer diameter of the piece occurred after the initial fracture.

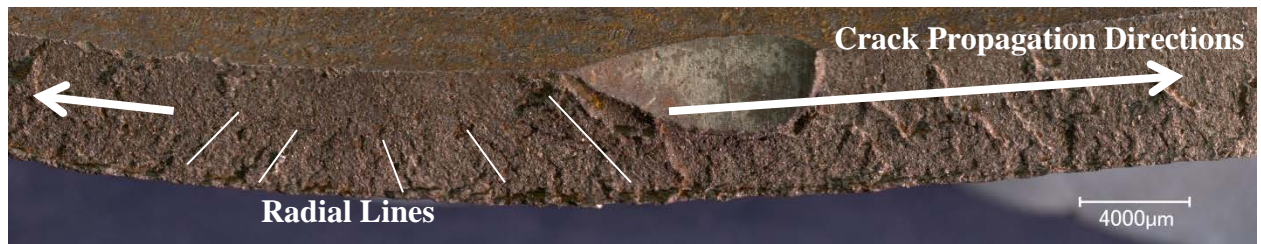
Figure 63. High-magnification image of sample EJ Frac 1-SEM showing the area in which the crack met the long seam and started to propagate in either direction.

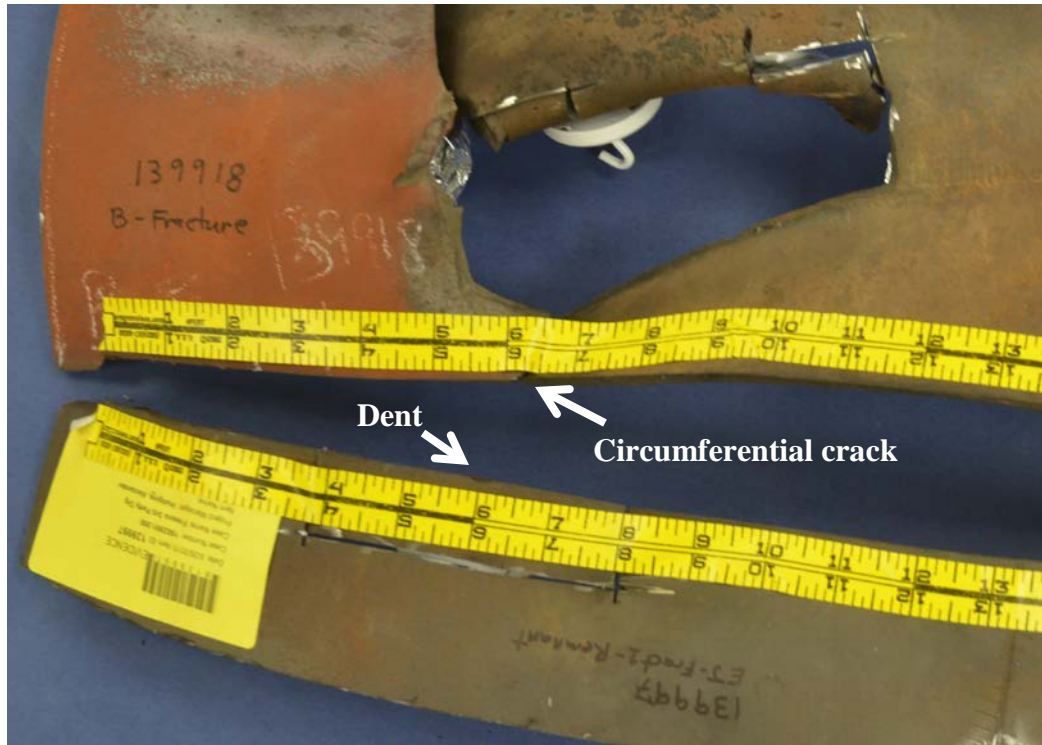
Figure 64. Photograph showing that the circumferential crack intersects the longitudinal seam at a distance of just over six inches downstream from the start of the seam fracture. On EJ Frac 1 (bottom), the dent shown in Figure 63 can be observed at the six-inch mark, and therefore the initiation site identified in Figure 63 as just downstream of the dent corresponds to the location of the circumferential crack.

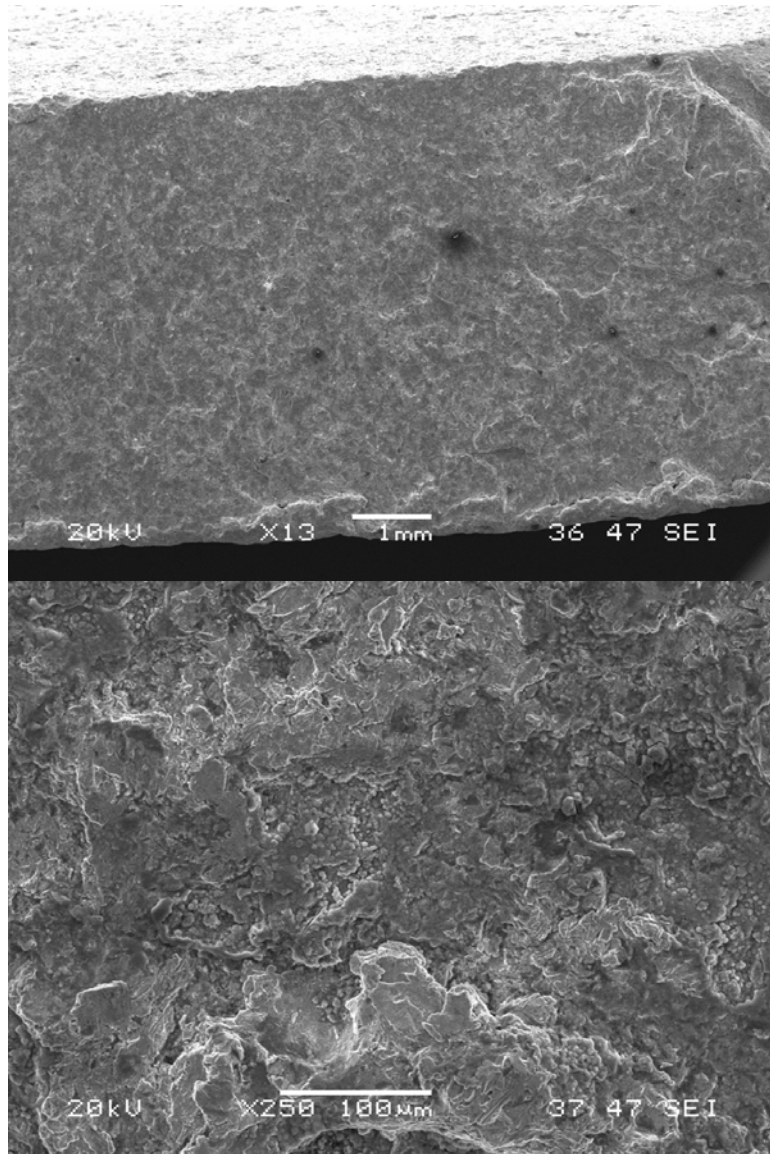
Figure 66. SEM images of the fracture surface near the area of crack intersection, labeled as A in Figure 65.

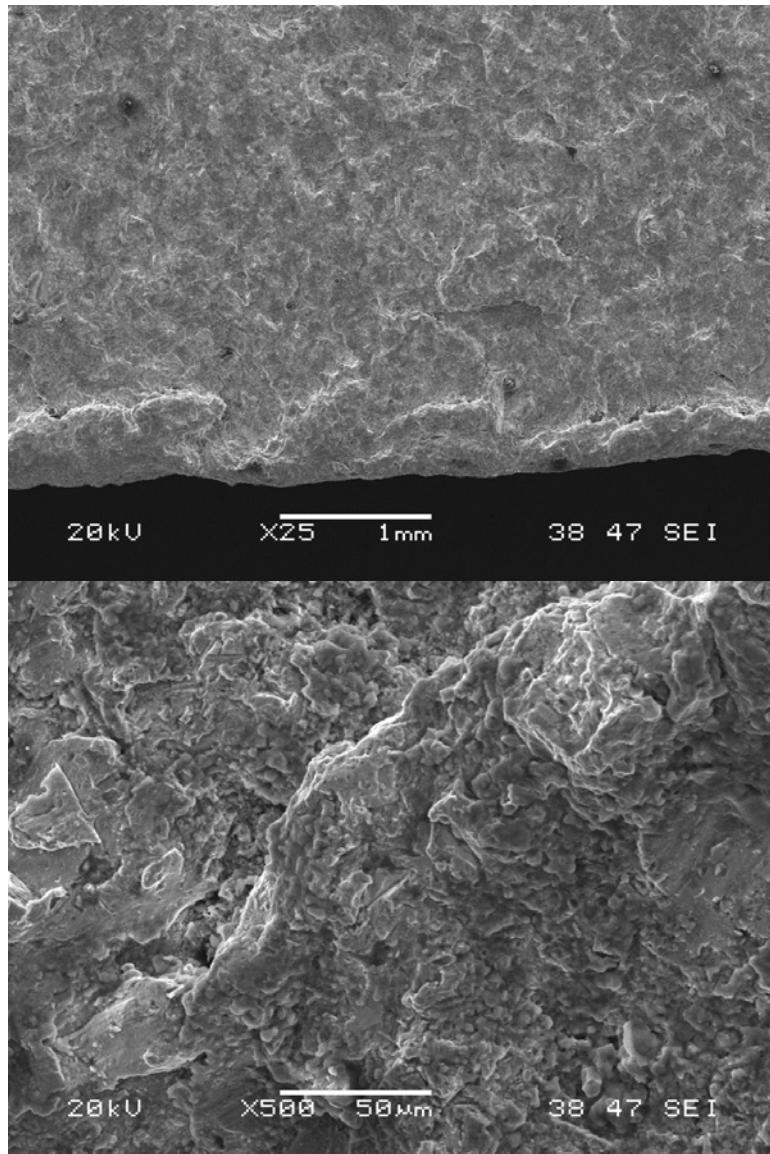
Figure 67. SEM images of the fracture surface along the inner diameter, labeled as B in Figure 65.

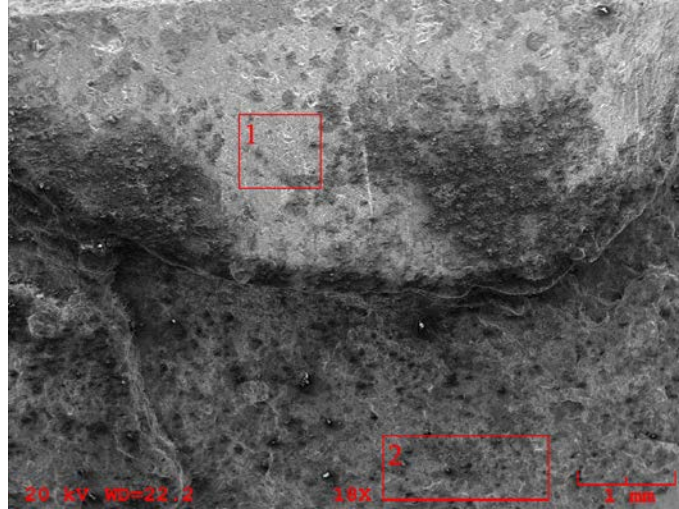
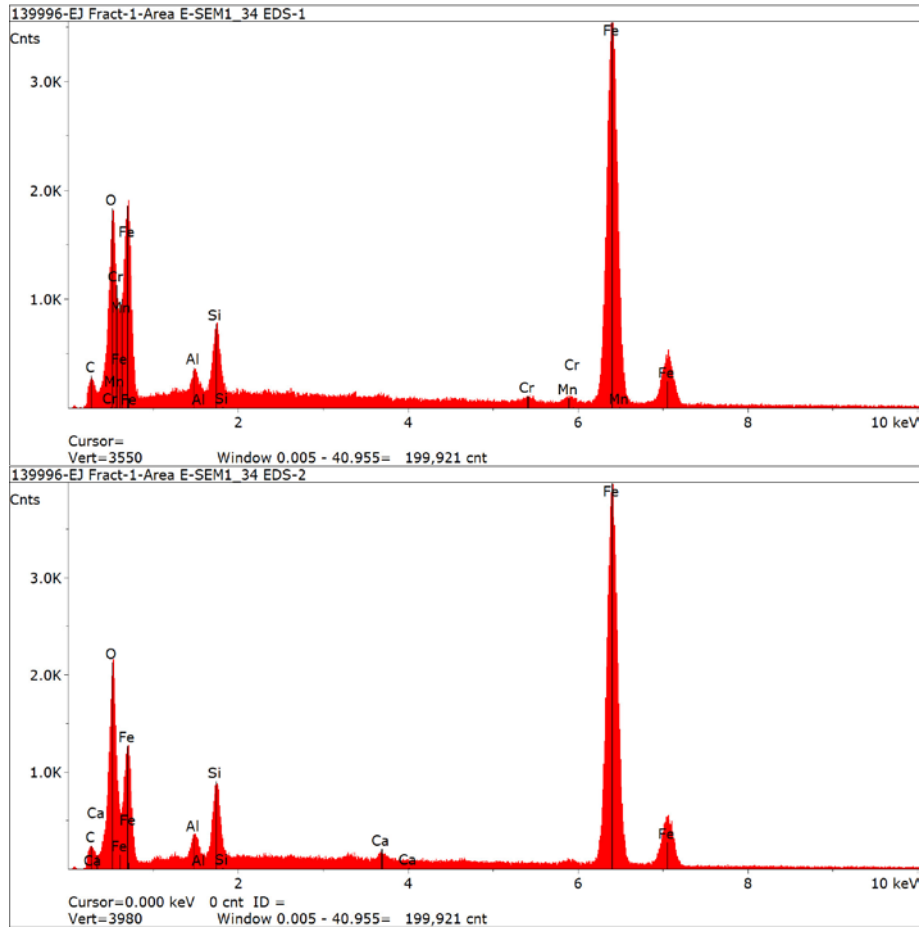
Figure 68. SEM image and EDS spectra of the dent area on sample EJ Frac 1-SEM.
