Exponent[®]

Failure Analysis Associates

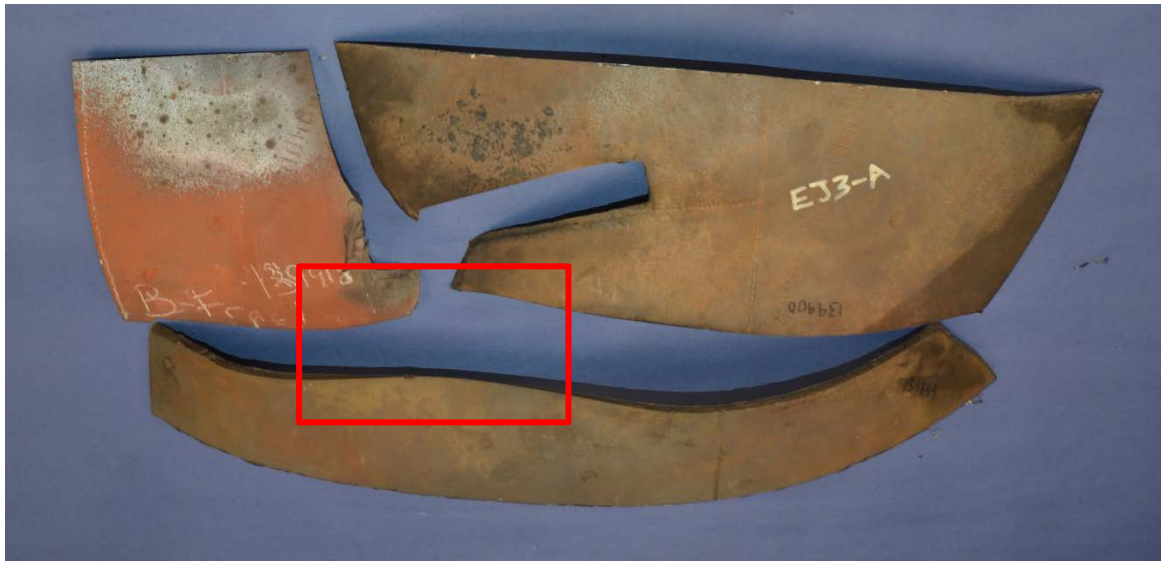
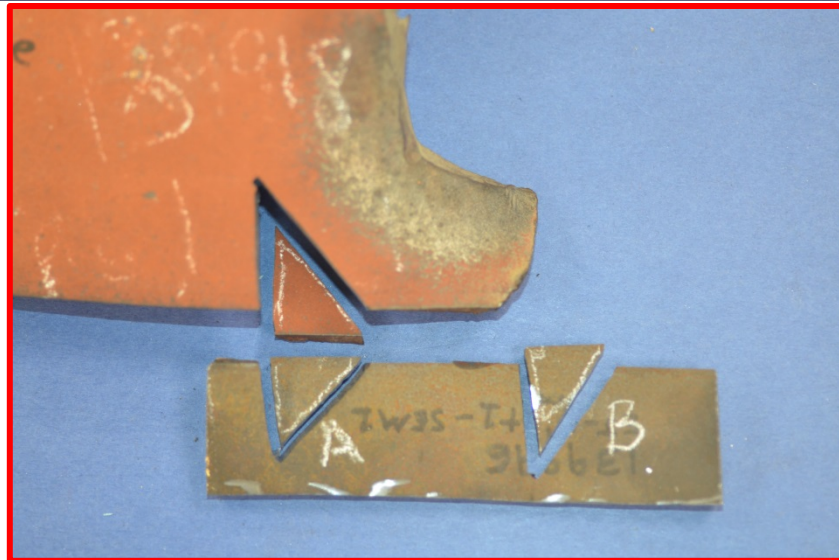
Figure 69. Photo documentation showing metallographic sample extraction from the long seam fracture.

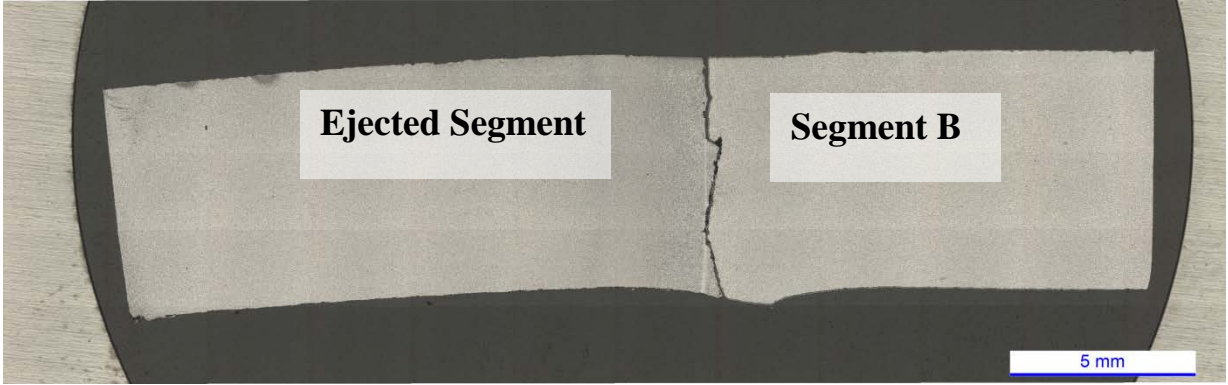
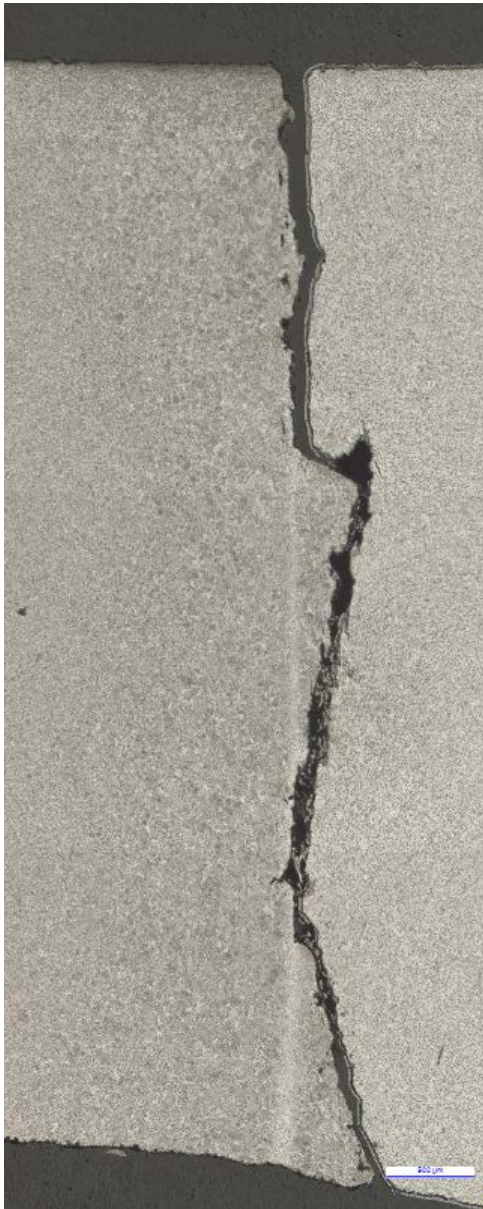
Figure 70. Metallographic images of the matched fracture surfaces shown in Figure 69.

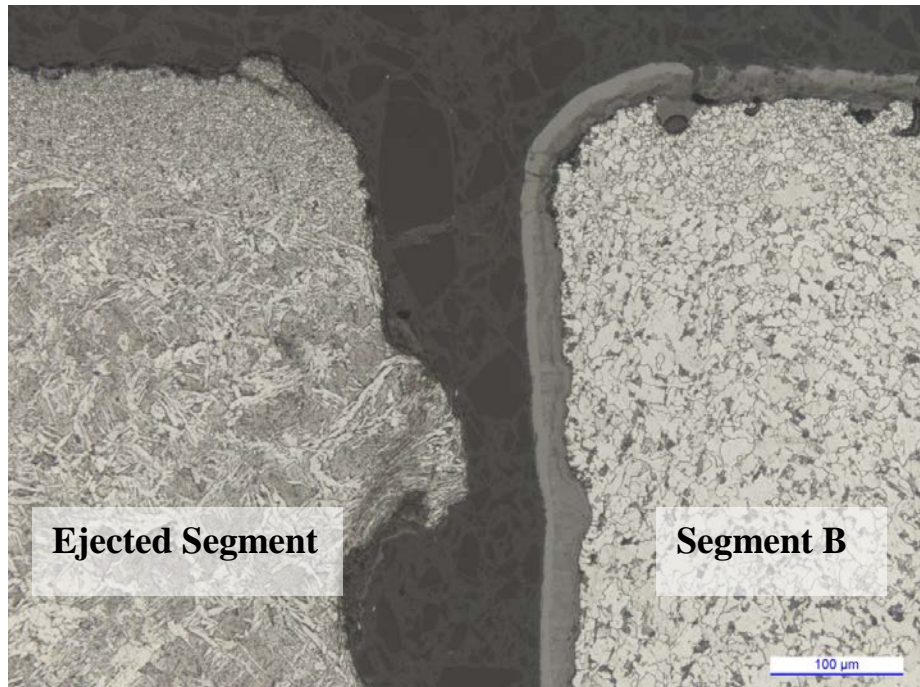
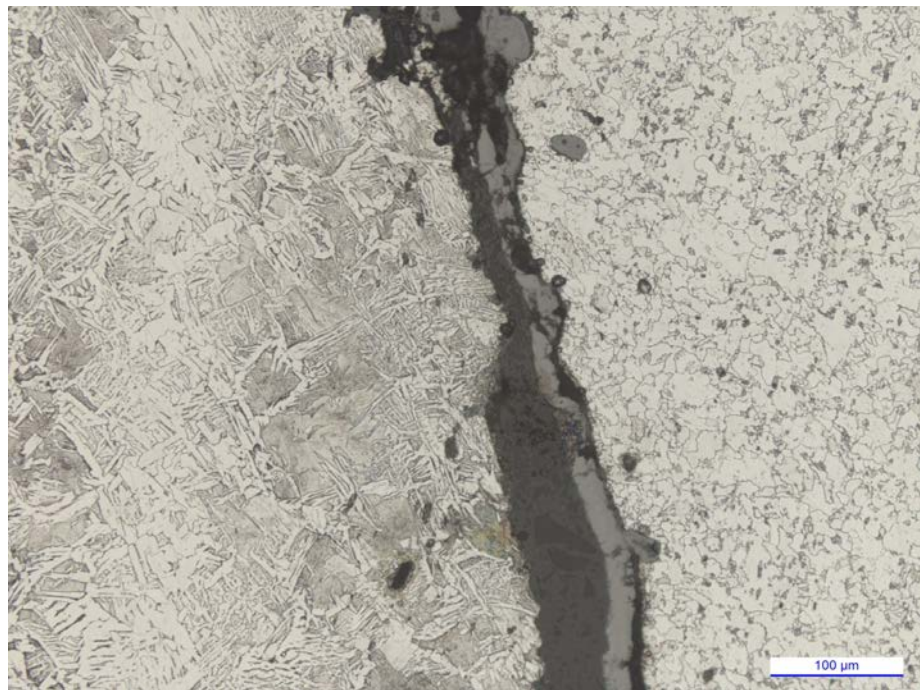
Figure 71. Metallographic images of the matched fracture surfaces shown in Figure 69. The right-hand piece, which was extracted from pipe Section B, has a well-defined oxide layer. Segment B was exposed to the fire during the incident.

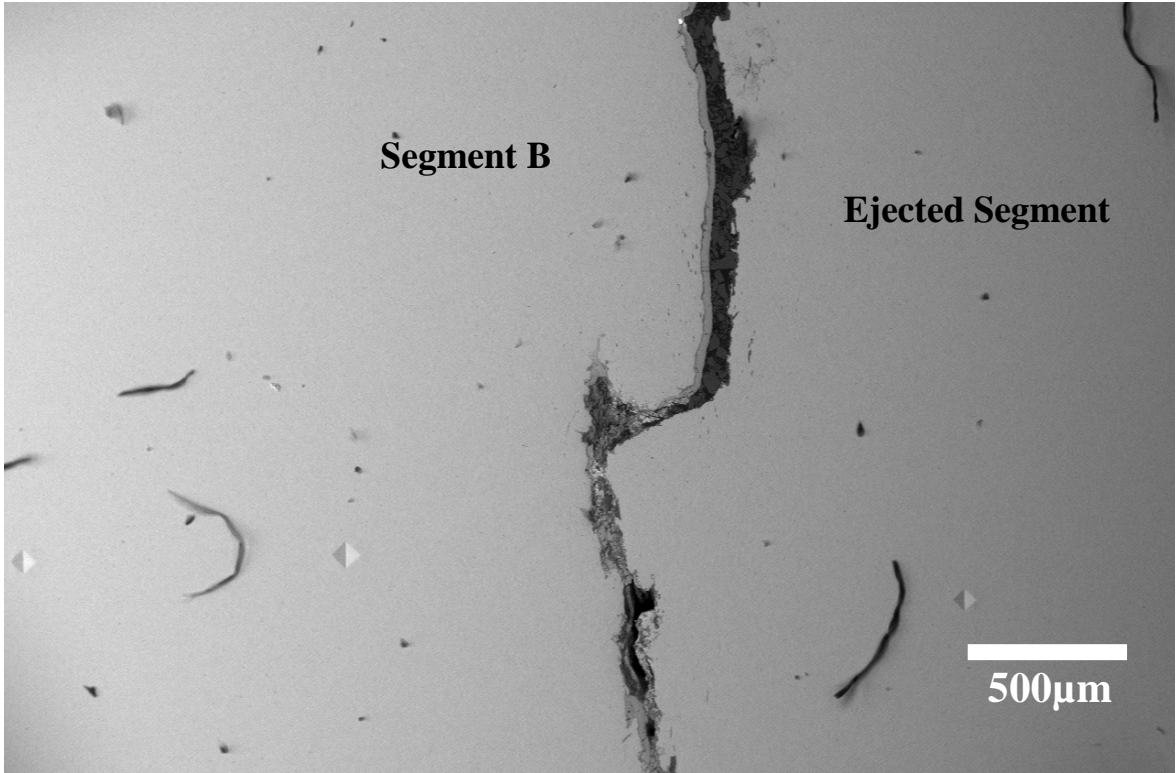
Figure 72. SEM image of the matched fracture surfaces of the long seam fracture.

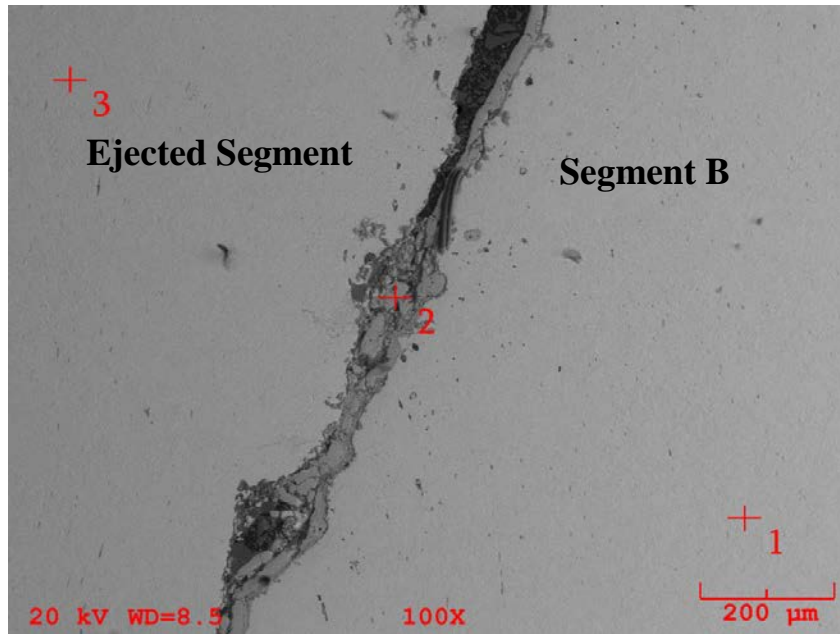
Figure 73. SEM image of the matched fracture surfaces of the long seam fracture. EDS spectra for the areas identified by Numbers 1 (Segment B), 2 (Segment B oxide), and 3 (Ejected Segment) are shown in Figure 74.

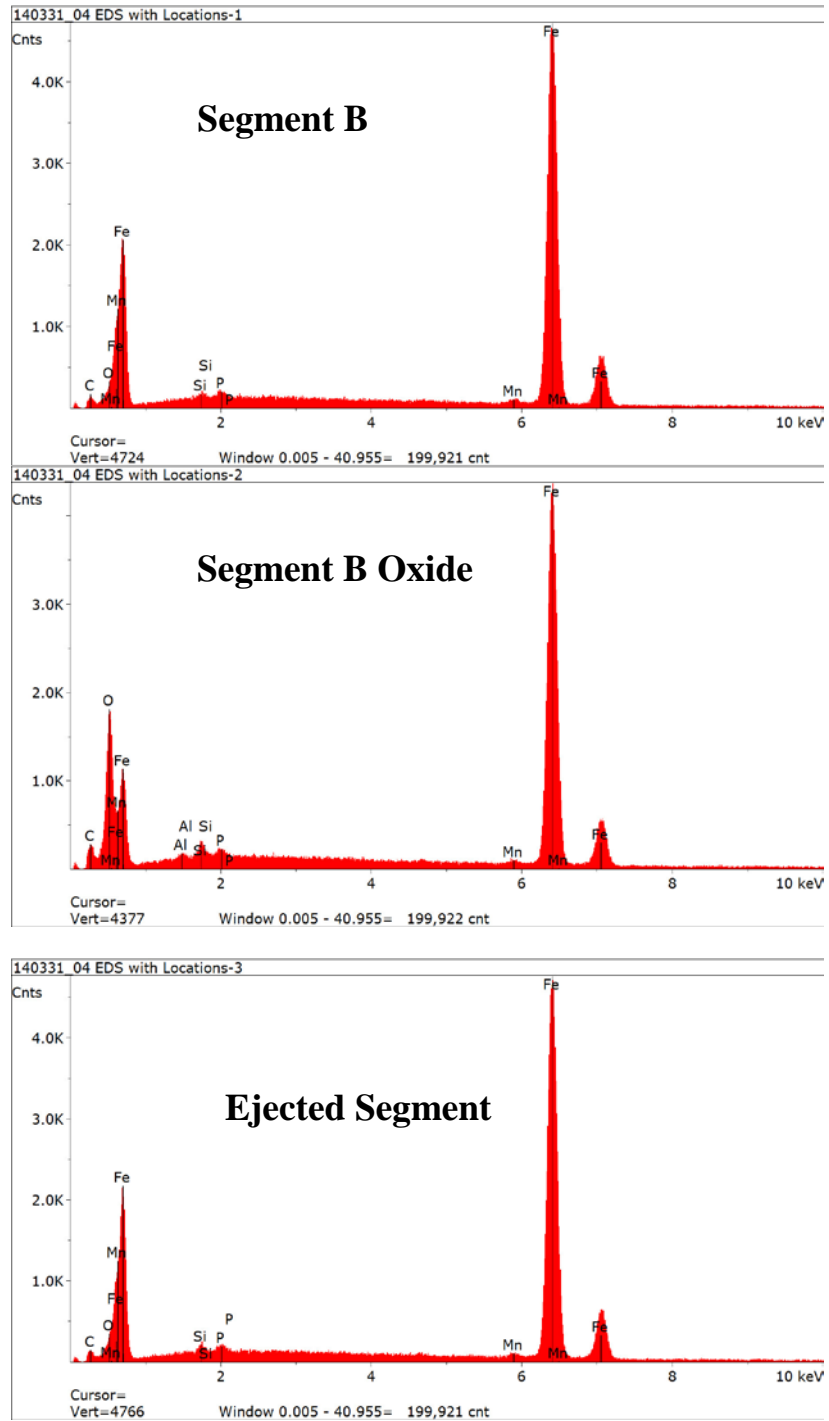
Figure 74. EDS spectra shown for areas of the matched fracture surfaces in Figure 73.

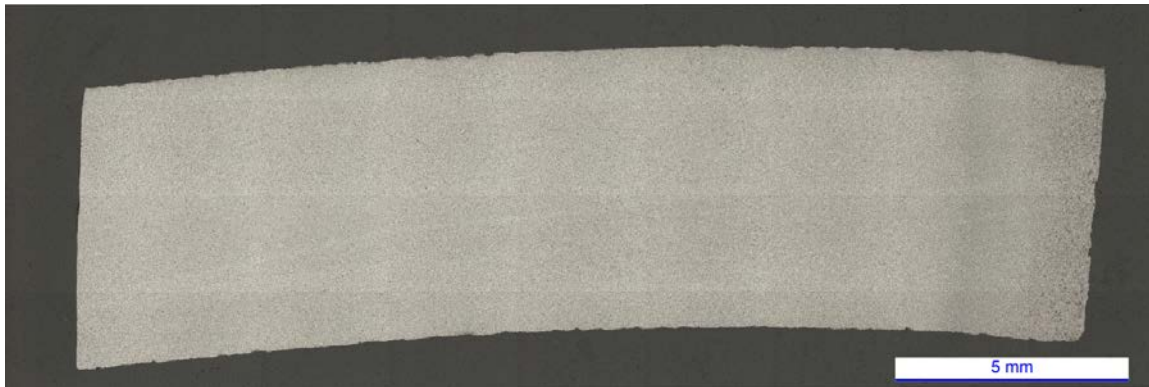
Figure 75. Metallographic mount of the B location in Figure 69, EJ Frac 1-SEM B. This location corresponds to the area where the crack joined the long seam and began to propagate in either direction along the long seam per Figure 36 and Figure 63. The outer diameter of the pipe is at the top, and the fracture surface is on the right.

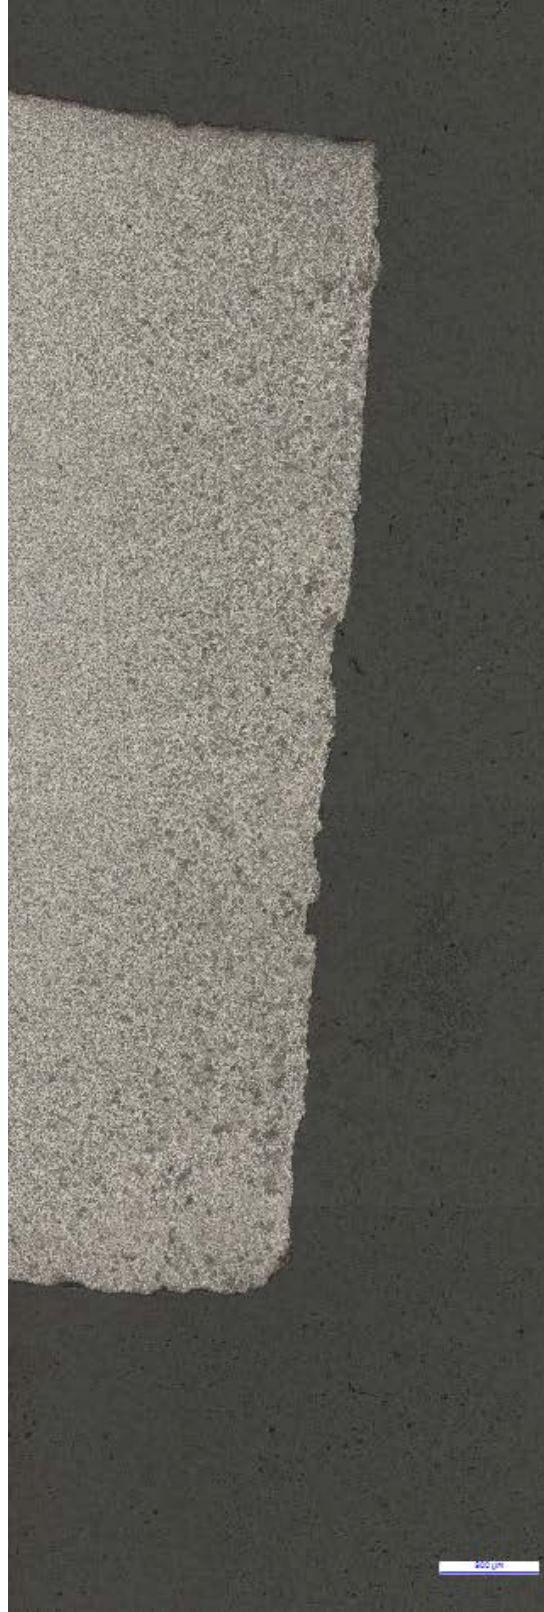
Figure 76. The fracture surface area of the previous image (Figure 75), EJ Frac 1-SEM B.

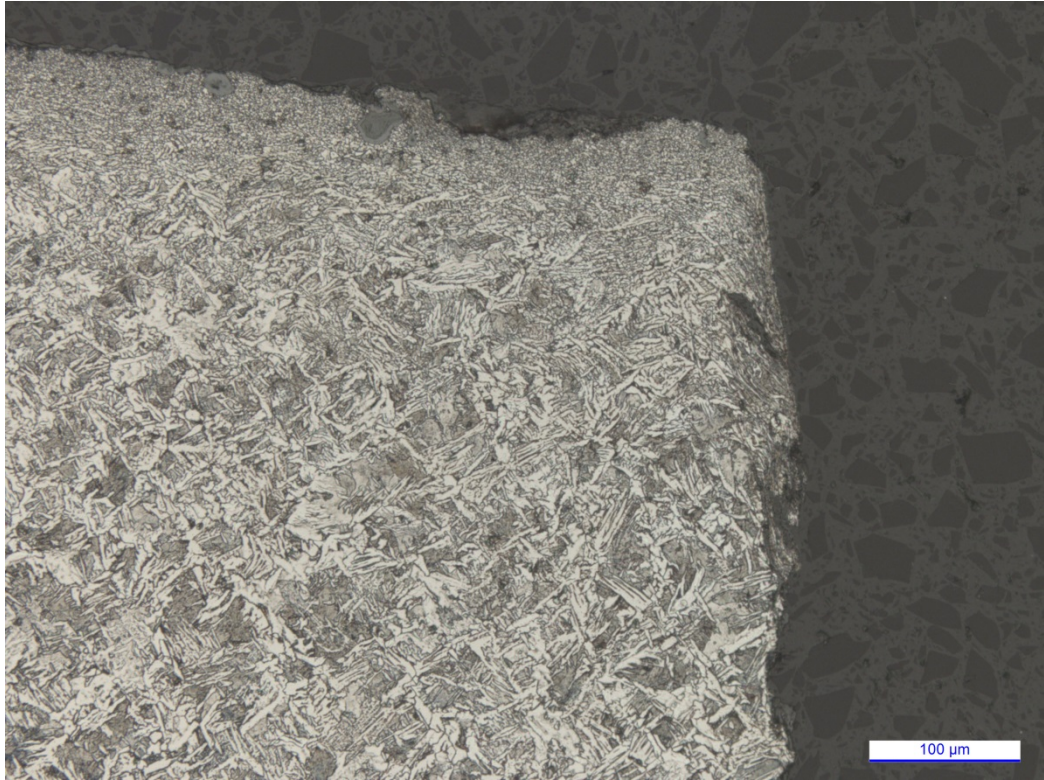
Figure 77. A high-magnification metallographic image of the fracture surface and outer diameter of EJ Frac 1-SEM B.

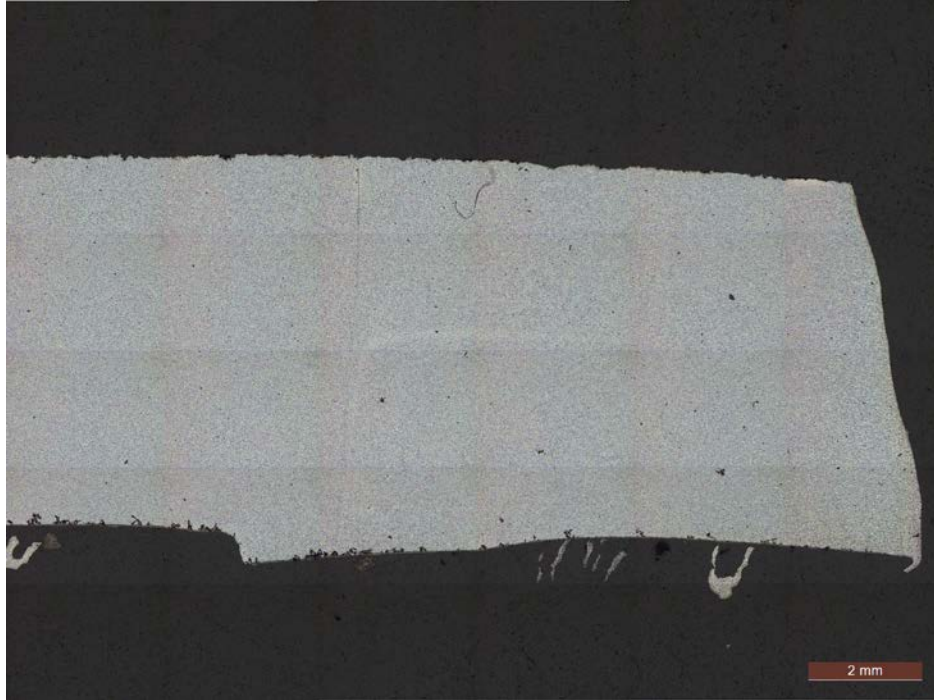
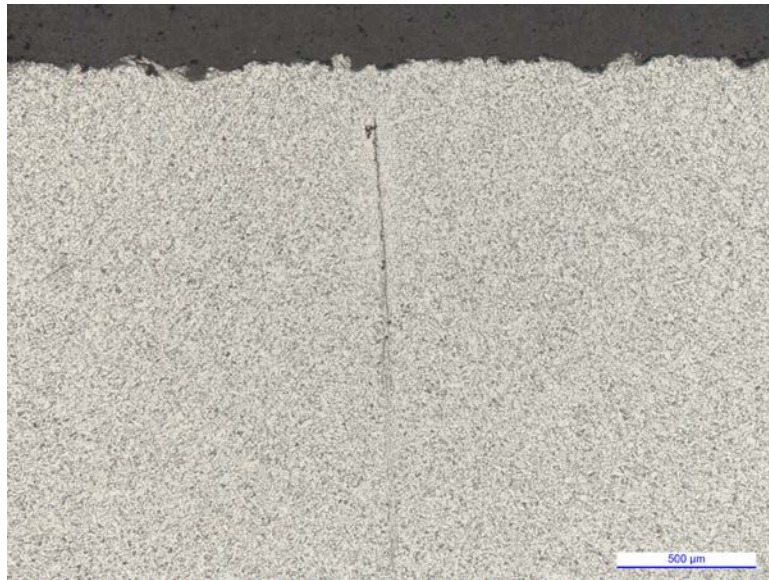
Figure 83. Metallographic images of indication B-MP7, showing oxide in the long seam. A surface-connecting crack was not observed at the viewing location.

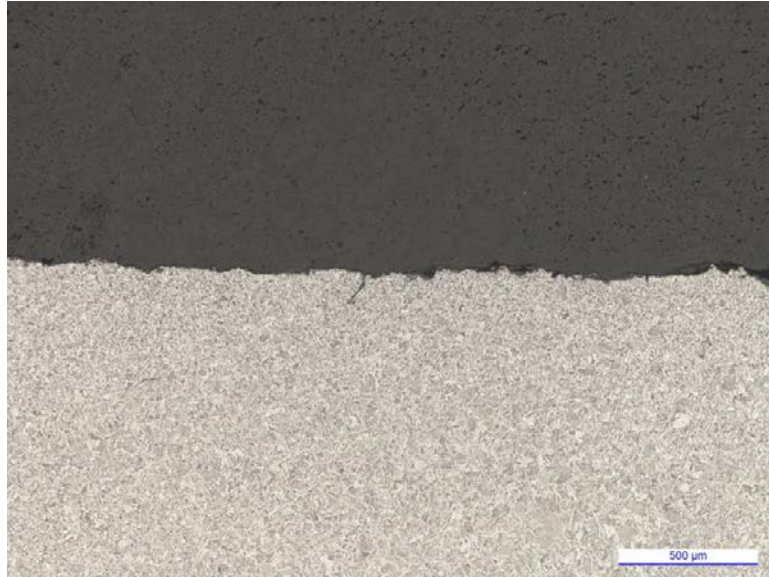
Figure 84. Metallographic image of indication C-MP1. Indication depth was measured to be 0.004 inch (~103 μm).

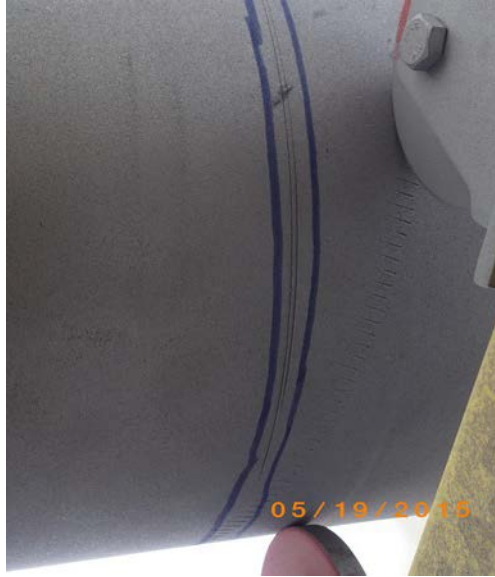
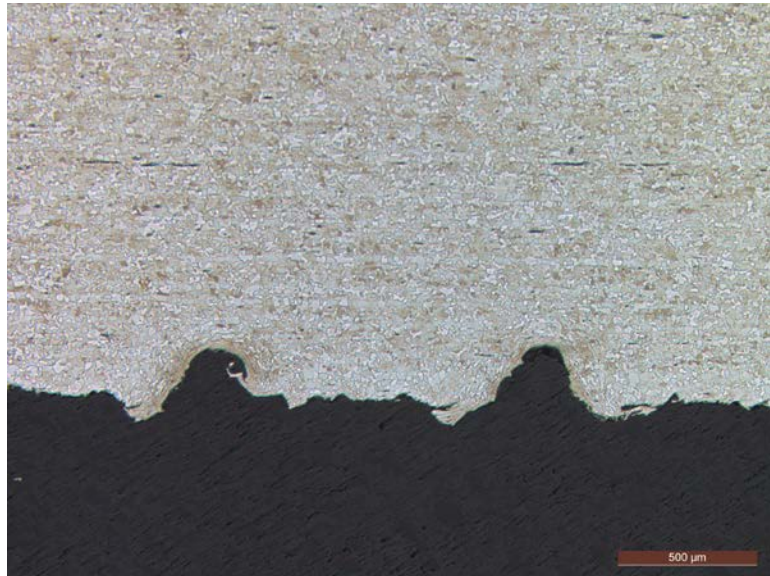
Figure 87. Photograph and metallographic image of Indication D-MD7. This indication ran along a large portion of the pipe circumference. A similar indication was observed on the Ejected Segment and is shown in Figure 94 through Figure 96.

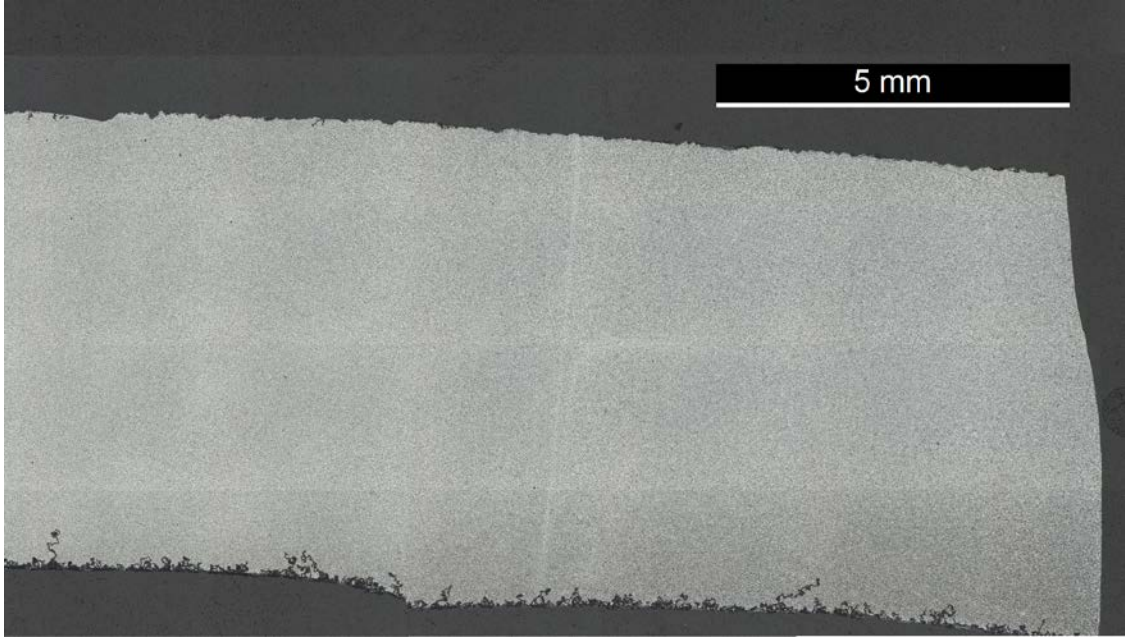
Figure 88. Metallographic image of typical ERW seam in Segment B shown by indication B-MP1.

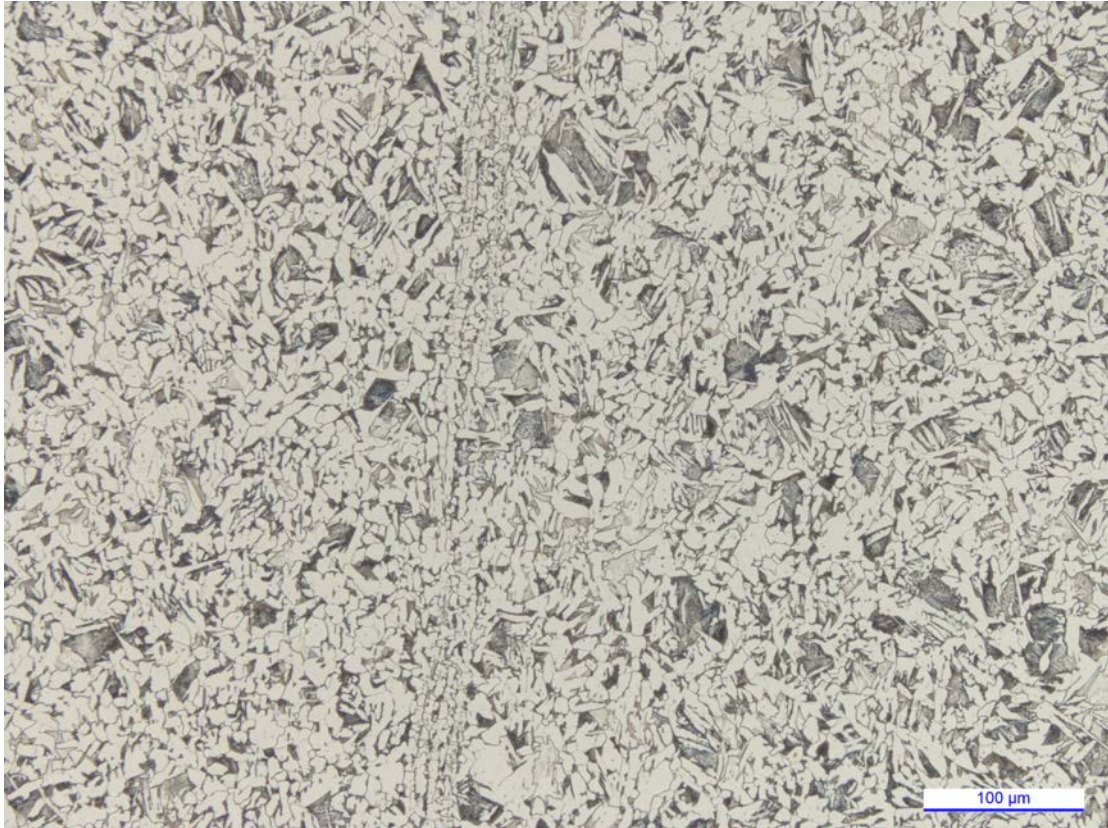
Figure 90. Metallographic image of typical ERW seam microstructure (A-MP2 shown). A Widmanstätten morphology is shown.

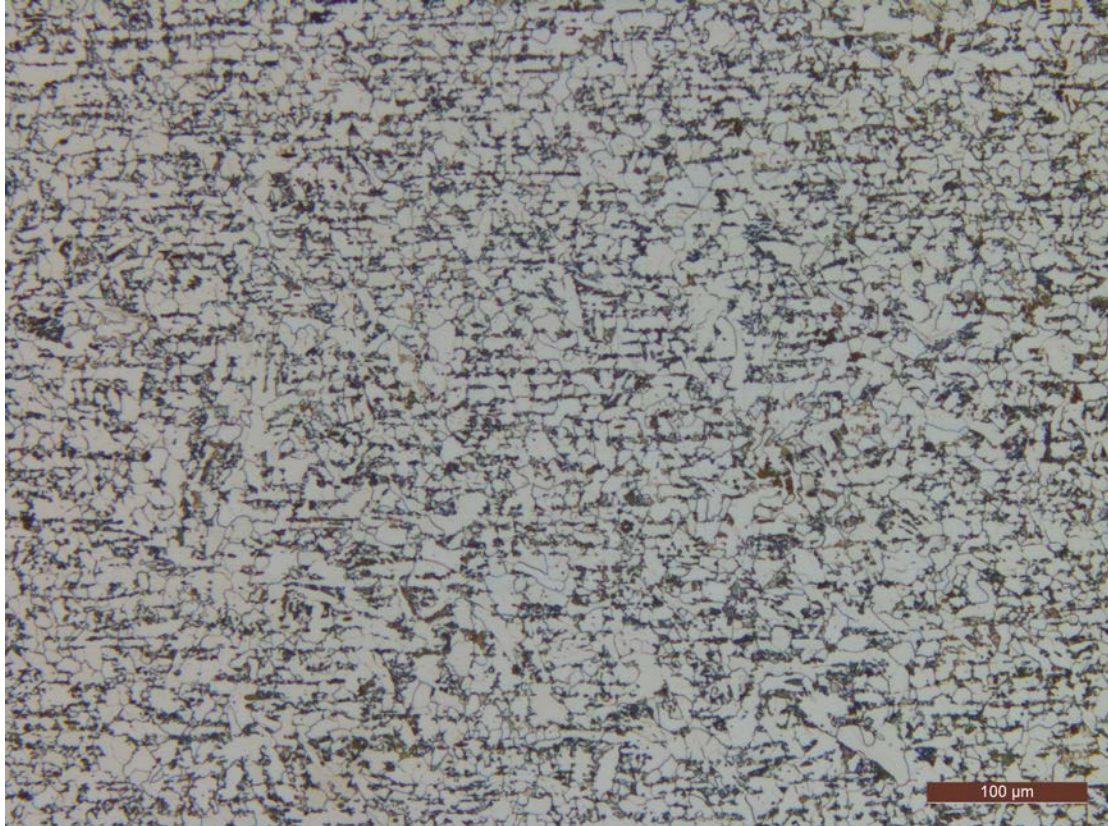
Figure 91. Metallographic image of typical base metal microstructure (A-MP2 shown, away from weld). A typical ferrite-pearlite microstructure is shown.

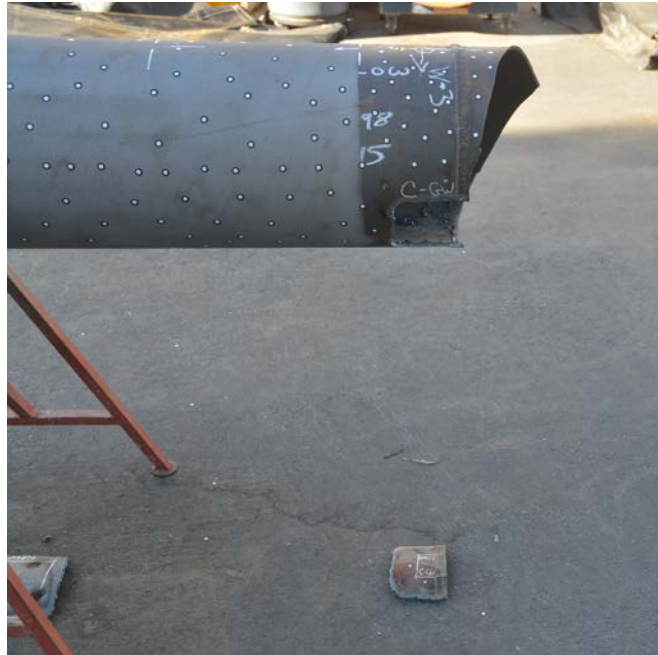
Figure 92. Sectioning of the Segment B–C girth weld. The sample was taken from a region where the fracture was closest to the weld. The pipe is shown in the correct orientation with the sample taken at about the 8:00 position.

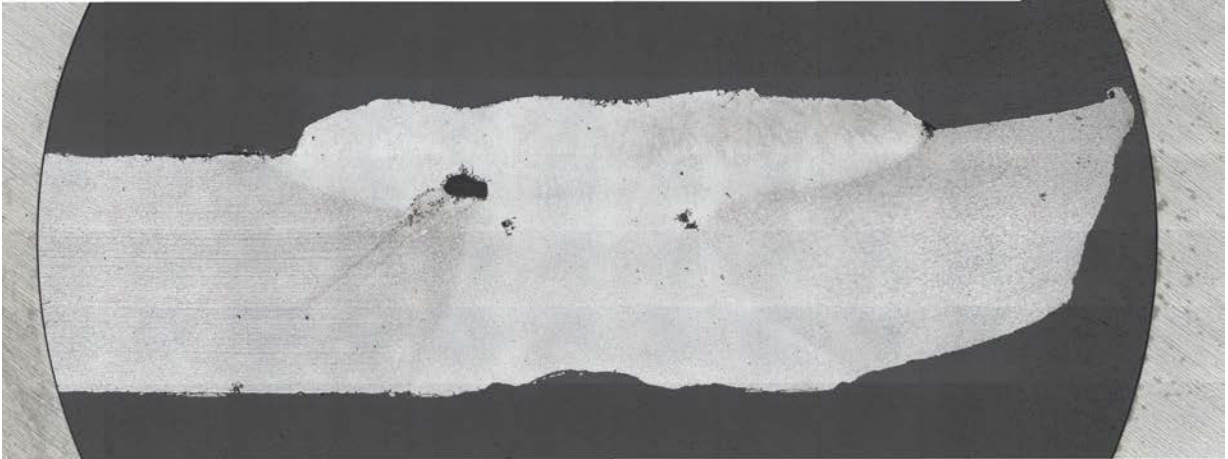
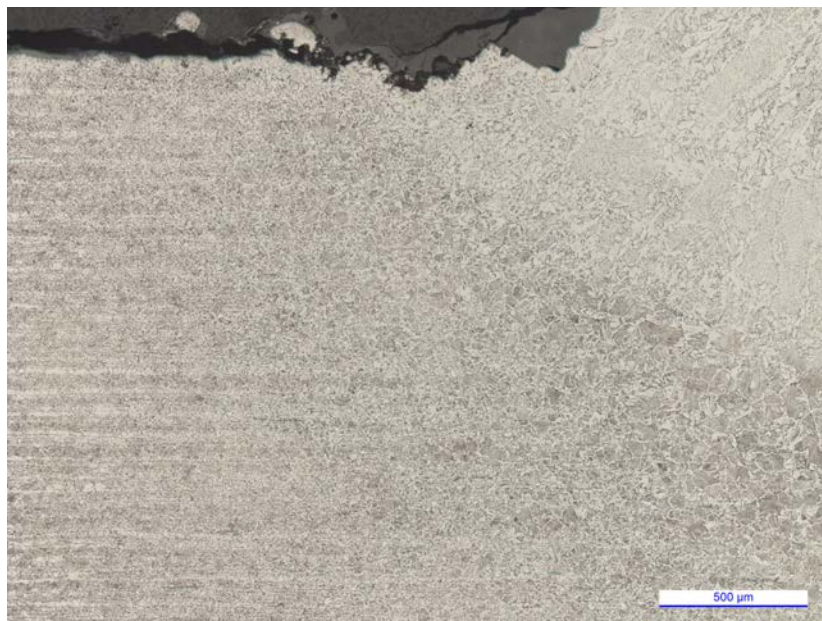
Figure 93. Metallographic images of the girth weld connecting pipe Segments B and C. The fracture surface can be seen on the right in the top image.

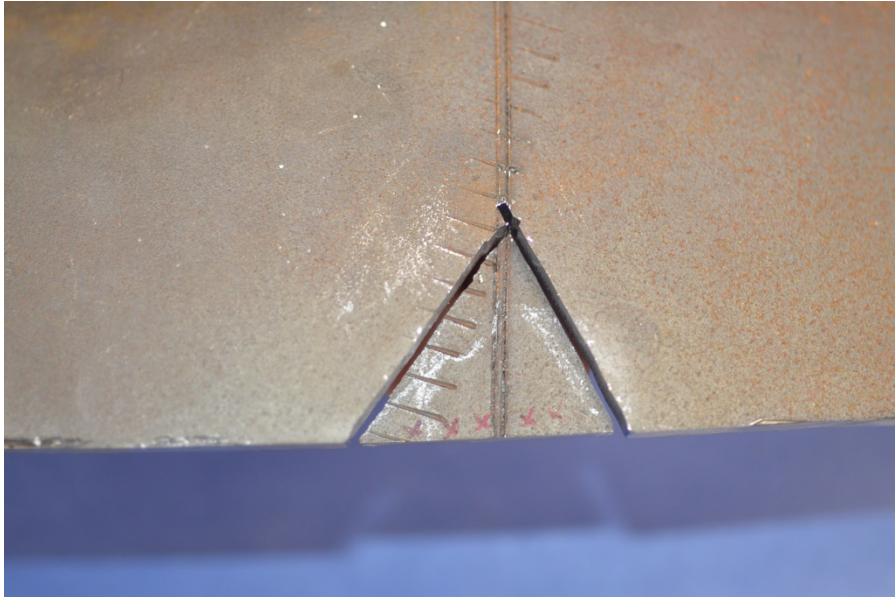
Figure 94. Photo documentation of metallographic sample extraction for an indication labeled EJ Frac 1-Linear. This metallographic mount was prepared for the purpose of investigating the linear indication running from the top of the image to the bottom on the outer surface of the Ejected Segment. The piece was cut from the Ejected Segment per Figure 61.

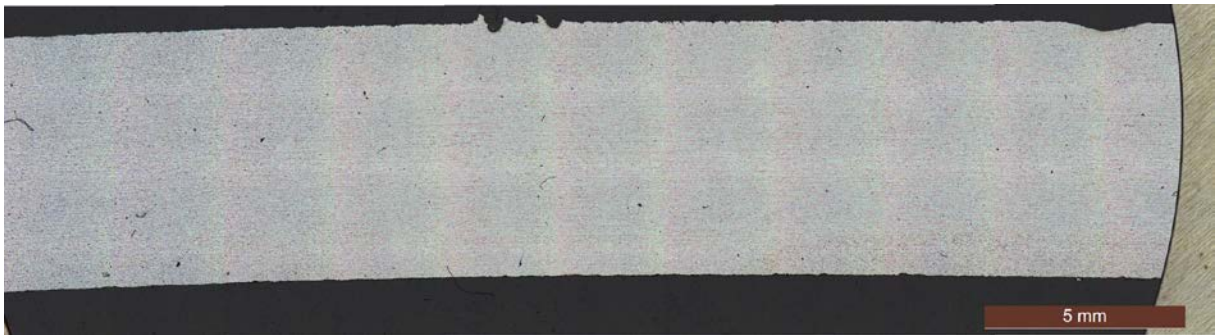
Figure 95. The EJ Frac 1-Linear metallographic mount. The feature can be observed along the outer diameter as two small indents.

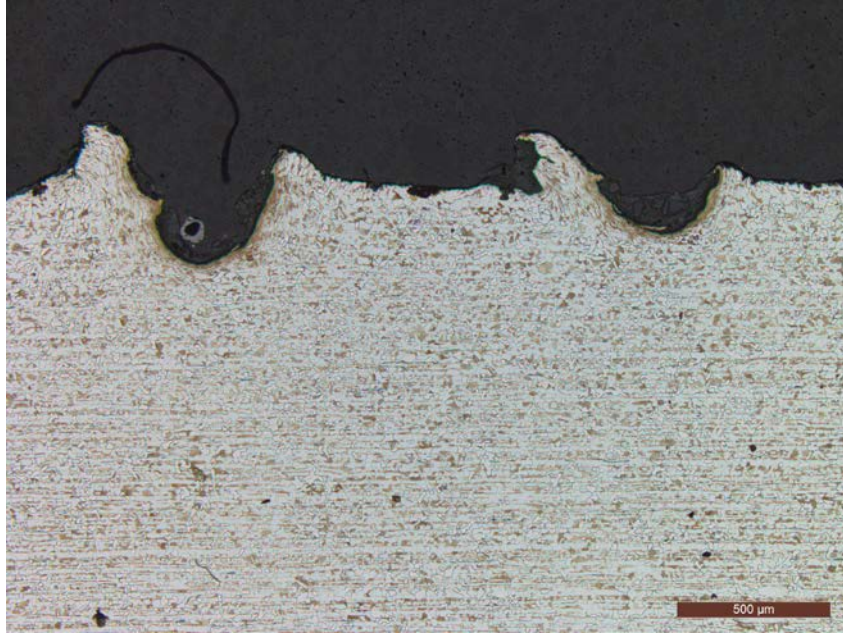
Figure 96. Higher-magnification metallographic image of the EJ Frac 1-Linear sample. The feature is consistent with D-MD7.

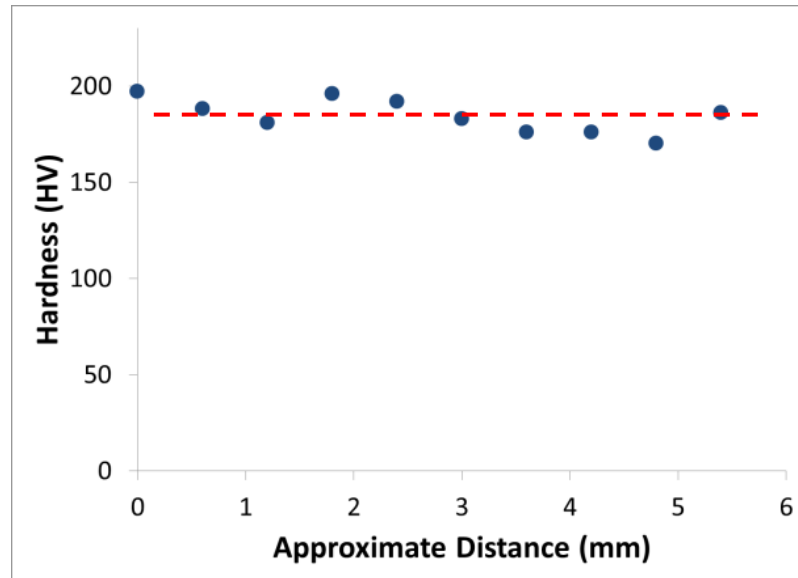
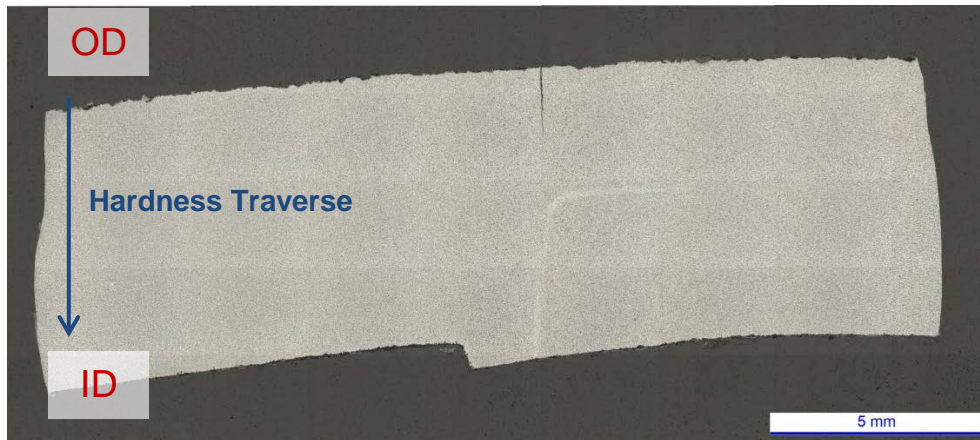
Figure 97. An optical micrograph of the cross section associated with indication A-MP2 and microhardness traverse. Etched with 2 percent Nital. This microhardness traverse was performed to characterize base metal hardness.

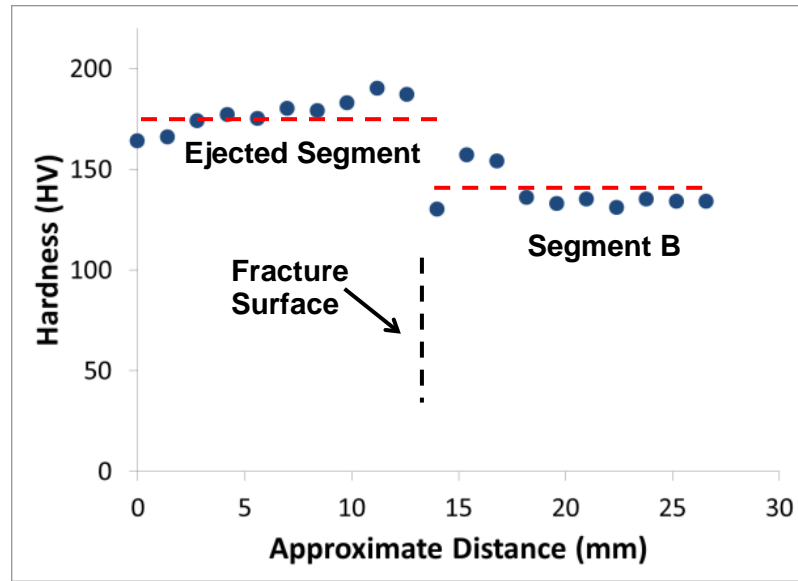
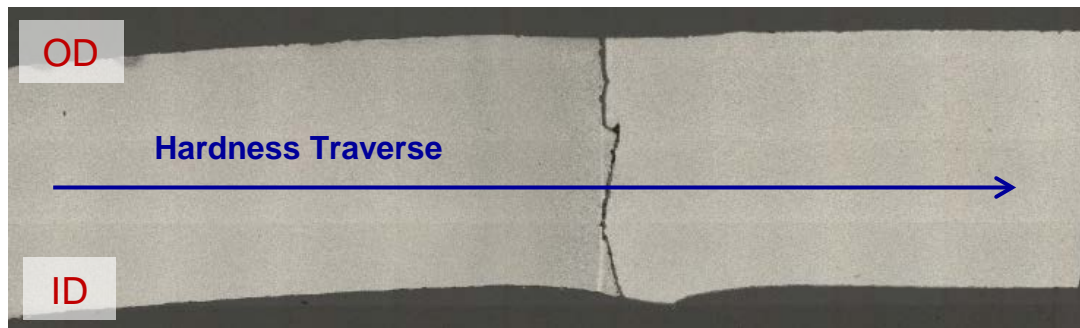
Figure 100. An optical micrograph and microhardness traverse of the matched fracture surfaces shown in Figure 70. The right-hand side corresponds to the piece extracted from Segment B, whereas the left-hand side corresponds to a sample taken from the Ejected Segment. Segment B shows significantly lower hardness than the Ejected Segment due to exposure to the fire's high heat.

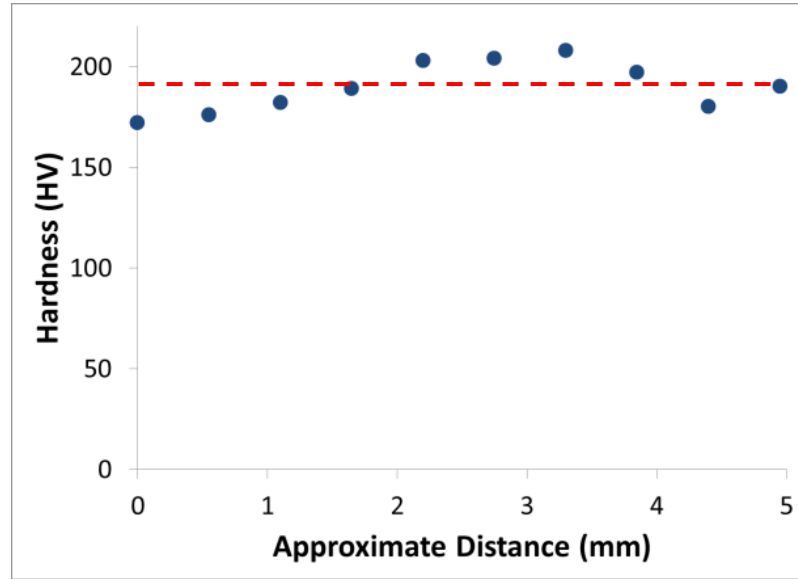
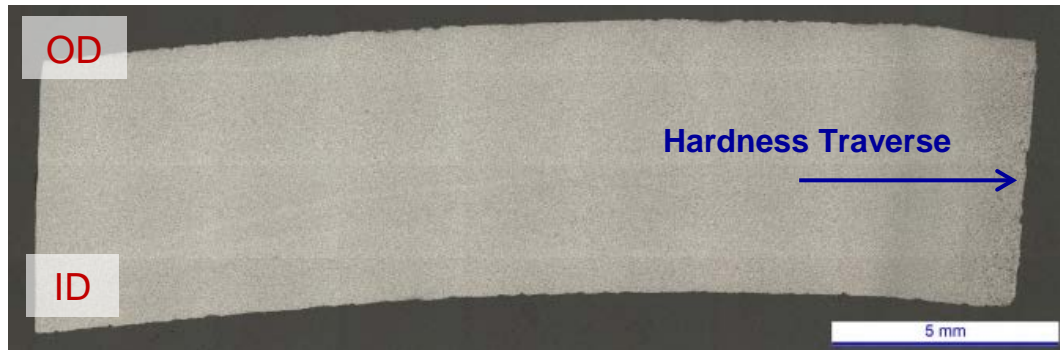
Figure 101. An optical micrograph and microhardness traverse of EJ Frac 1-SEM B (i.e., Location B shown in Figure 69). The fracture surface at the long seam is on the right-hand side of the sample. Etched with 2 percent Nital.

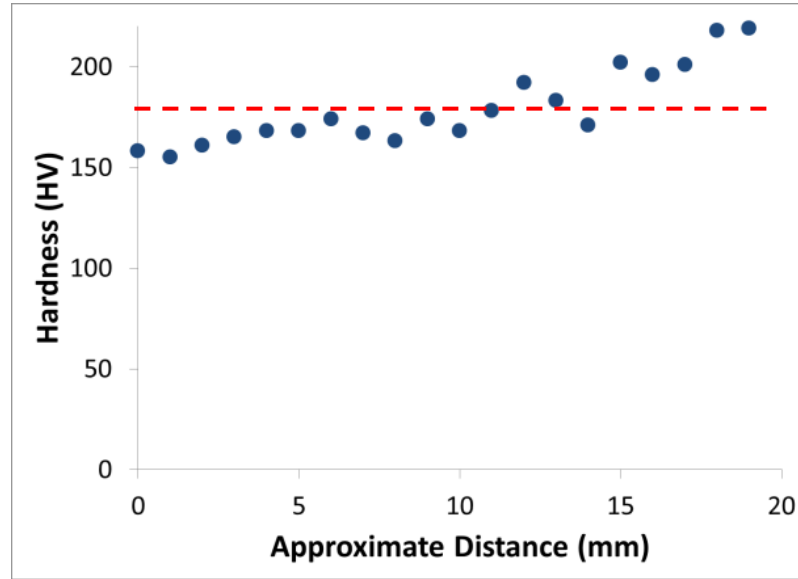
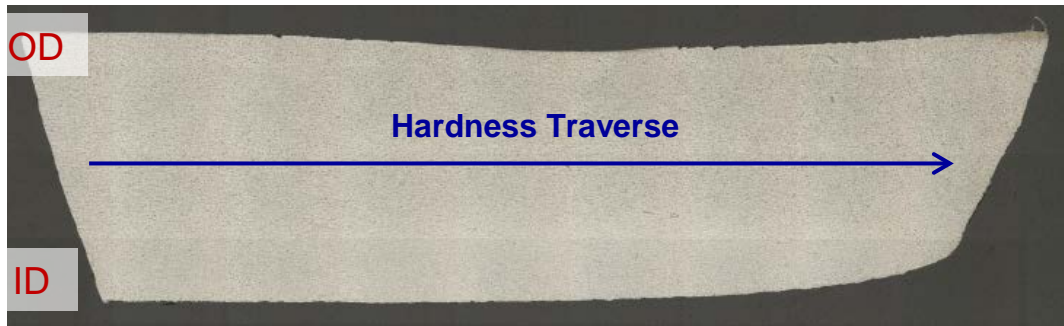
Figure 102. An optical micrograph and microhardness traverse of the EJ Frac 2-2 sample, where increasing hardness is observed approaching the fracture surface on the left-hand side of the micrograph. Etched with 2 percent Nital.

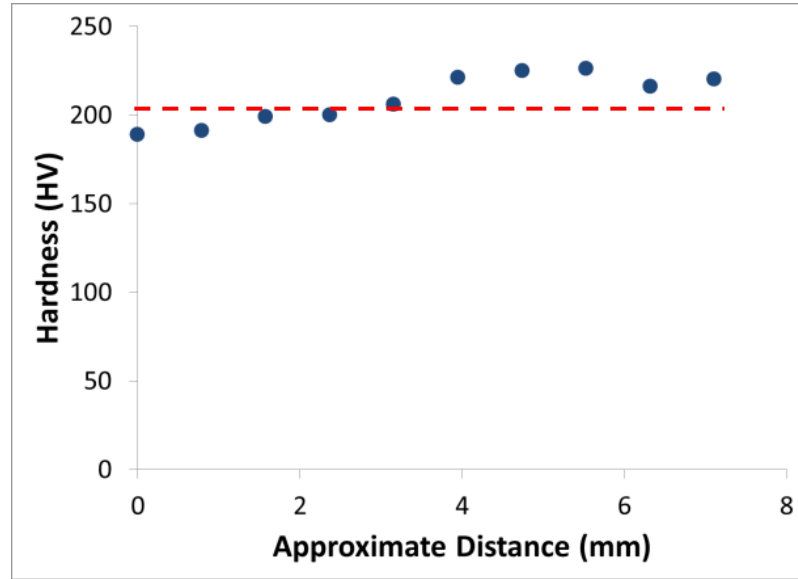
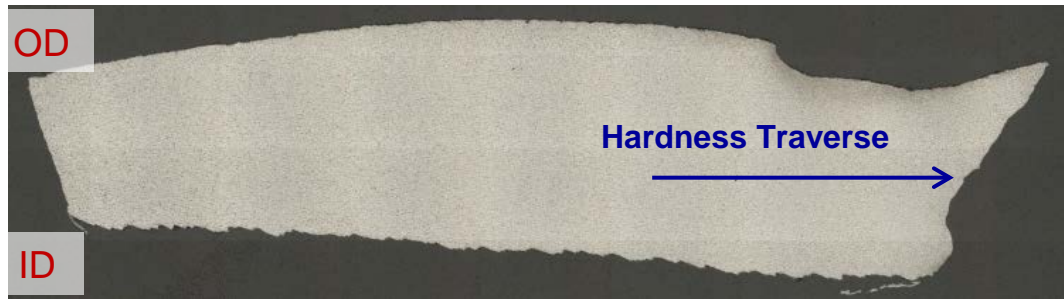
Figure 103. An optical micrograph and microhardness traverse of the Fracture 3 sample. Similar to EJ Frac 2-3, hardness increases closer toward the fracture surface. Etched with 2 percent Nital.

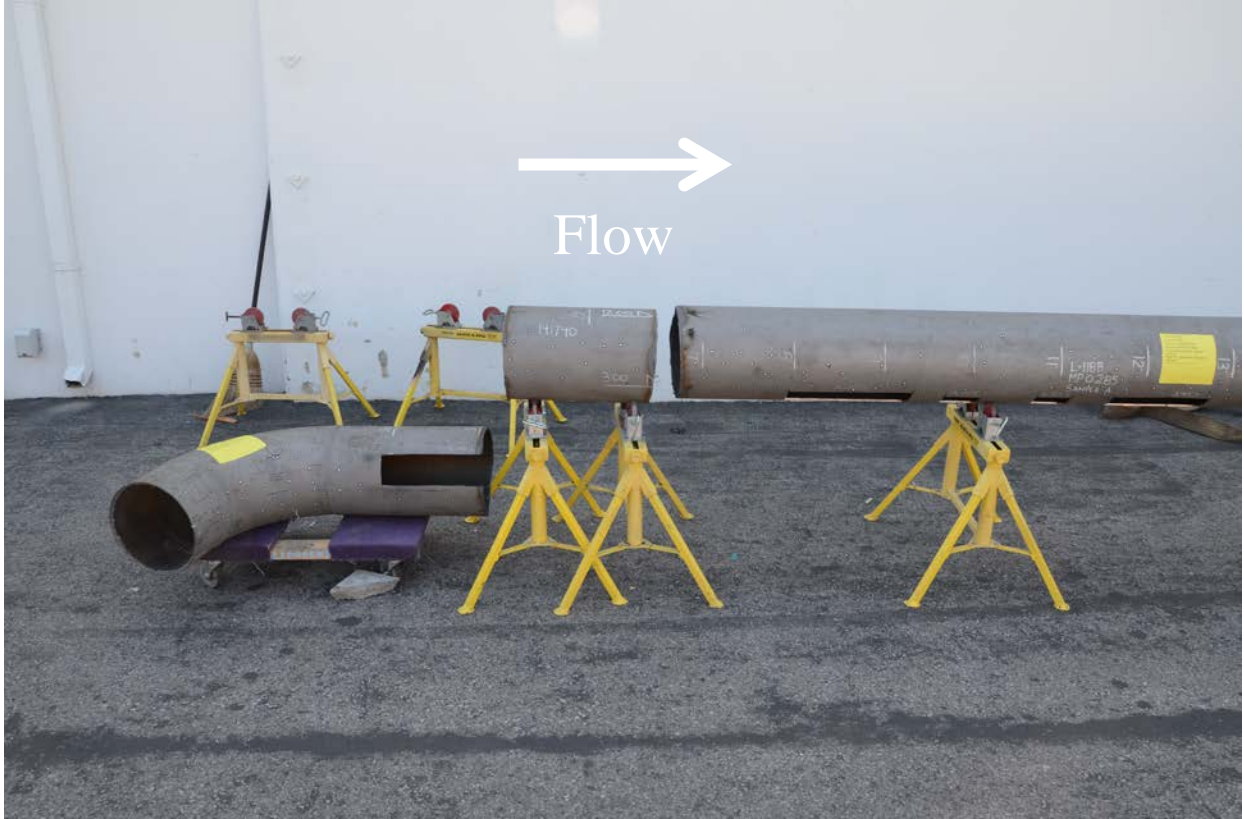
Figure 104. Photo documentation showing the location used for the Segment A mechanical testing specimens on the upstream side of Segment A.
