Exponent[®]

Failure Analysis Associates

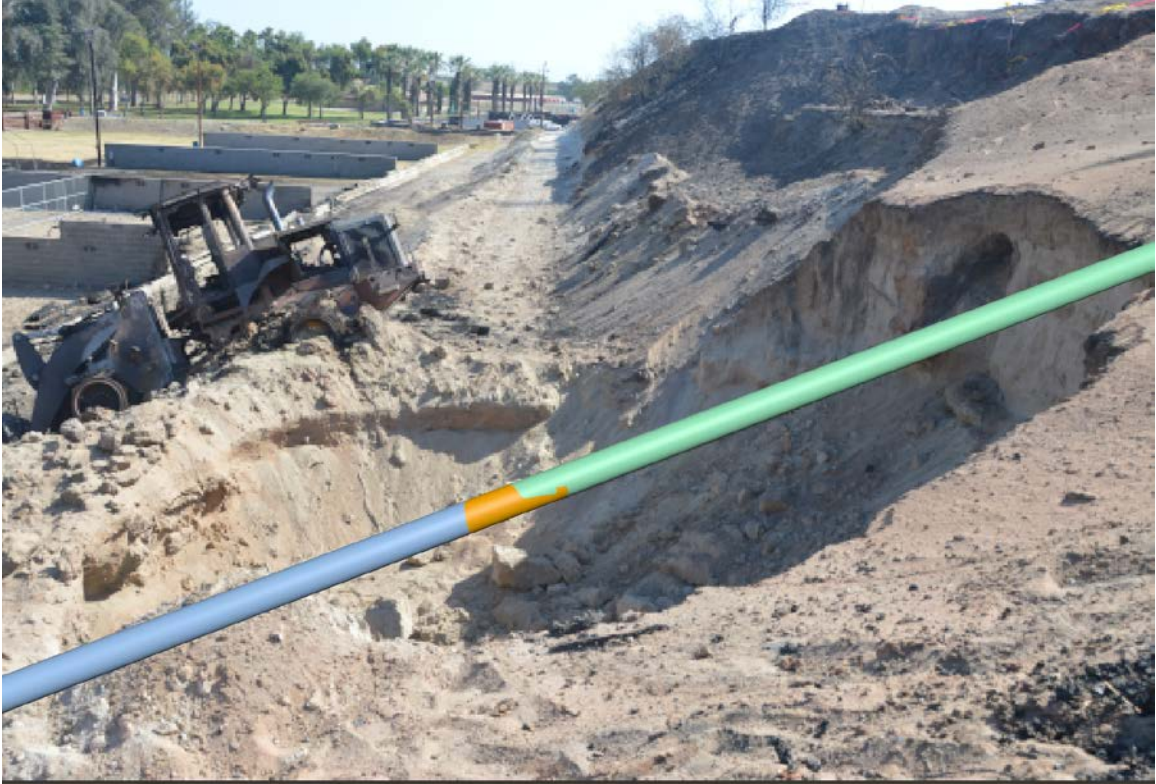
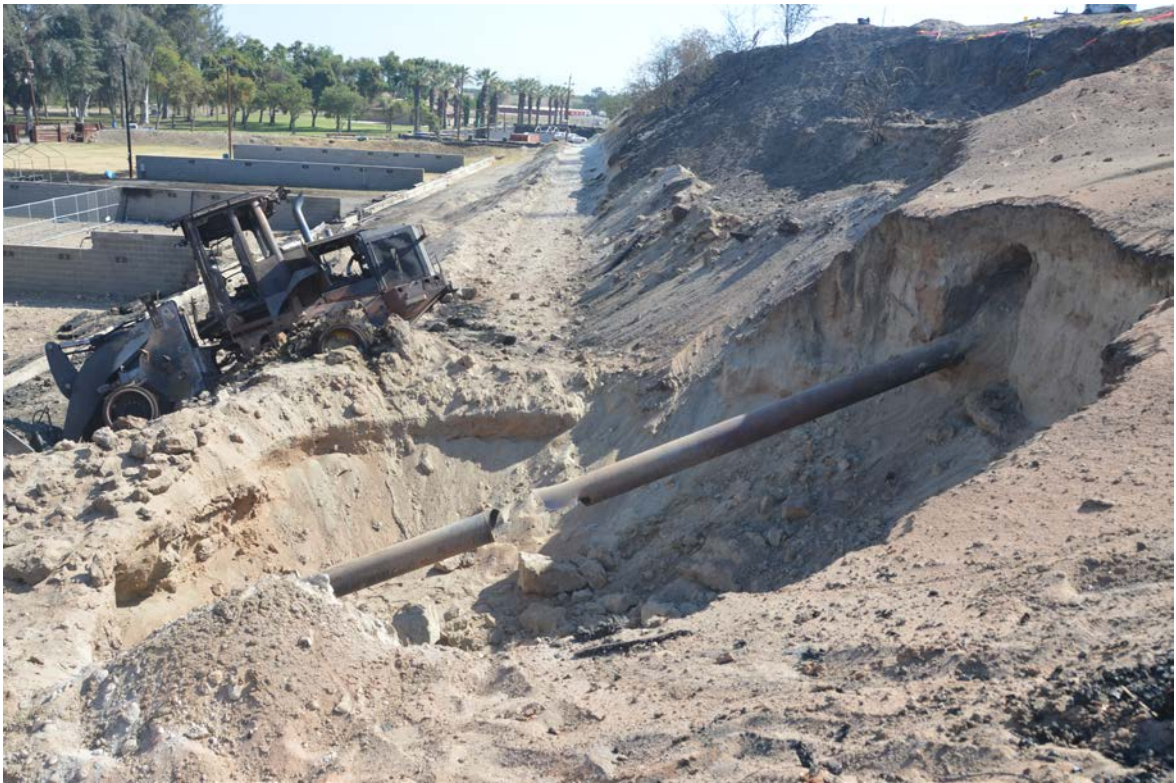
Figure 116. A three-dimensional reconstruction of the pipe overlaid on a photograph of the incident scene. The relative position of the pipe pieces to the ground was estimated based on laser scan and photography matching.

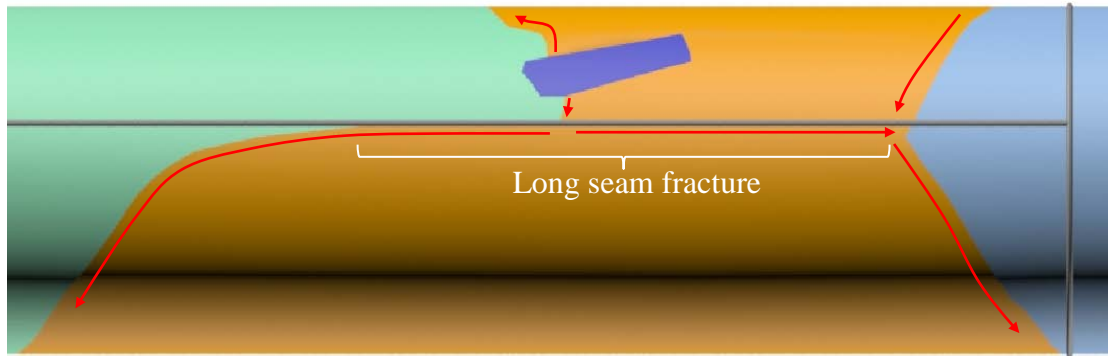
Figure 117. Laser-scan reconstruction of the fractured pieces, with the metal fold shown in purple. The direction of crack propagation is shown by the red arrows.

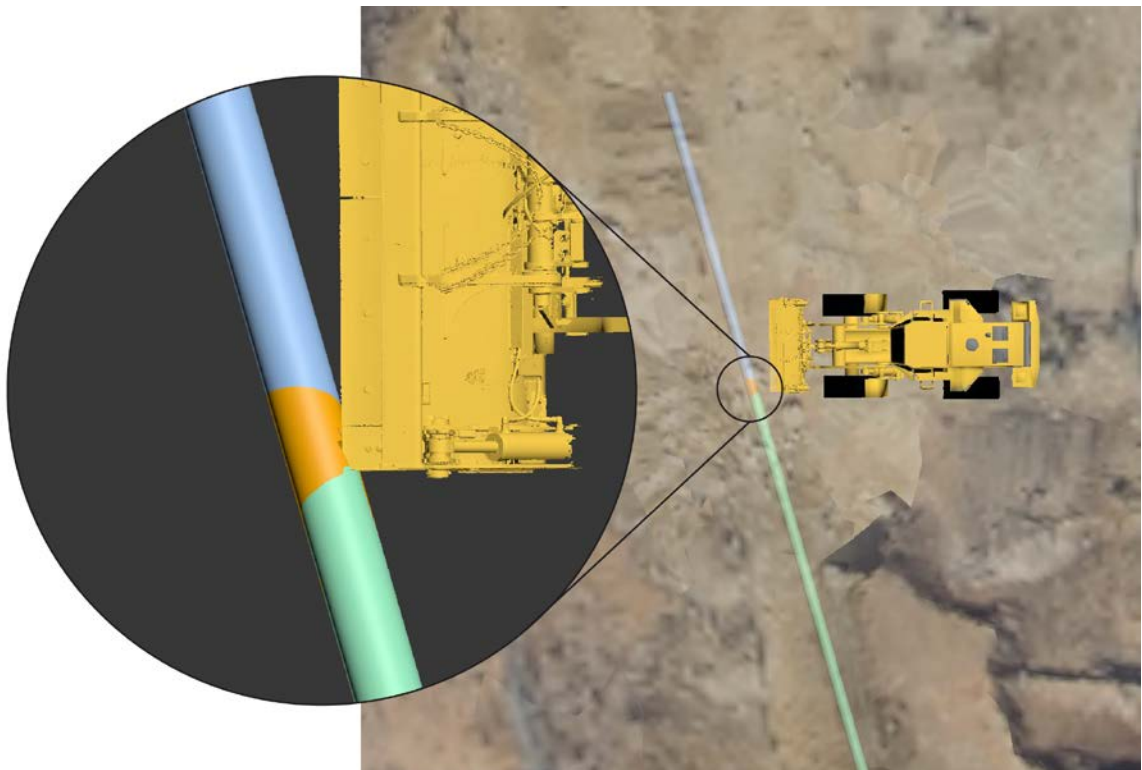
Figure 118. Plan-view laser-scan reconstruction of the front loader bucket striking the pipe, based on laser-scan data. The position of the pipe with respect to the ground was estimated based on laser scan and photography matching.

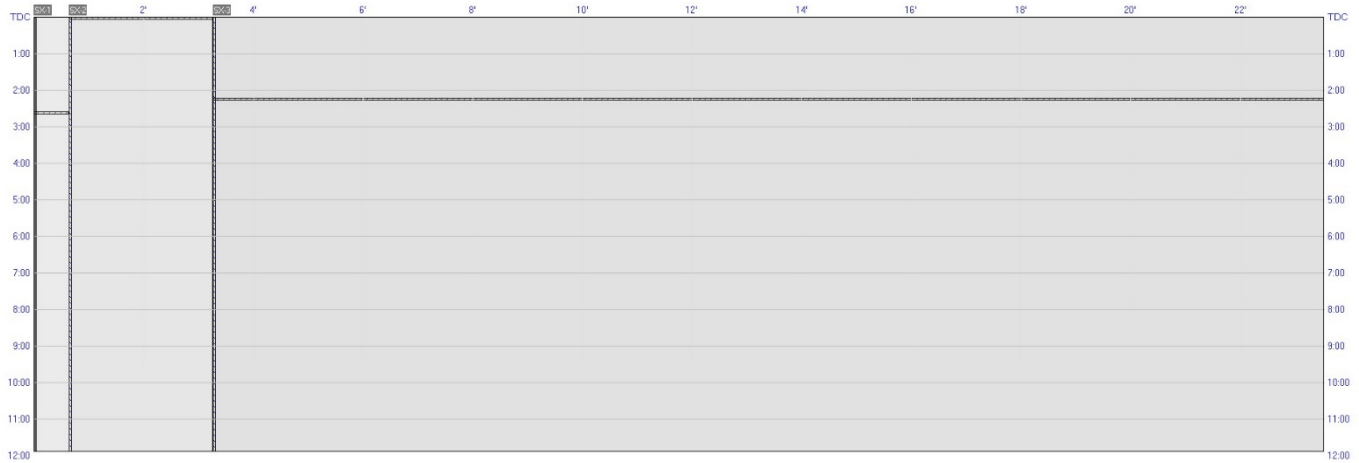
P/S Potential Measurements

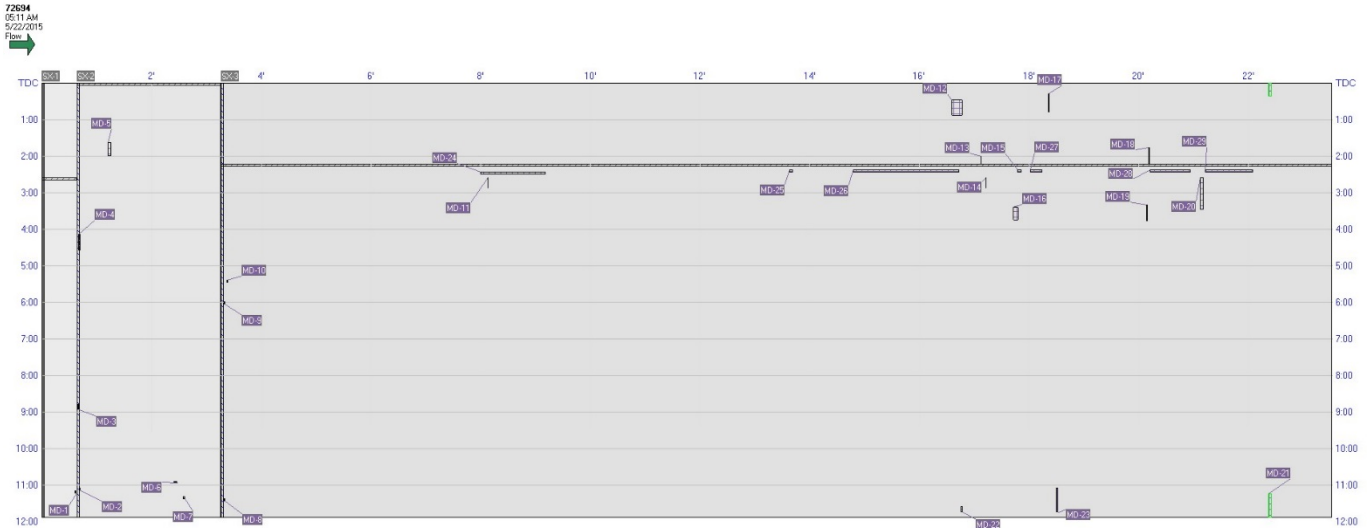
Map of Mechanical Damage

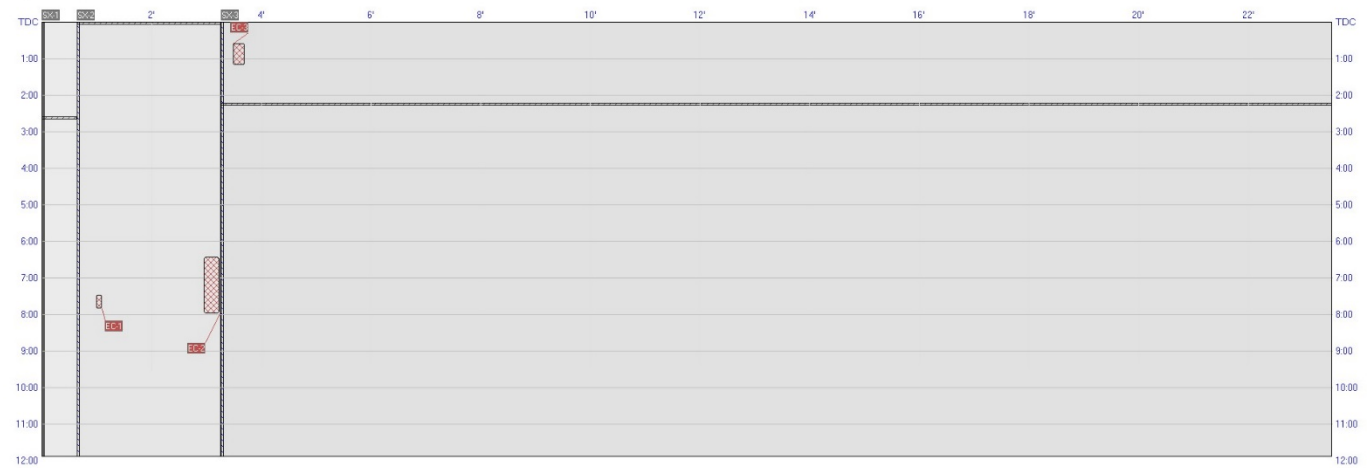
72694
05:11 AM
5/22/2015
Plot A

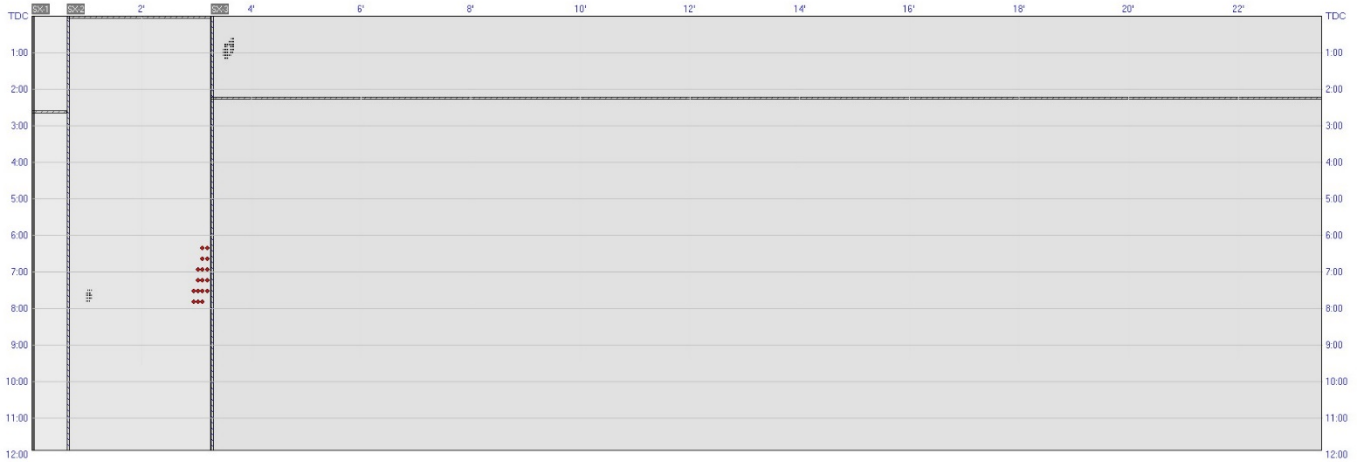
UT - Internal Corrosion Grid (UTG)

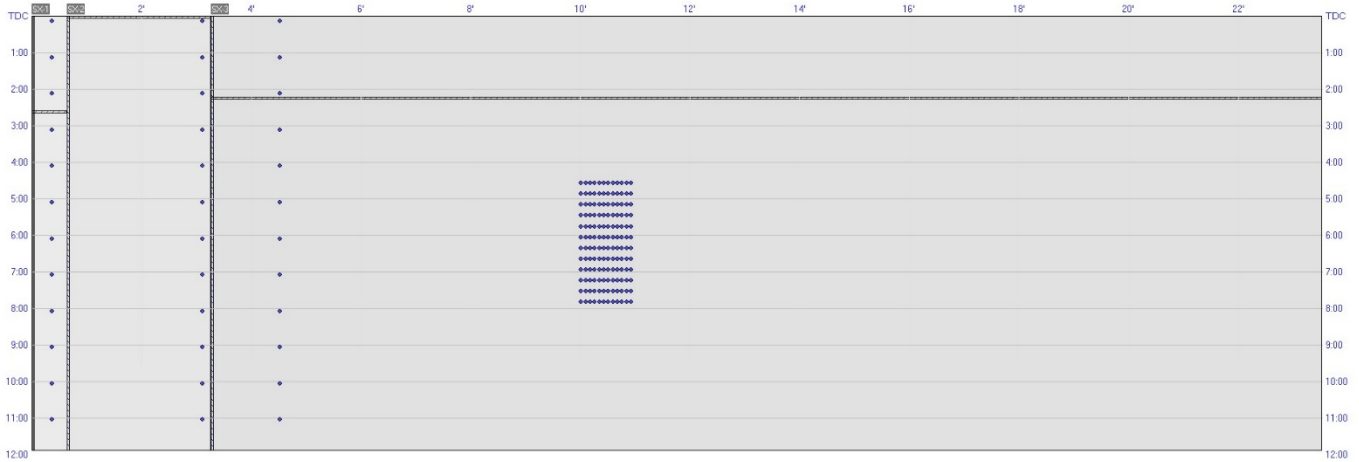
72694
05:11 AM
5/22/2015
Flow →

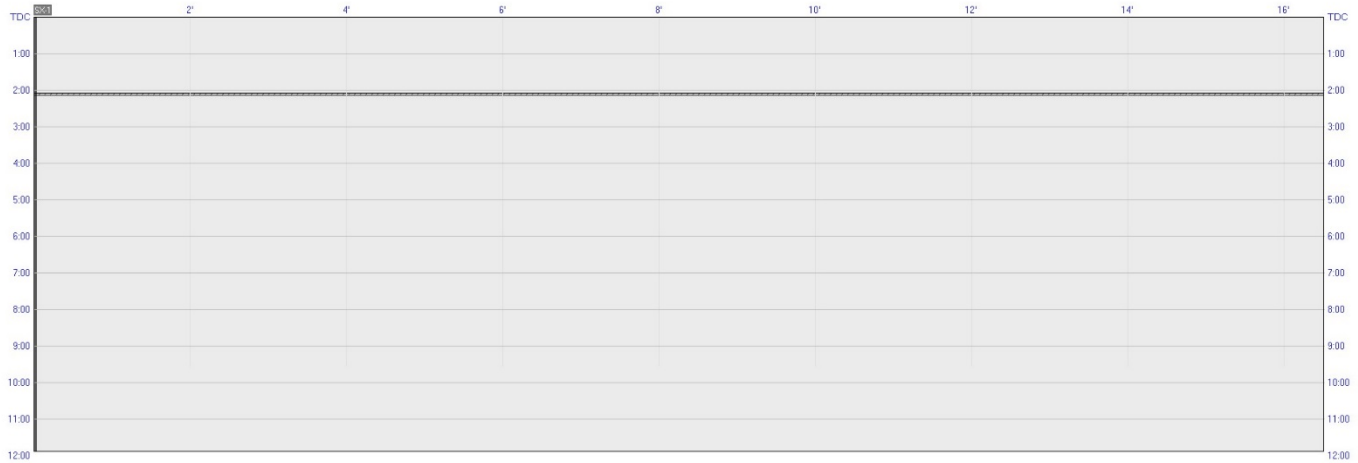
P/S Potential Measurements

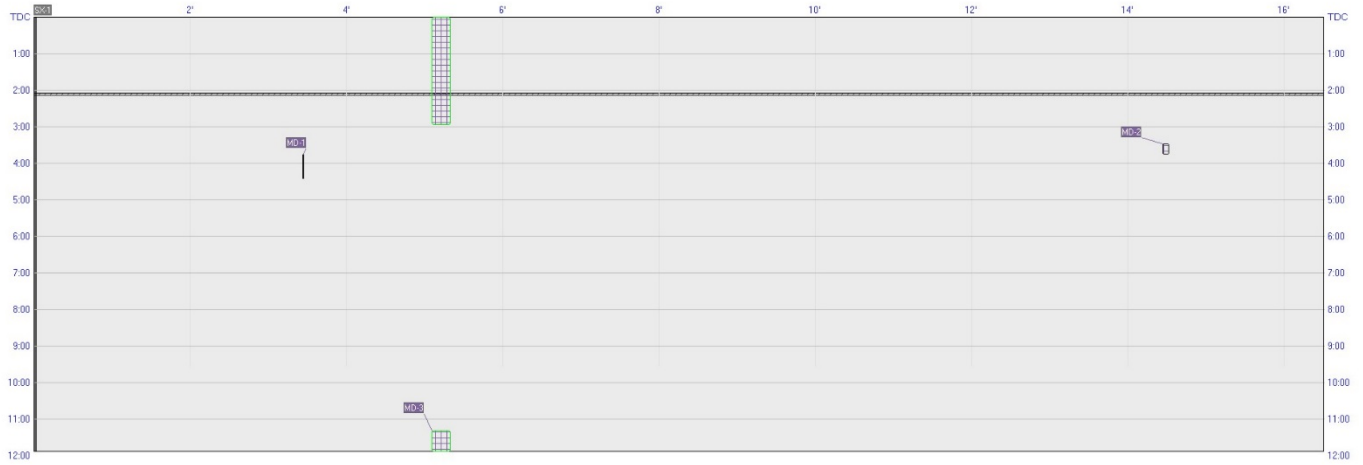
72695
05:27 AM
5/22/2015
Flow →

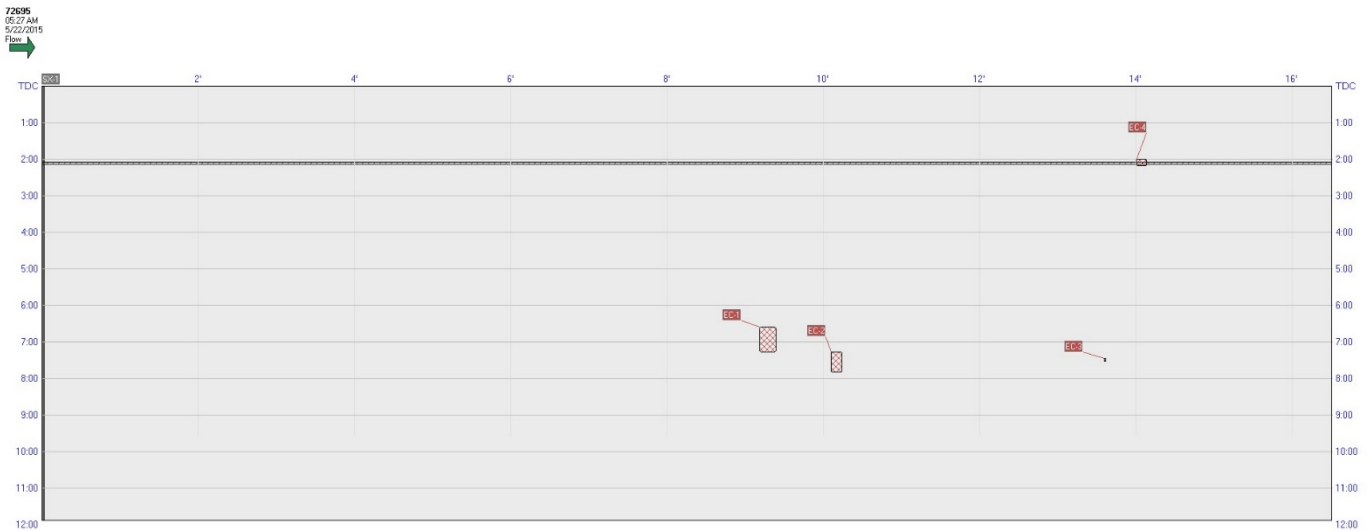
Map of Corroded Area

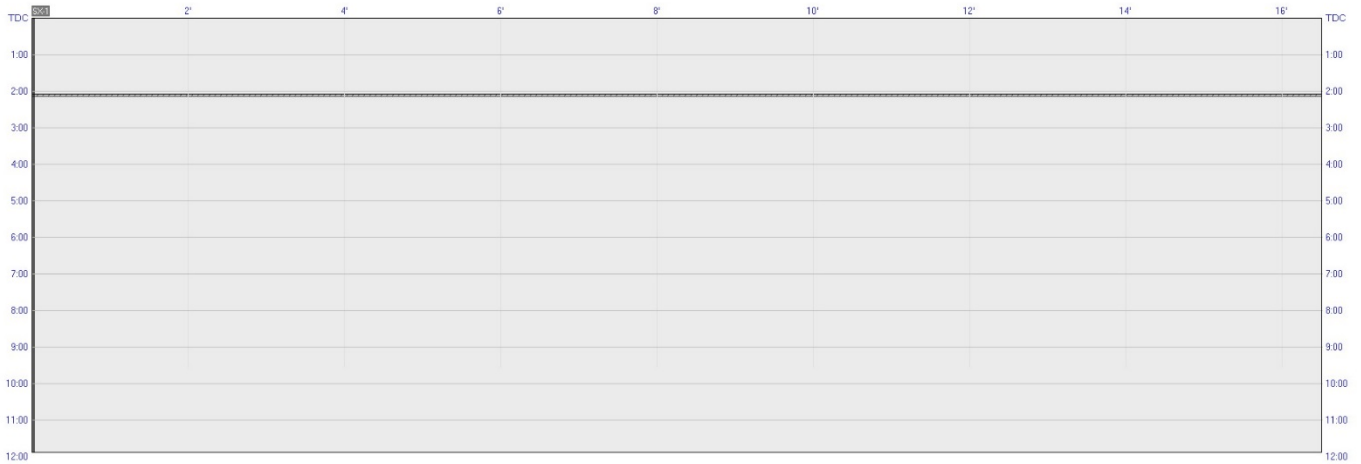
UT - Internal Corrosion Grid (UTG)

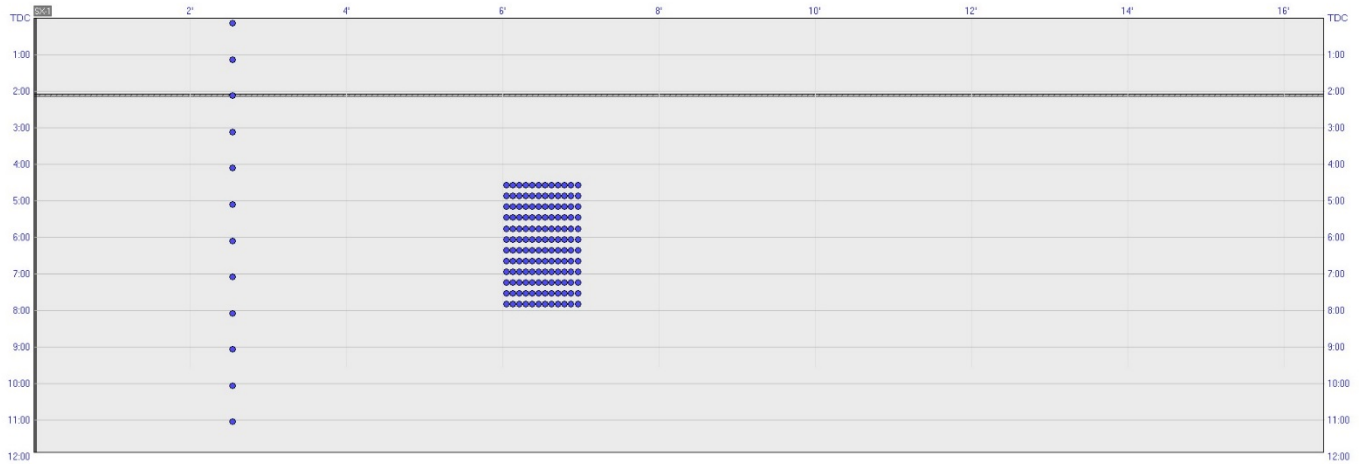
72695
 05:27 AM
 5/22/2015
 Flow →

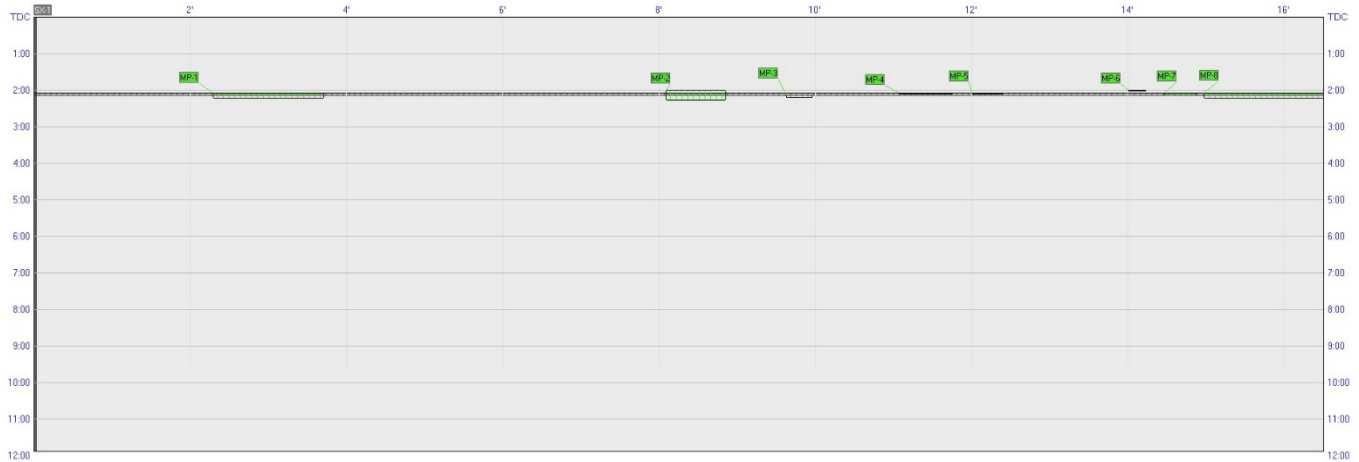
Comments WFMT was performed in accordance with Mears Procedure MPE-01 Rev.6, full circumference for the entire length of inspection. (8) MP indications were found within the inspection area.

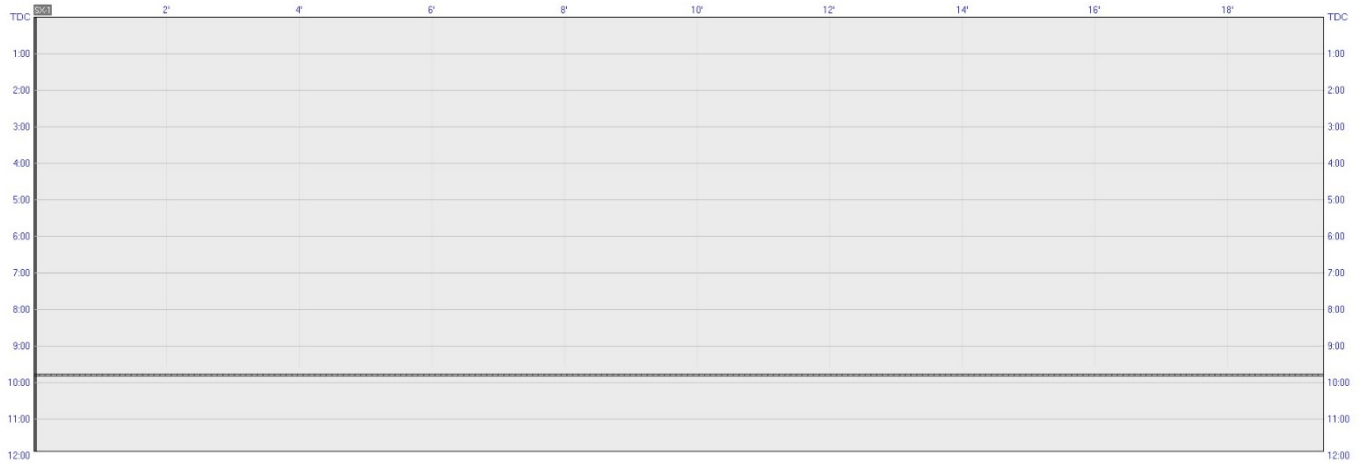
P/S Potential Measurements

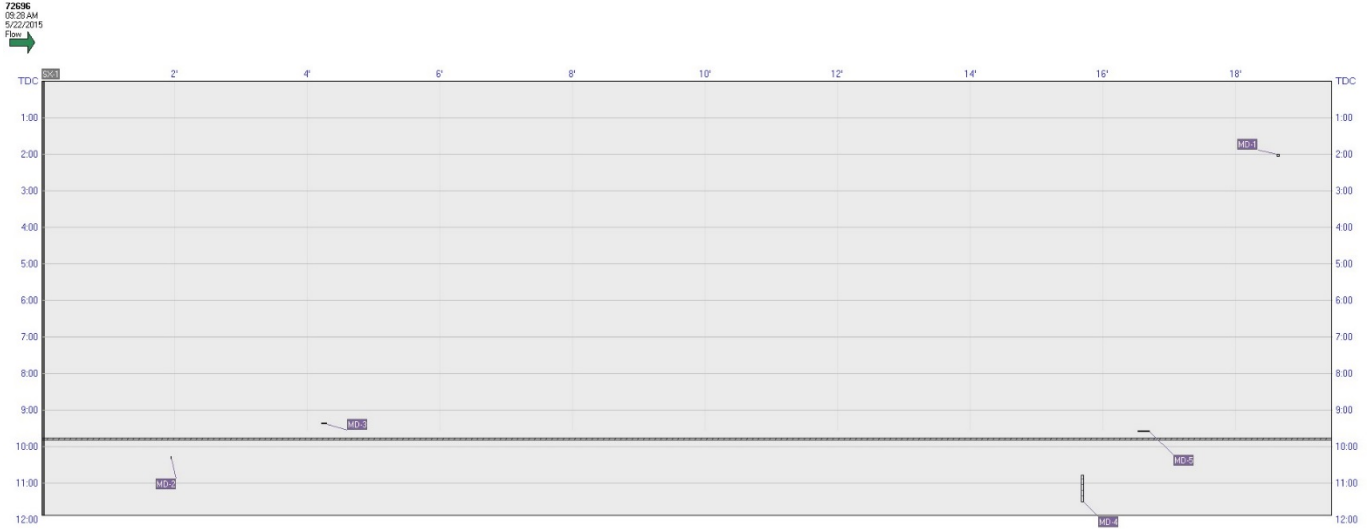
External Corrosion Mapping

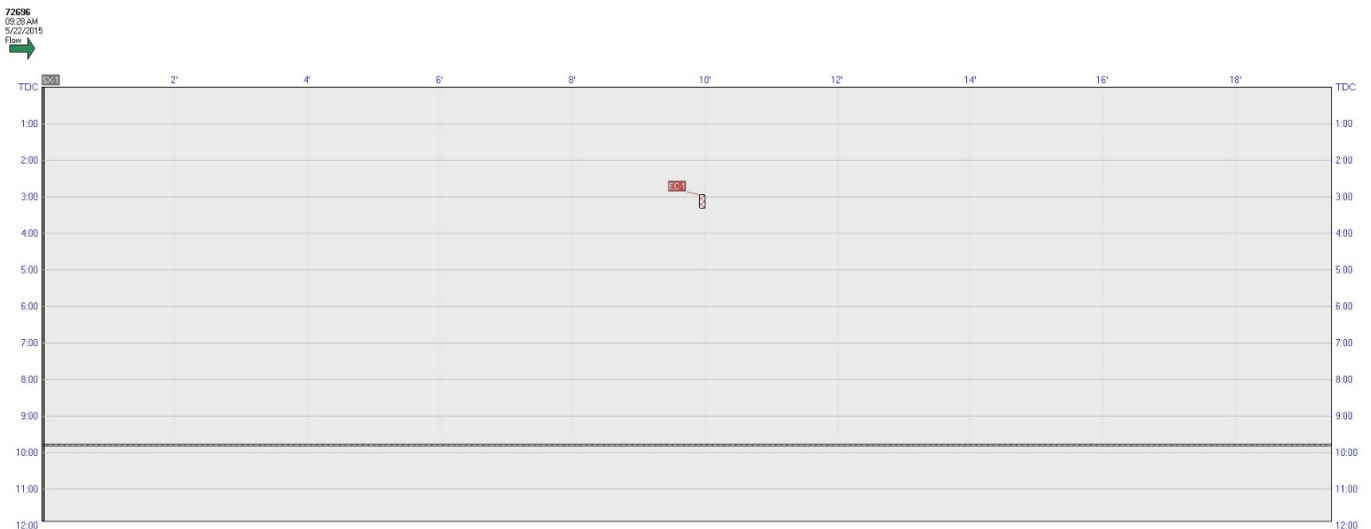
Map of Corroded Area

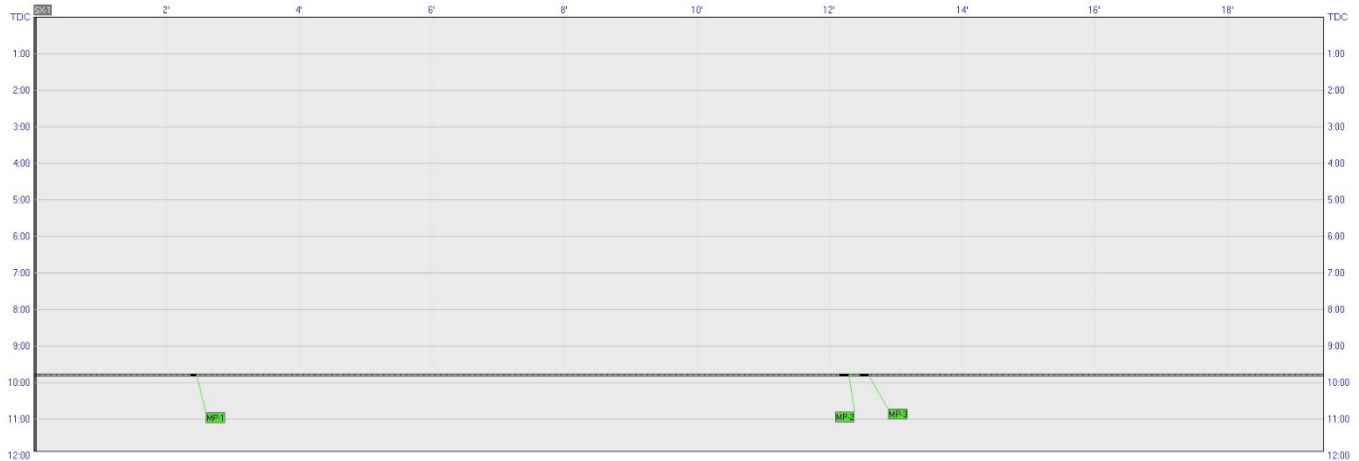
Comments WFMT was performed in accordance with Mears Procedure MPE-01 Rev.6, full circumference for the entire length of inspection. (3) MP indications were found within the inspection area.

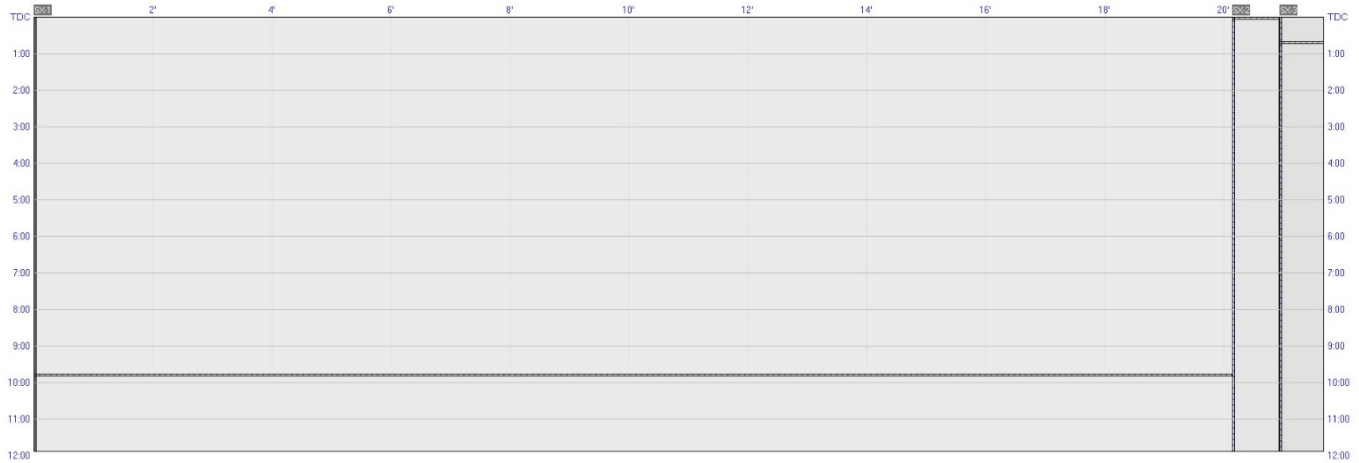
P/S Potential Measurements

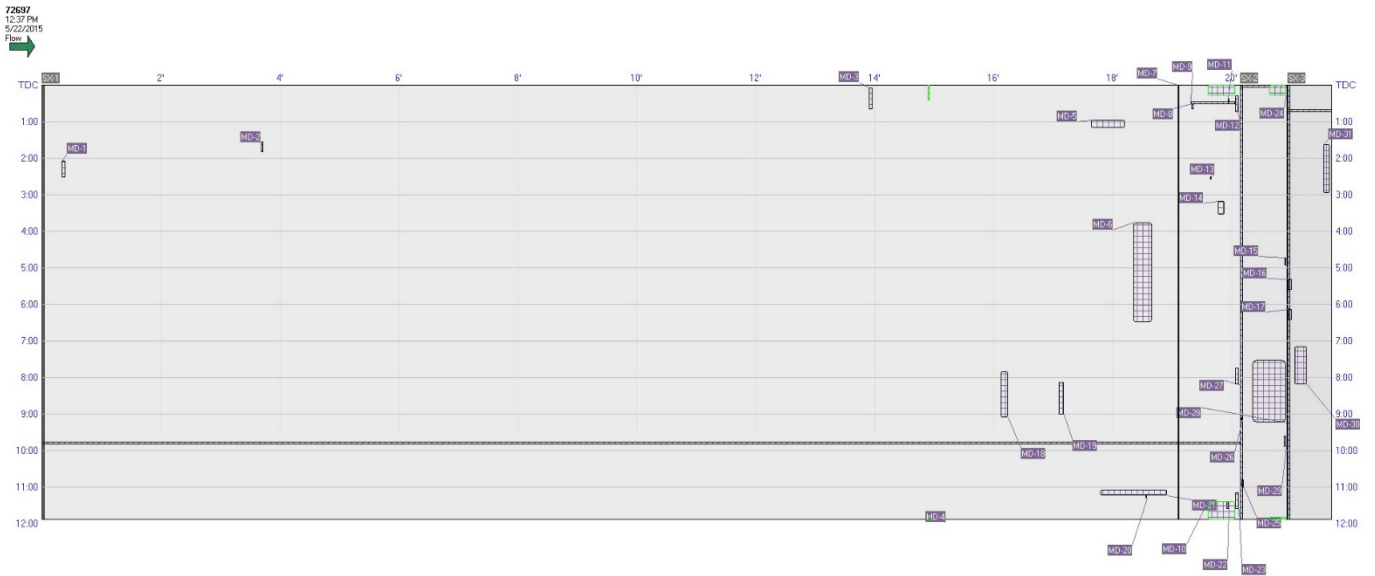
Map of Mechanical Damage

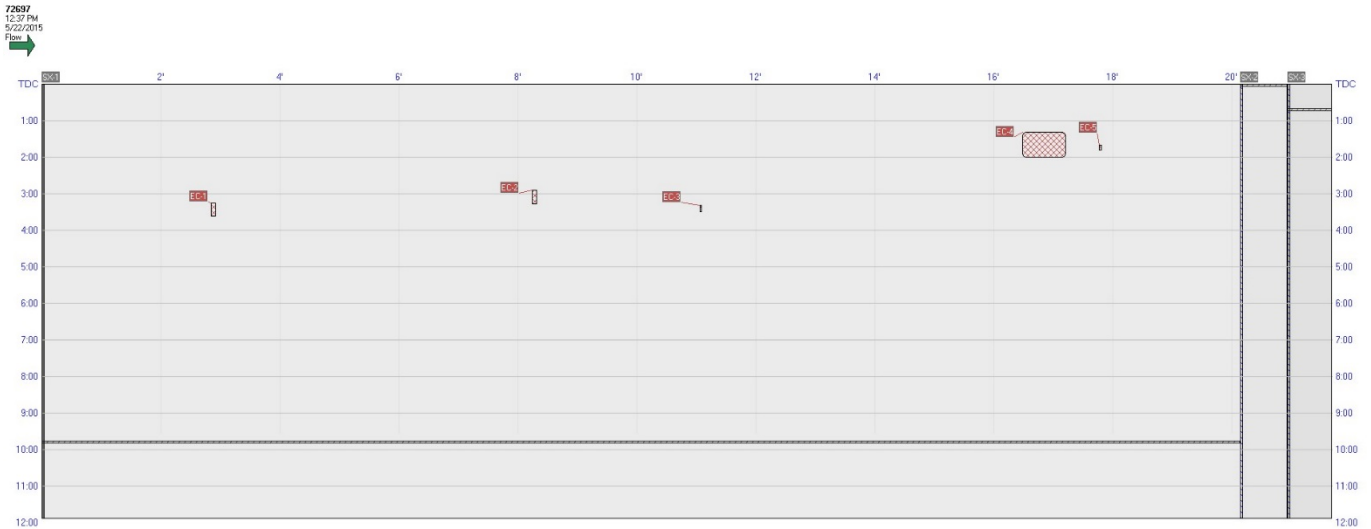
Map of Corroded Area

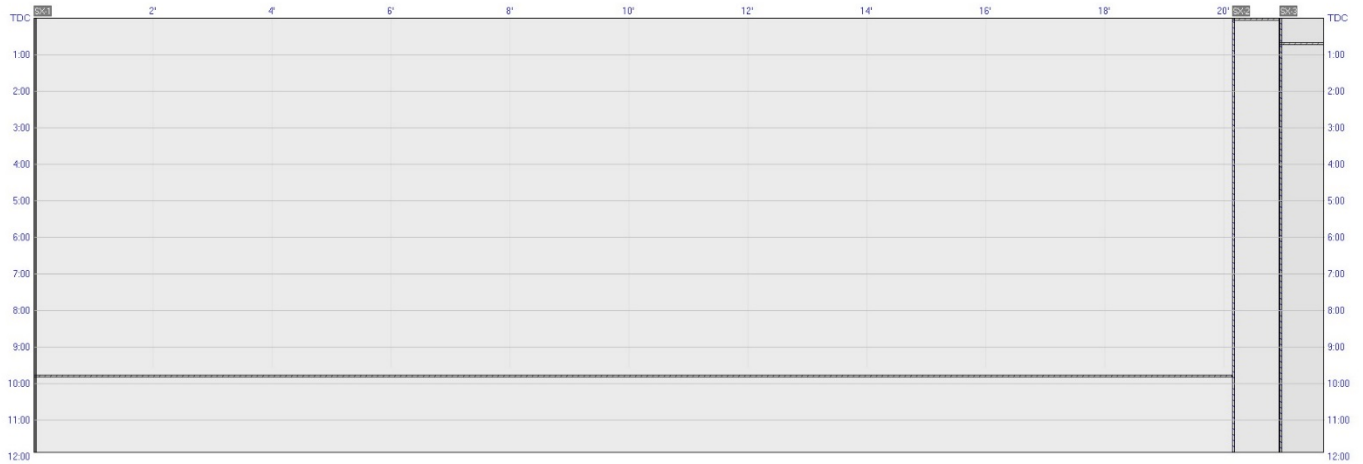
UT - Internal Corrosion Grid (UTG)

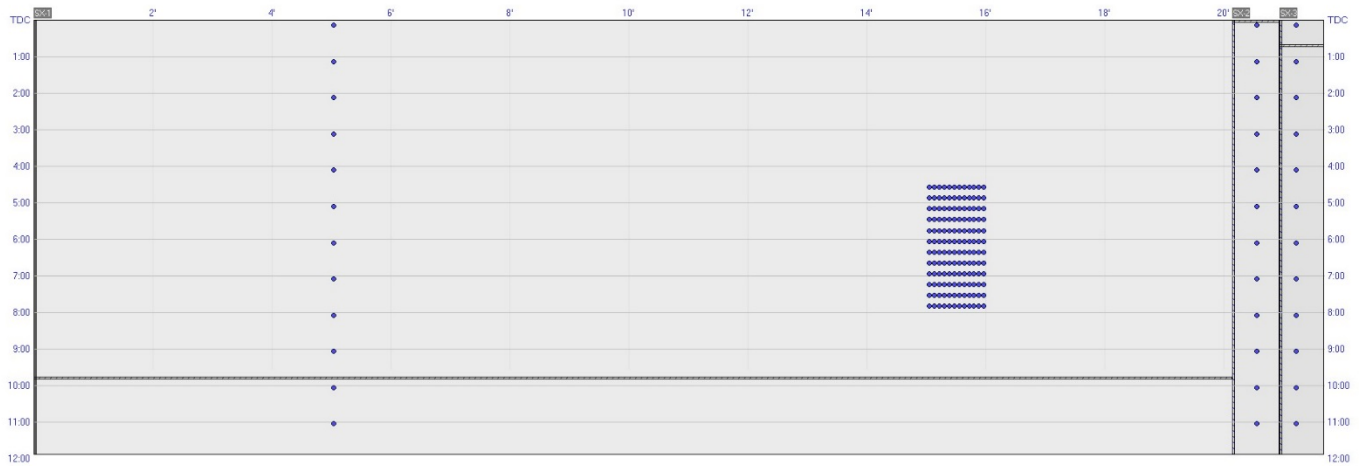
72697
 12:37 PM
 5/22/2015
 Flow →

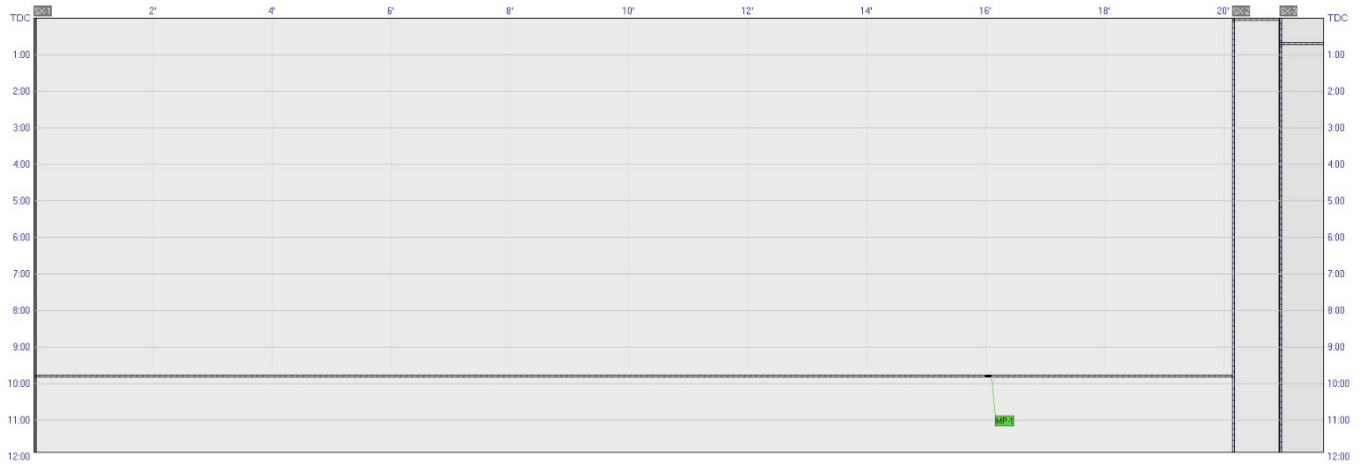
Comments WFMT was performed in accordance with Mears Procedure MPE-01 Rev.6, full circumference for the entire length of inspection. (1) MP indication was found within the inspection area.
