SS-25 Root Cause Analysis

Webinar

CPUC Proceeding: I.19-06-016

November 1, 2019

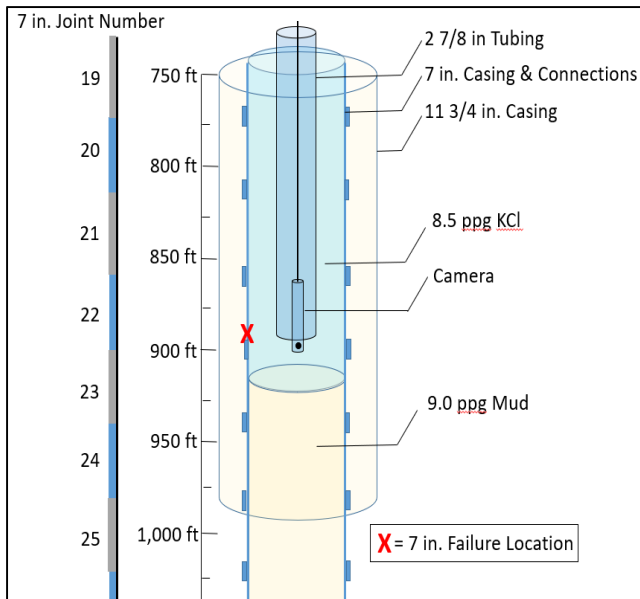
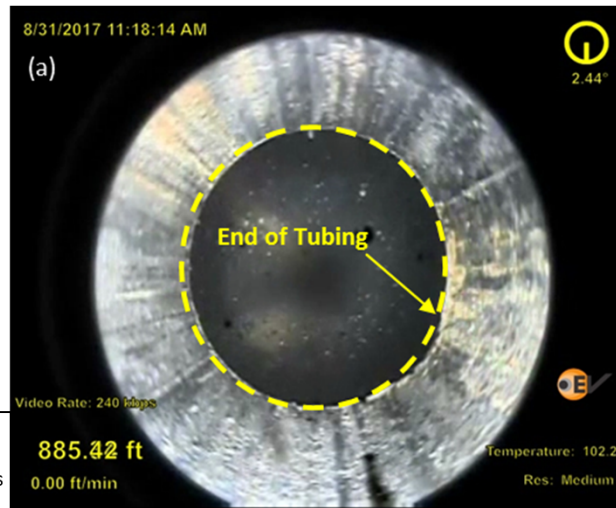
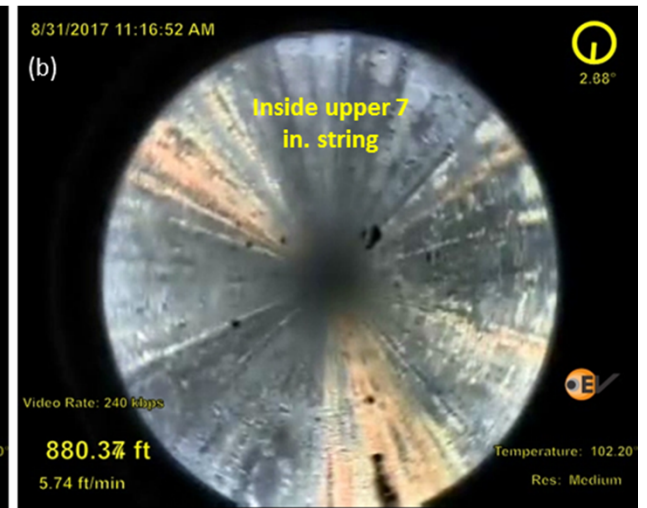
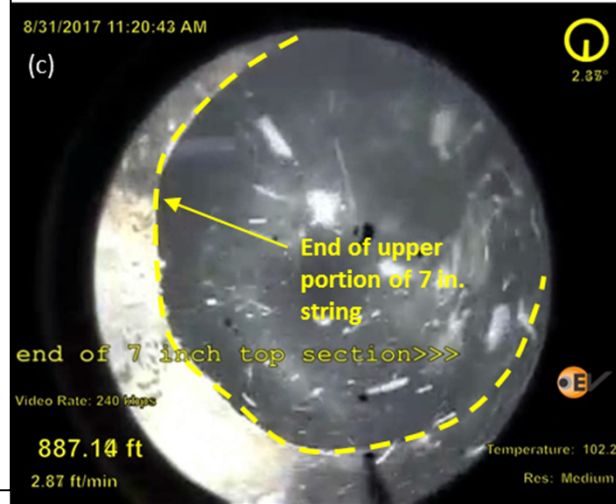
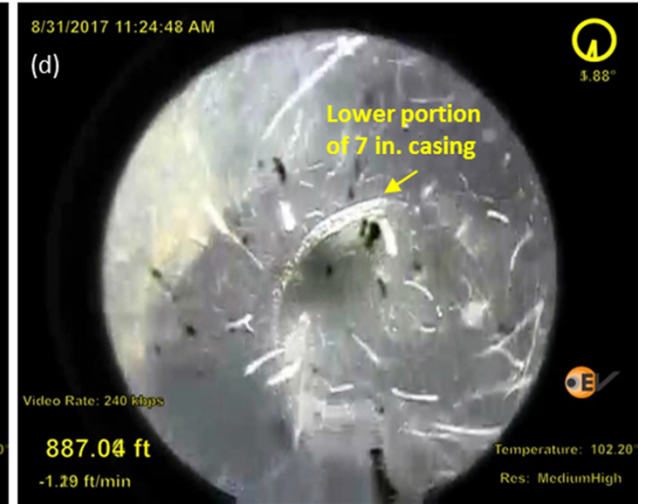
Tubing Extraction and Video Camera Results

- Logs indicated 7 in. casing metal loss at approximately 895 ft
- Downhole Camera run below end of tubing to determine location of parted 7 in. casing

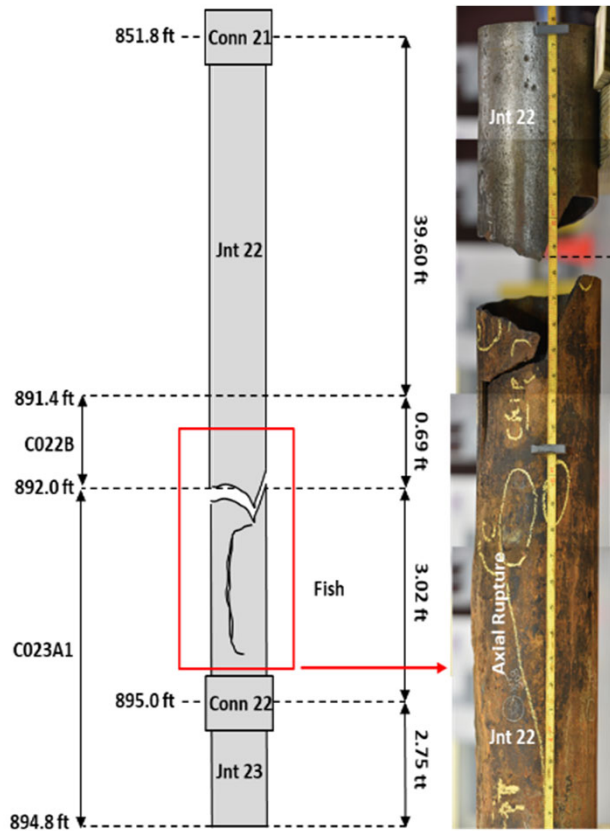
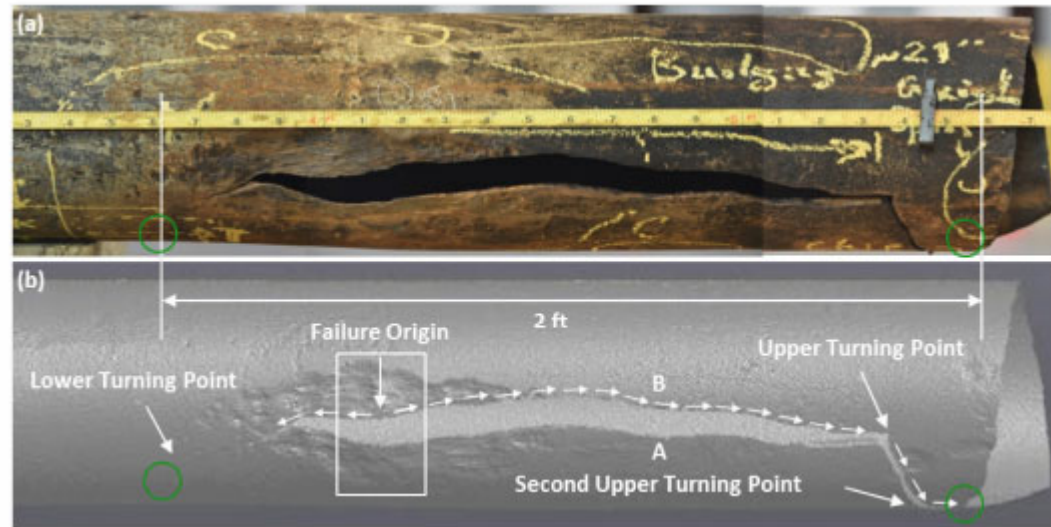
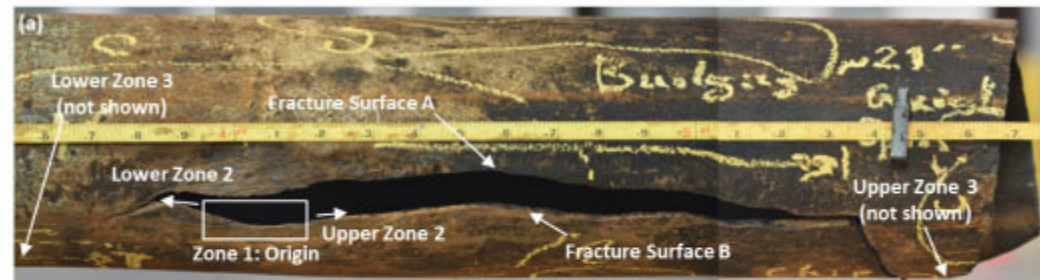
7 in. Casing Rupture

- Axial rupture region
 - Bulged
 - Wall Loss maximum at Origin
 - Chevron Marks towards origin

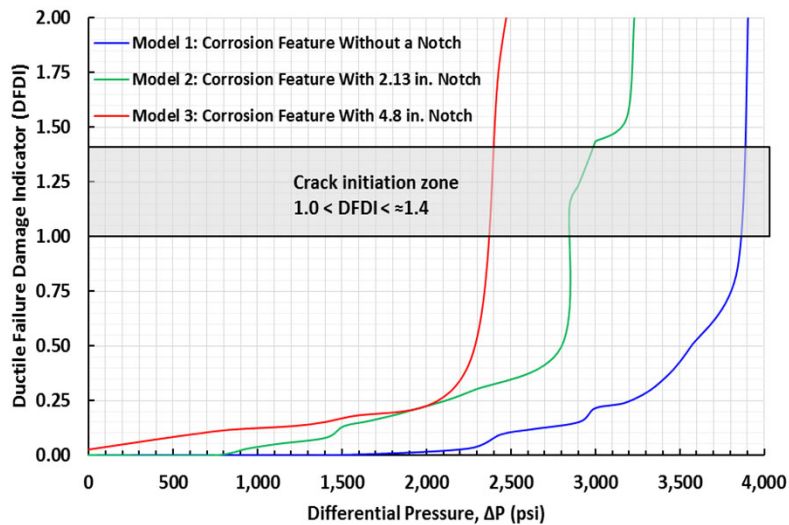
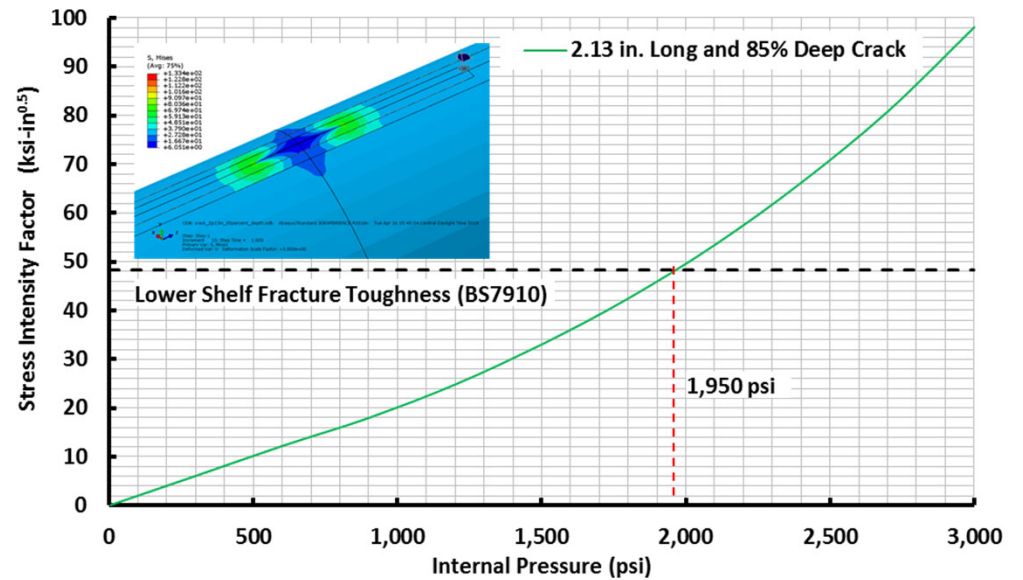
7 in. Axial Rupture Origin Verified

Crack initiated within the groove.
 Cracked region unstably grew and the axial rupture resulted

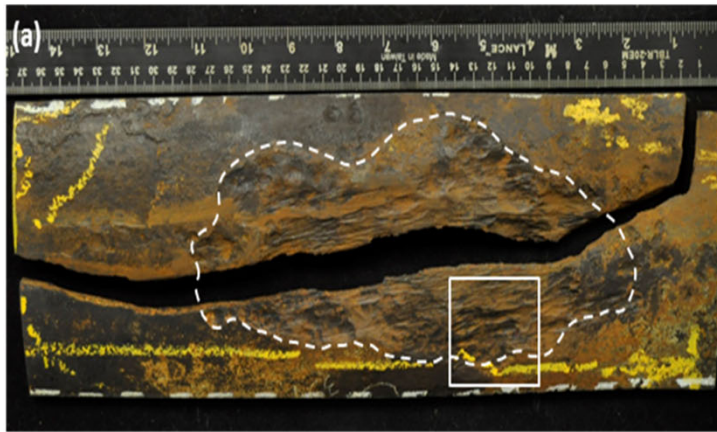
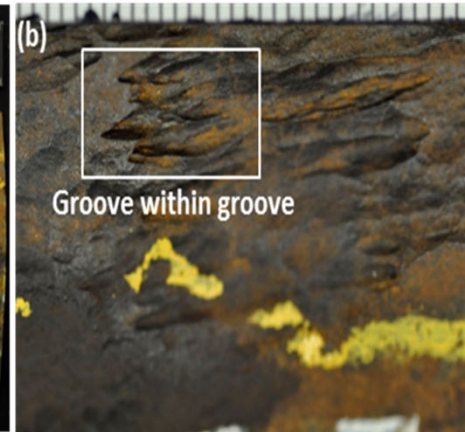
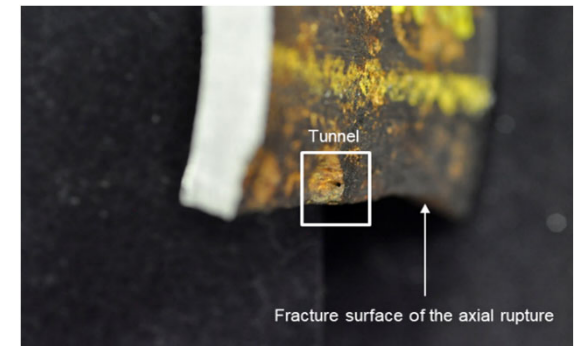
7 in. Casing Corrosion at Failure Location

- Metal Loss with striated grooves
- Grooves off axial around 10 to 15 degrees and not associated with any microstructural feature
- Numerous tunnels parallel to the axial rupture fracture surface
- Organic matter within tunnels
- Anerobic environment
- Amplicon Metagenomics- Predominantly Methanogens a form of Archaea that have been known to cause corrosion

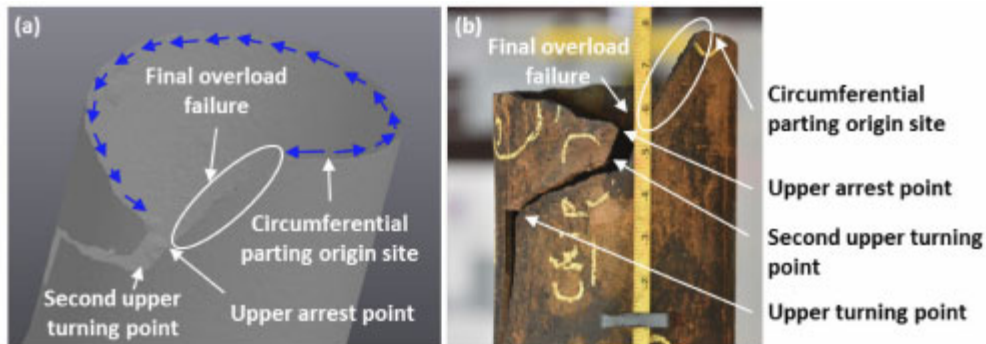
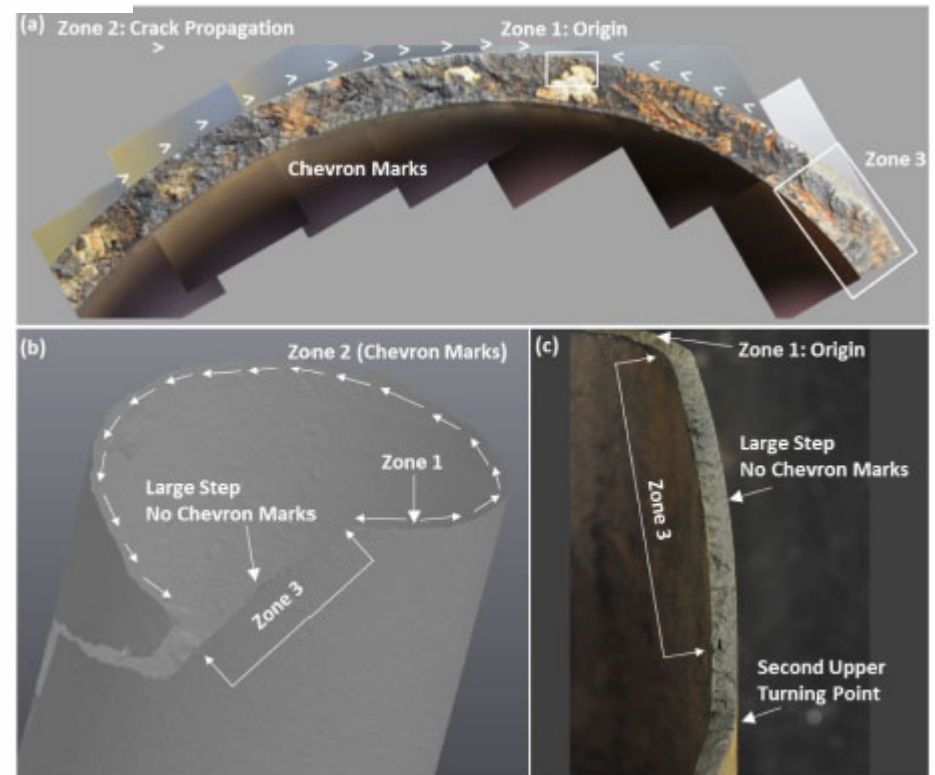
7 in. Casing Parting

- Circumferential Parting a separate event
- Indications of a brittle fracture confirmed with fractographic work
- Separate initiation
- Temperature estimated based on fracture toughness measurements to range from -76°F to -38°F

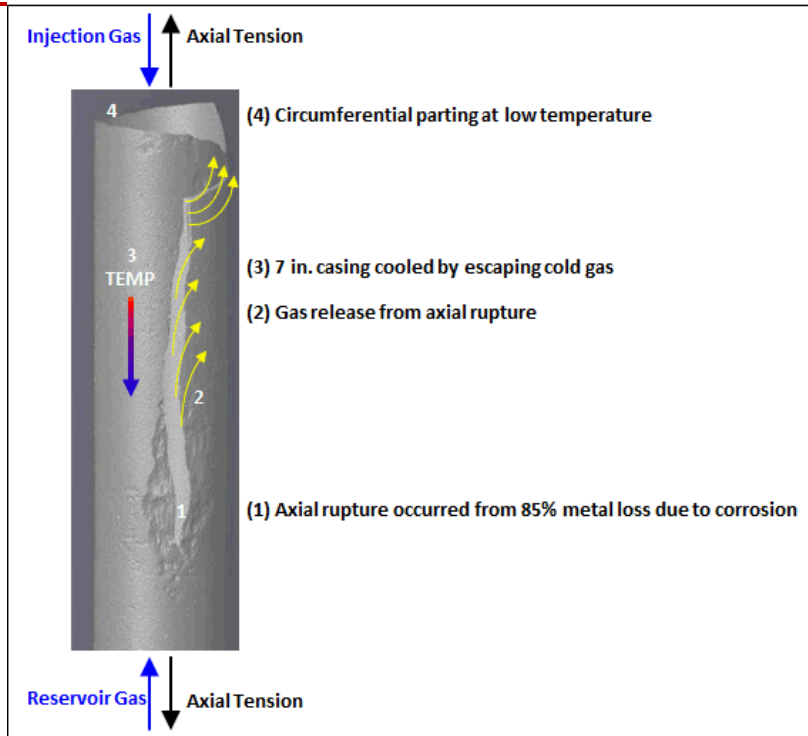
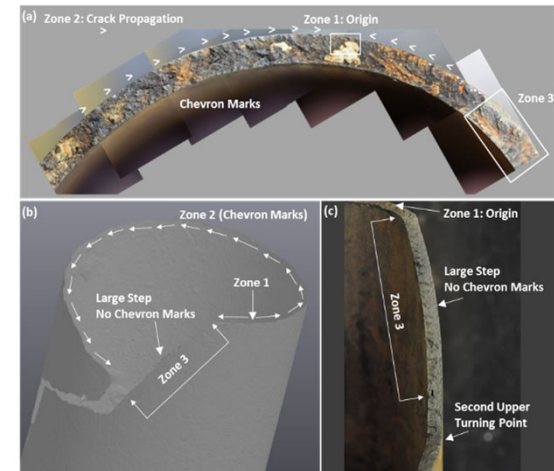
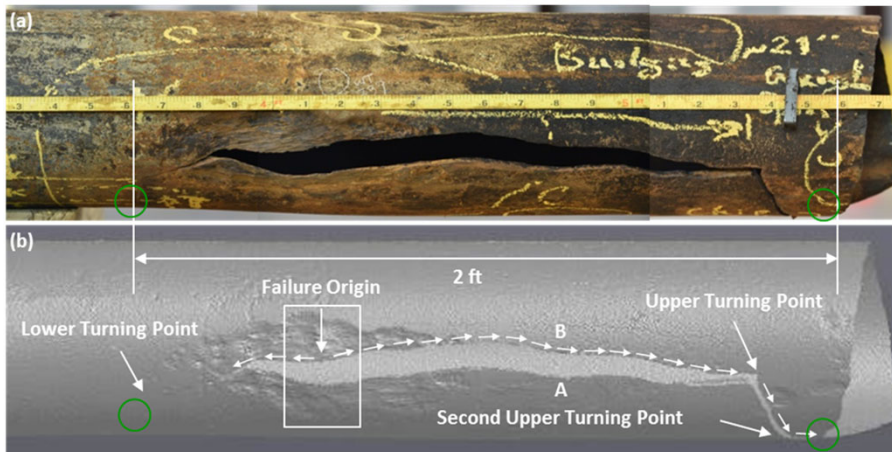
7 in. Casing Failure Sequence

- External corrosion with 85% wall reduction
- Corrosion caused by microbes resulting in grooves
- Notch acted like a stress concentrator
- Large patch of corrosion
- Axial rupture
- Cooled (-60°C to -39°C) and then circumferential parting

Two separate events-failure sequence
