**CALIFORNIA PUBLIC UTILITIES COMMISSION**  
**Safety and Enforcement Division**  
**Electric Safety and Reliability Branch**

**Incident Investigation Report**

**Incident Number:** E20191030-01

**Location of the Incident:** 3505 Gateway Road  
Bethel Island, CA  
County: Contra Costa County

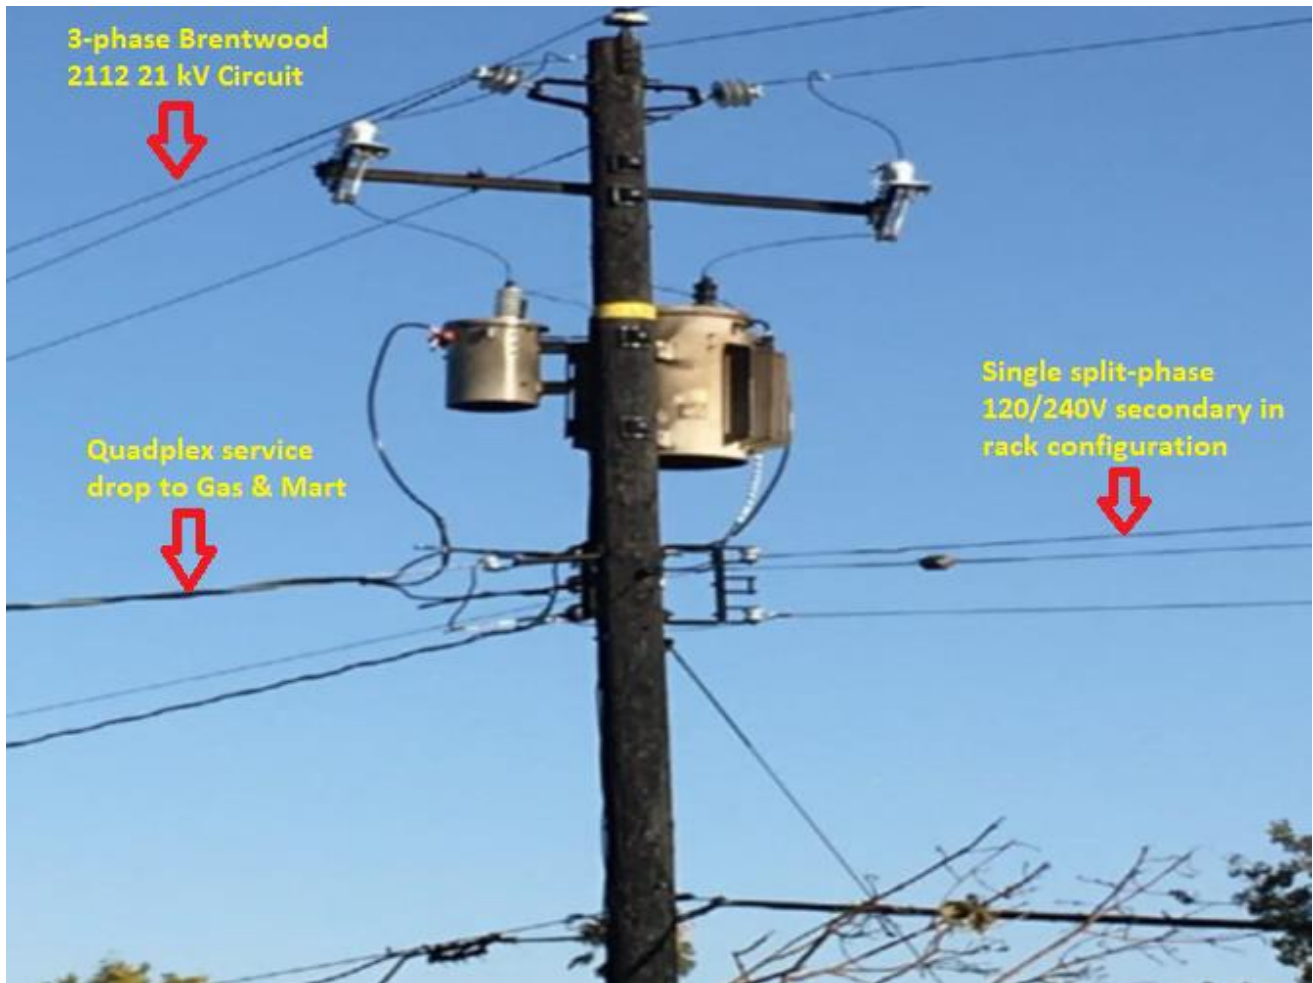
Figure 2: Pole #100457718 suffered char and burn damage from the fire. However, the two transformers were serviceable and put back into service after the fire.

After the fire, PG&E inspected Pole #100457718 and its two transformers. PG&E determined the equipment remained serviceable. The equipment was later put back into service. PG&E, however, had to replace the quadplex service drop that served the Gas & Mart.<sup>2</sup> PG&E also observed damage on the secondary conductors. The conductors had breaks approximately five feet from Pole #100457718 and exhibited signs of beading near the midspan. PG&E collected and retained the secondary span of conductors as evidence.

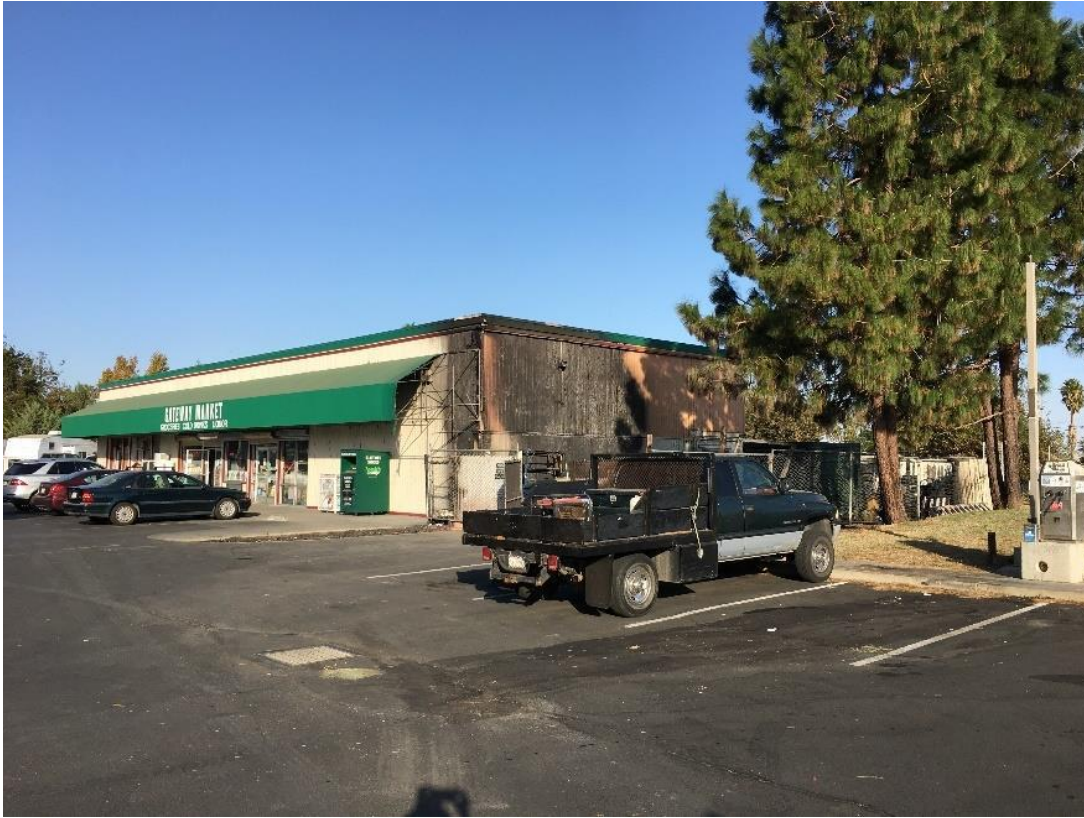
In addition to PG&E's facilities being damaged, the Gateway Gas & Mart also suffered fire damage (see Figures 3 & 4). And Fire Department reported minor damage on model homes under construction located atop the levee on the south side of Gateway Road.

*Figure 3: East side of the Gateway Gas & Mart suffered fire damage.*

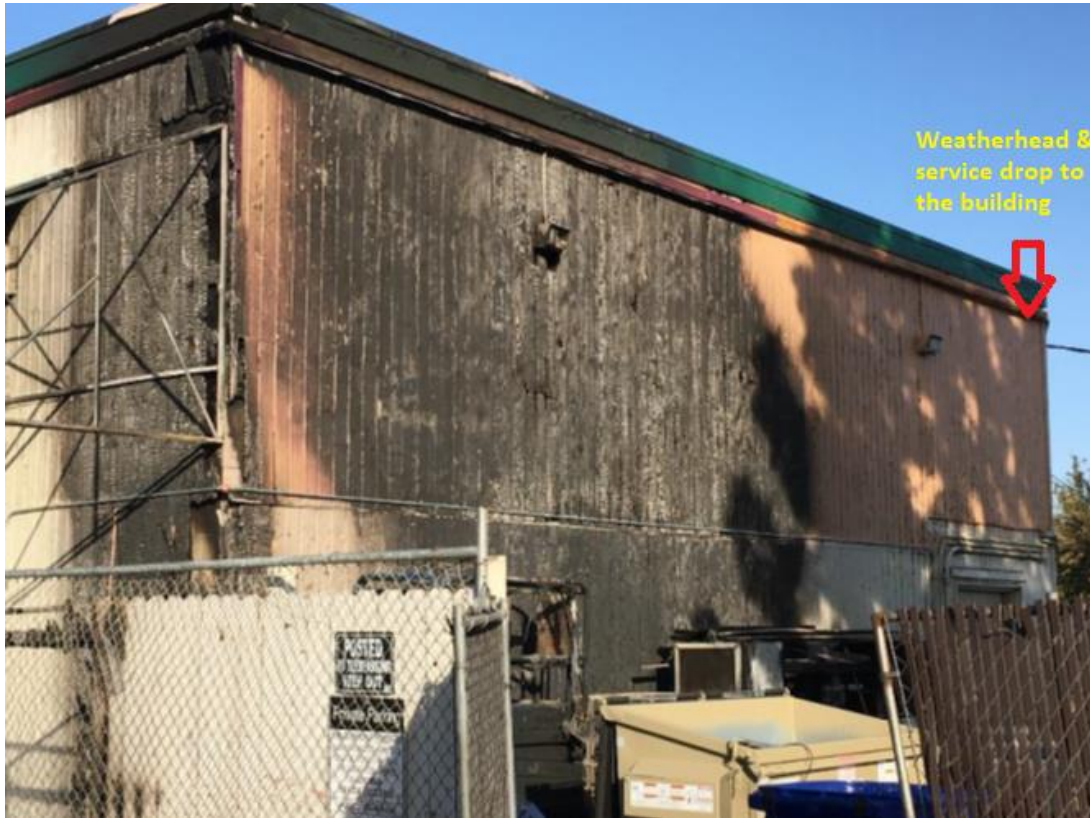
Figure 4: Closeup of damage at the Gateway Gas & Mart.

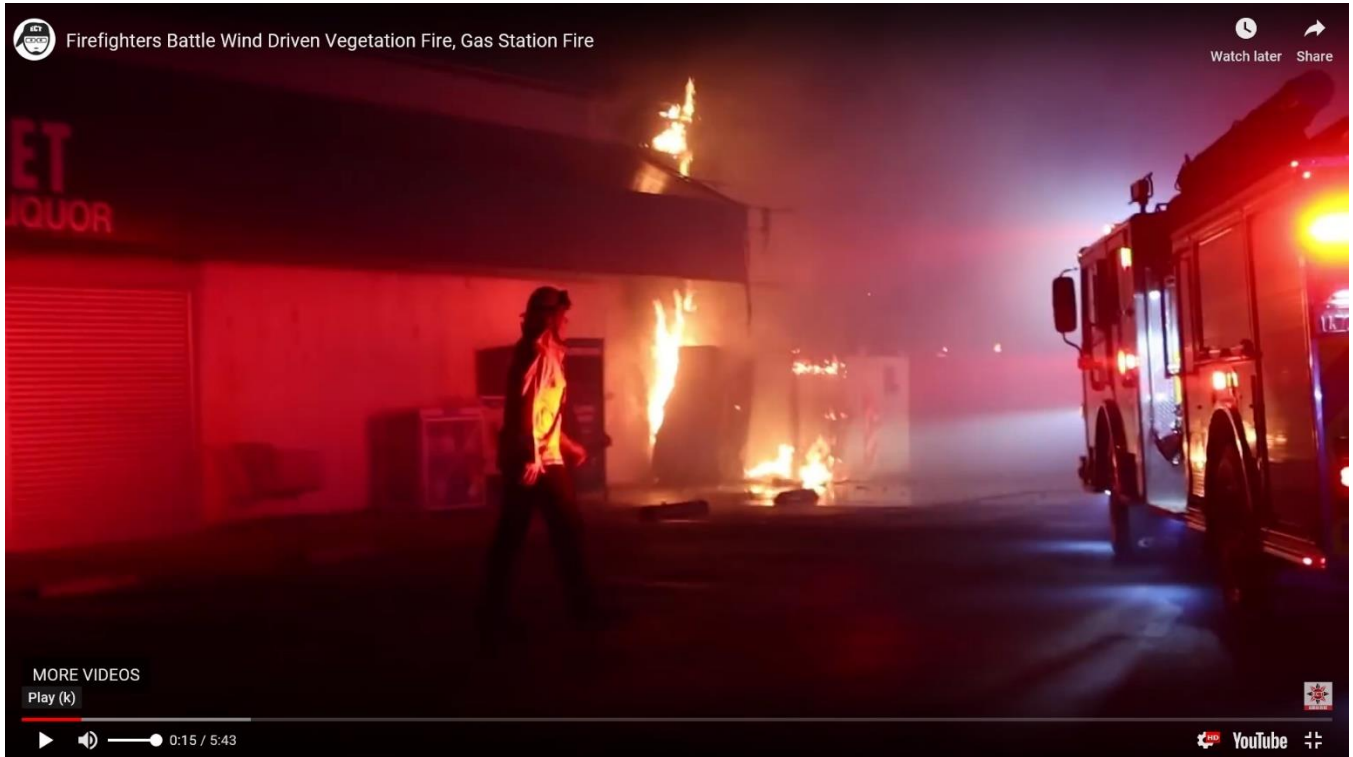
Figure 5: Video image of the structural fire at the Gateway Gas & Mart at the time of the fire. Source: East County Today

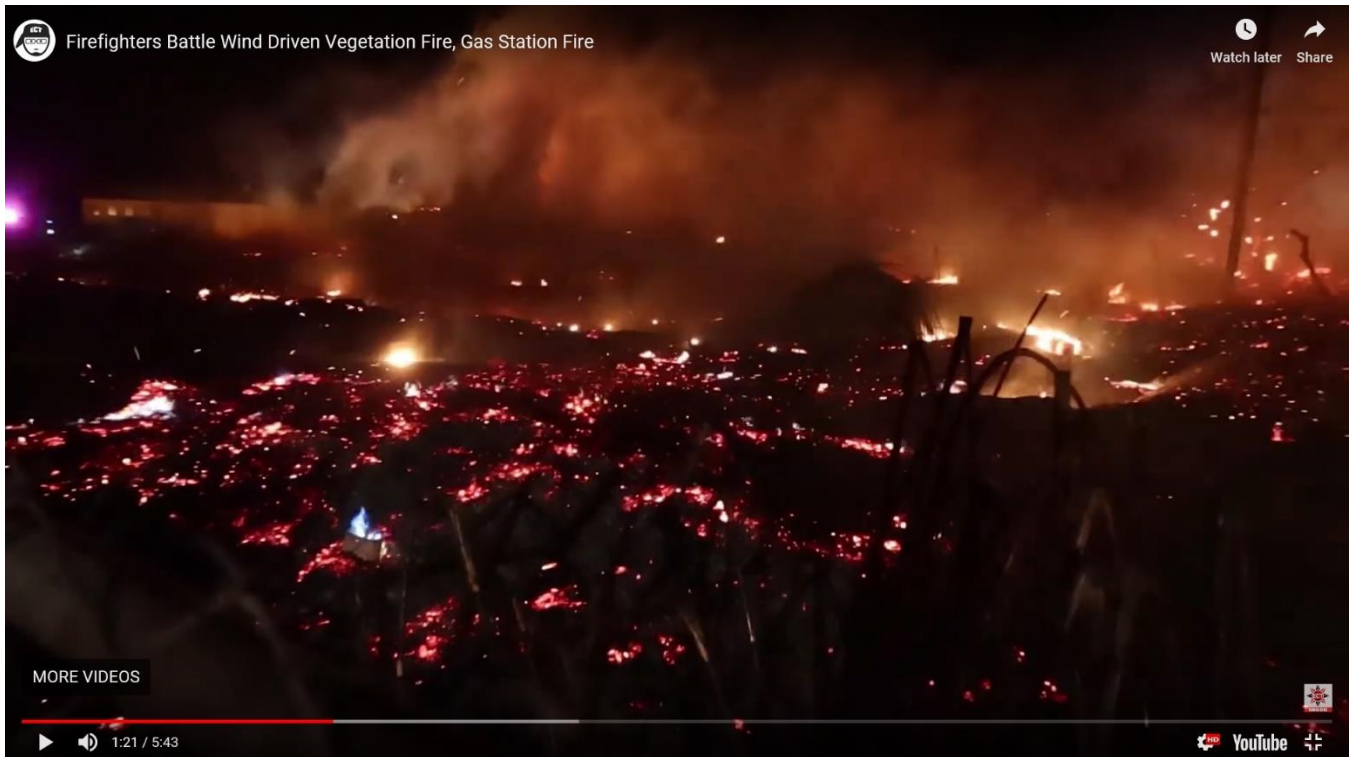
Figure 6: Video image of vegetation fire next to the Gateway Gas & Mart at the time of the fire. Source: East County Today

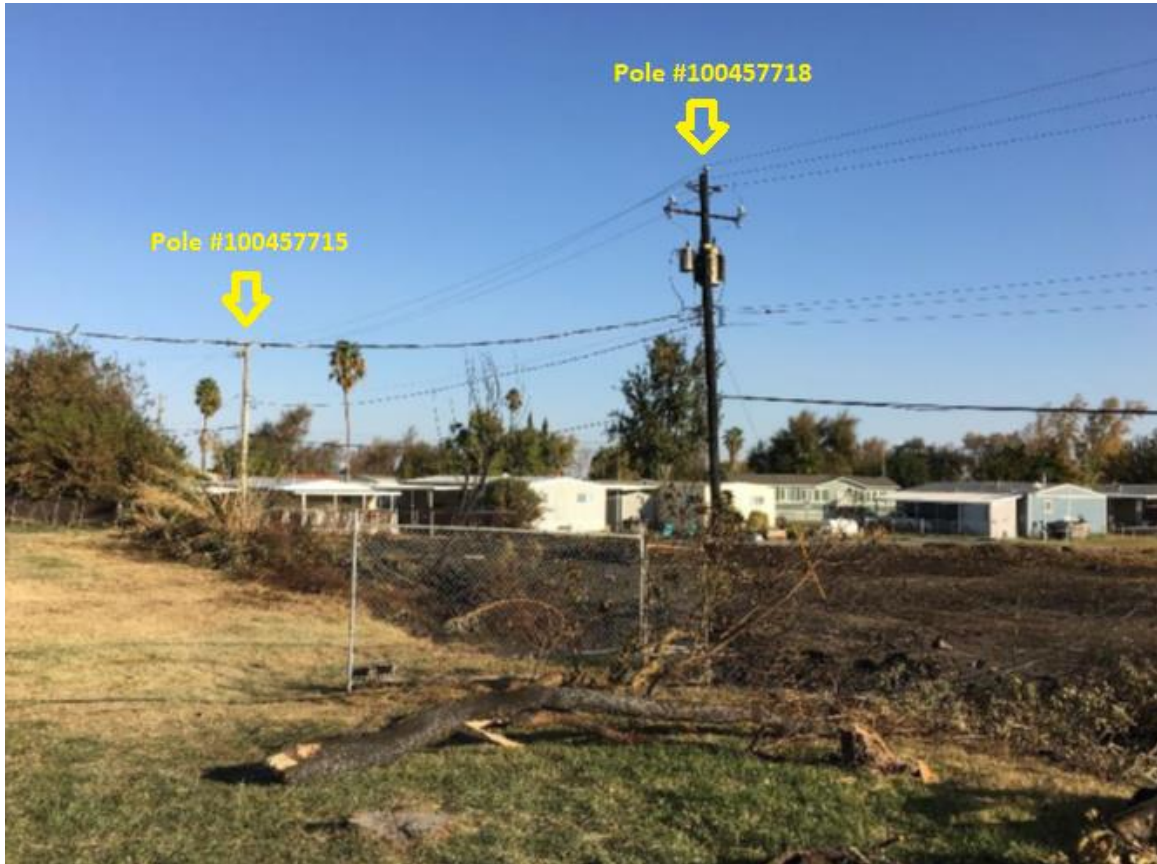
ESRB obtained links to two video footages related to the fire.<sup>3</sup> The first video showed fire fighters battling the blaze, which at the time, had already spread to the Gas & Mart and jumped across Gateway Road to a levee near new homes under construction. The second video showed sparking of overhead conductors followed by sparking near a power pole.<sup>4</sup> ESRB determined that pole to be Pole #100457715 (see Figures 1 & 7).

Figure 7: Charred field next to the Gateway Gas & Mart. Pole #100457715 is the subject pole where arc sparks were observed in the video clip shot by a witness at the time.

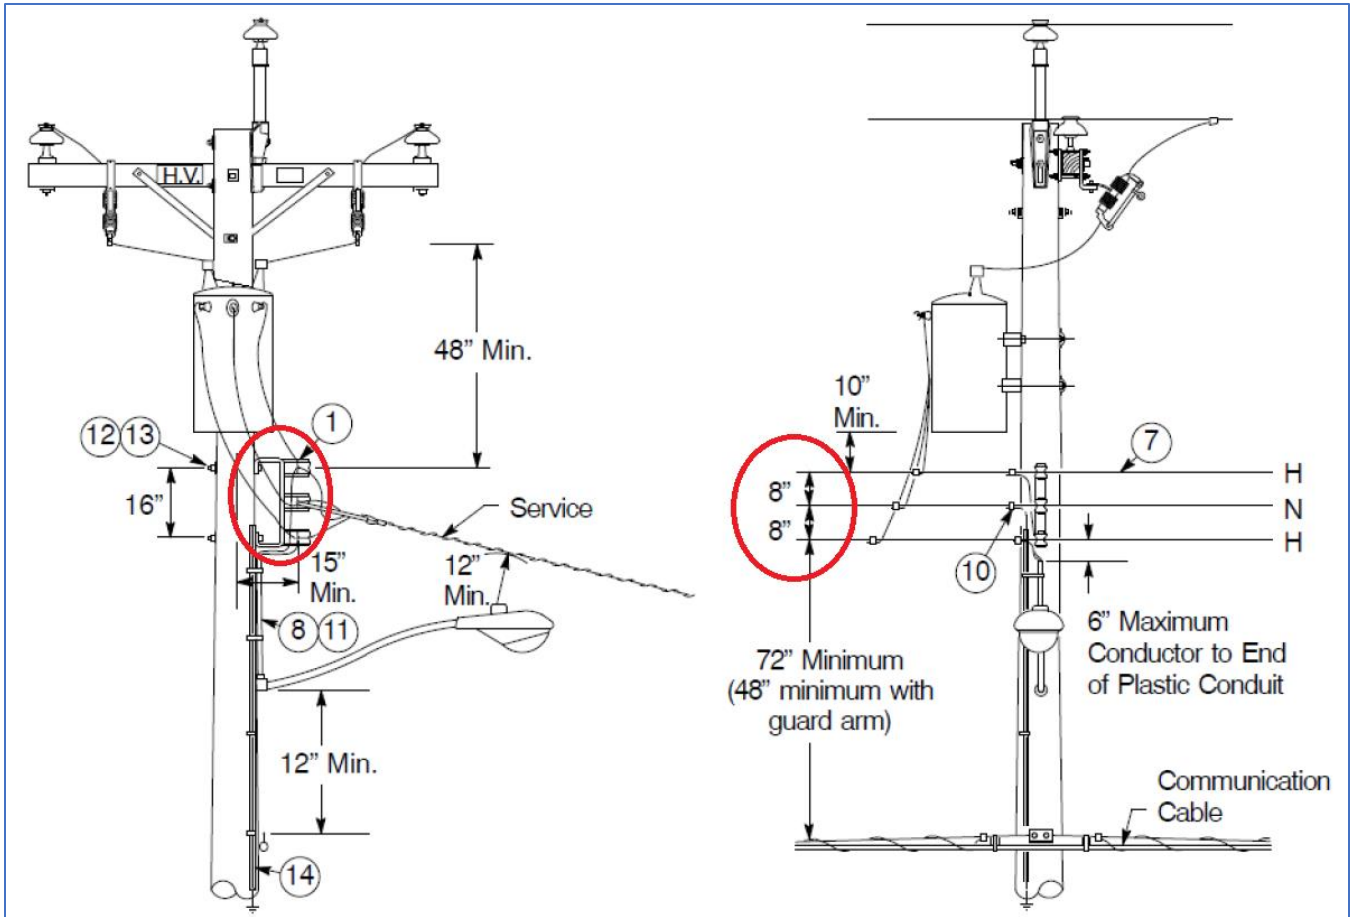
Figure 8: PG&E's standard of construction for conductors in rack configuration.

with gust up to 75 MPH.<sup>5</sup> Winds were out of the northwest and relative humidity was low at around 25%.<sup>6</sup> The secondary conductors were in a rack configuration. PG&E's standard of construction for rack configuration indicates just eight inches of vertical conductor separation (see Figure 8).<sup>7</sup> Indeed, PG&E conceded that the configuration resulted in the conductors having a smaller separation distance than that of a typical crossarm construction.<sup>8</sup> After the fire, PG&E observed breaks and signs of beading in the conductors that are consistent with line slapping.<sup>9</sup> Video footage taken by a security guard patrolling at the time showed sparking at locations consistent with where damage incurred on the conductors.<sup>10</sup> ILIS report showed Fuse Cutout #21611 (on Pole #100457722) operated due to a line-to-line fault around the time consistent with when sparking on the conductors were observed.<sup>11</sup> A witness who lives in the Santiago Mobile Home Park reported hearing crackling sound followed by a loud pop around the time of the incident, which is typical when fuses open.<sup>12</sup> Fire Department's investigation did not find other identifiable sources of ignition and determined the fire originated under PG&E's powerlines.<sup>13</sup> Based on these evidence, ESRB concludes that PG&E's secondary conductors slapped and contacted each other under high winds. Because the lines slapped, ESRB found PG&E in violation of General Order (GO) 95 Rule 31.1 for failing to design and construct its electrical system to enable the furnishing of safe, proper, and adequate service.
