**CALIFORNIA PUBLIC UTILITIES COMMISSION**  
**Safety and Enforcement Division**  
**Wildfire Safety and Enforcement Division**

**Incident Investigation Report**

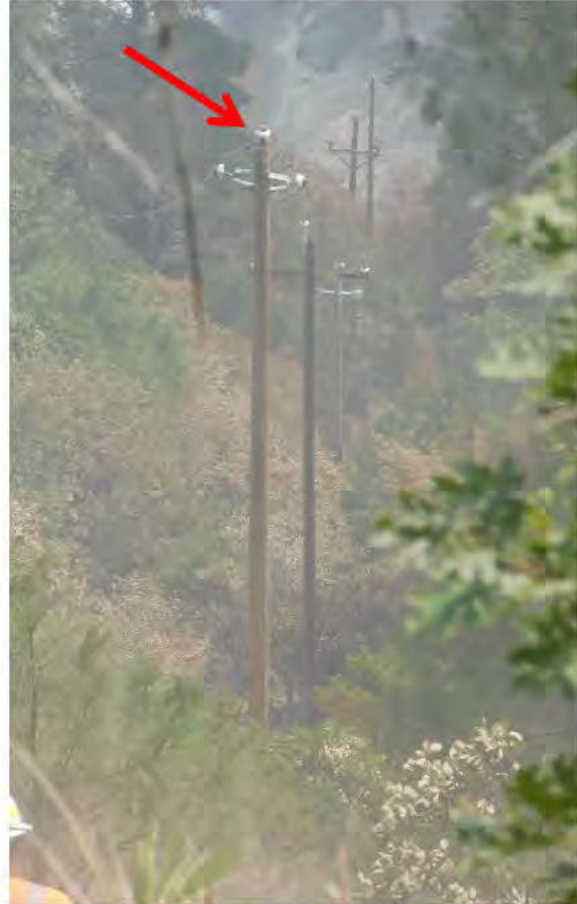
Figure 8: Pole 100403909 (red arrow) down a steep hillside with very loose soil. The incident occurred closer to Pole 100403909.

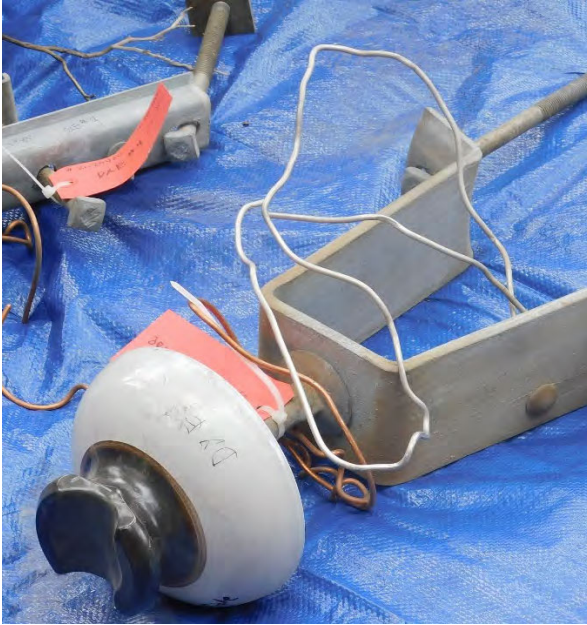
Figure 9: One of the insulators from Pole 100403909

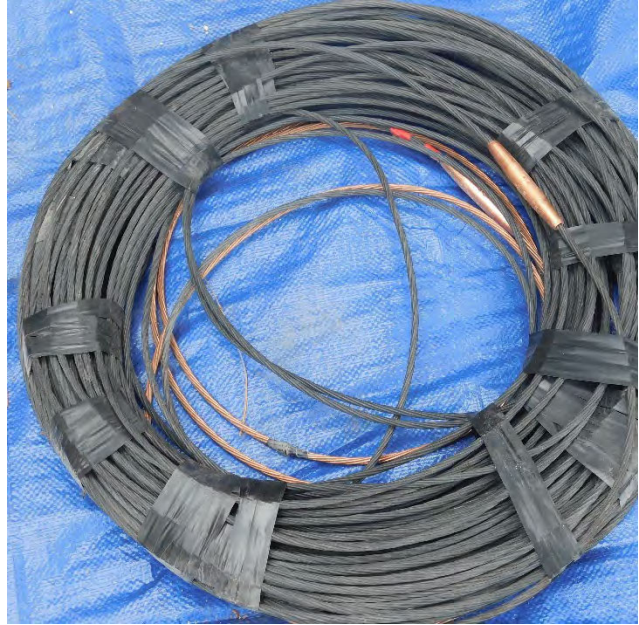
Figure 10: South phase conductor from the incident span

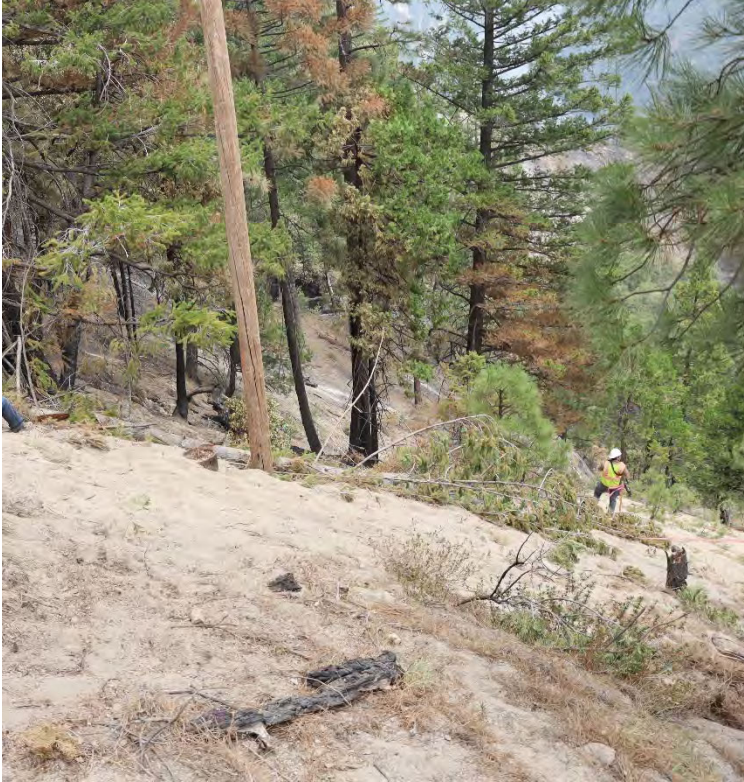
Figure 11: *Base of Pole 100403909 showing fallen Subject Tree*

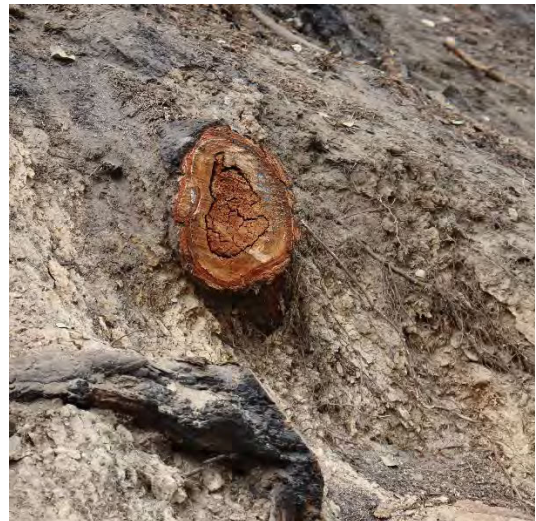
Figure 14: *Root showing significant rot*

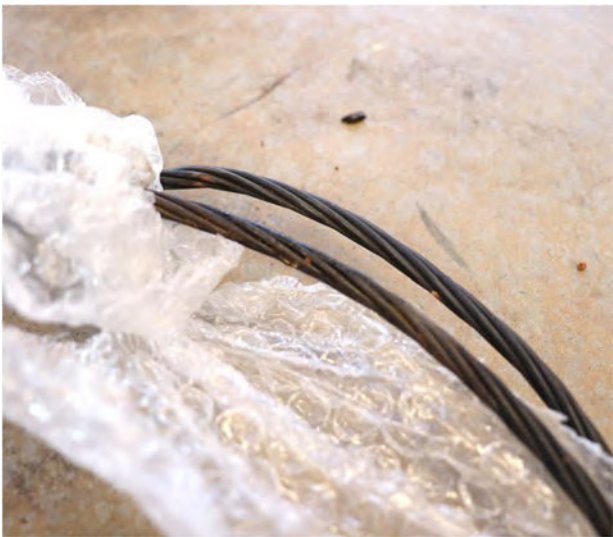
Figure 15: *Energized conductor in contact with tree*

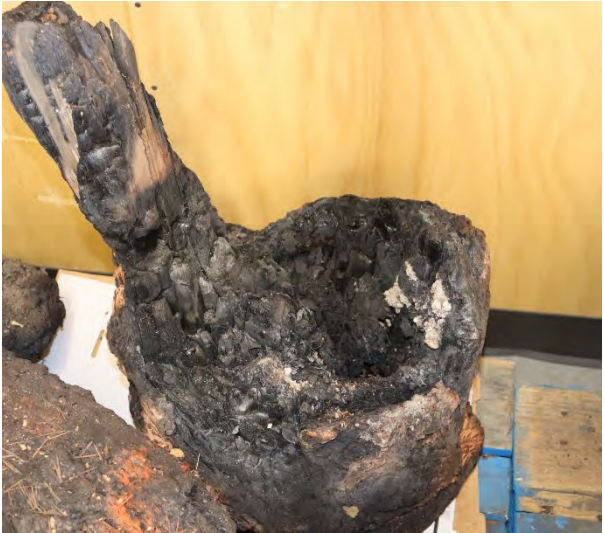
Figure 20: *Section of the Subject Tree trunk that failed causing the tree to fall.*

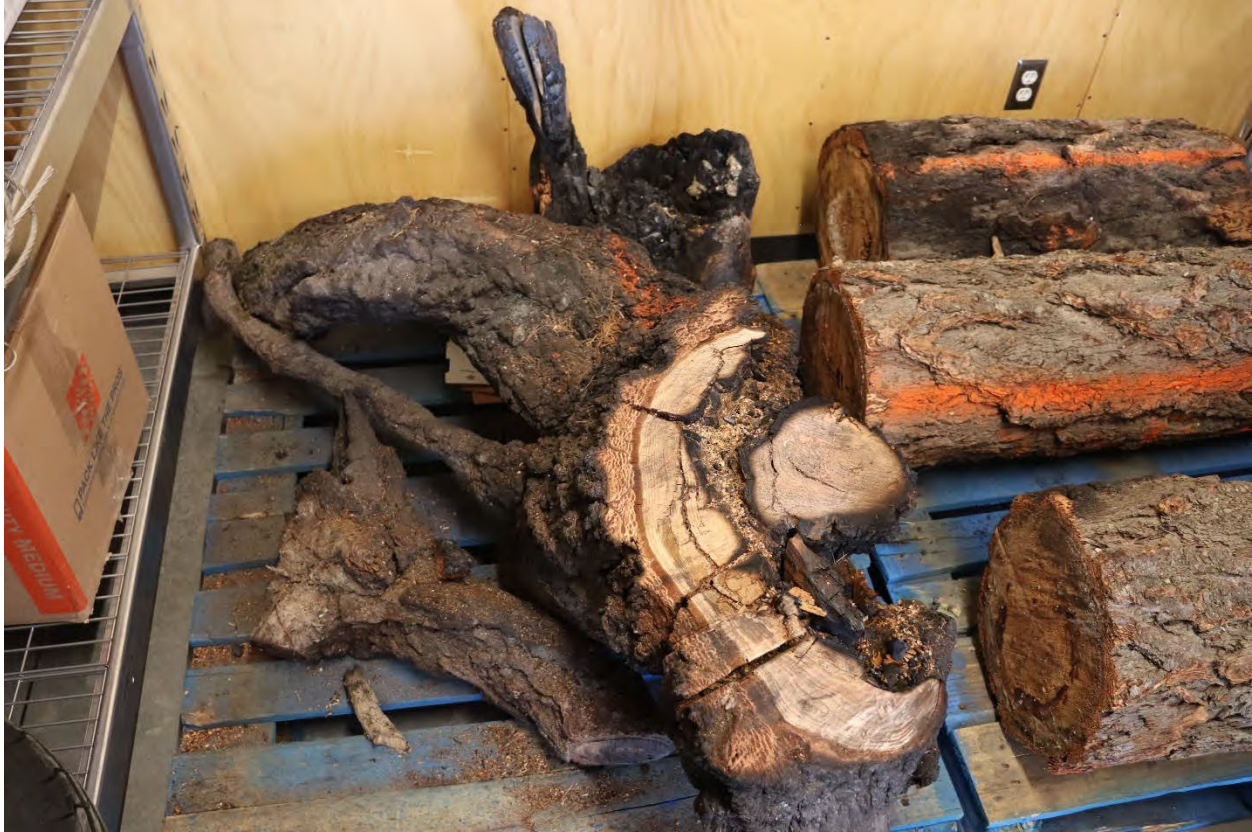
Figure 21: *Subject Tree stump. A large portion of tree trunk was damaged before the fire started.*

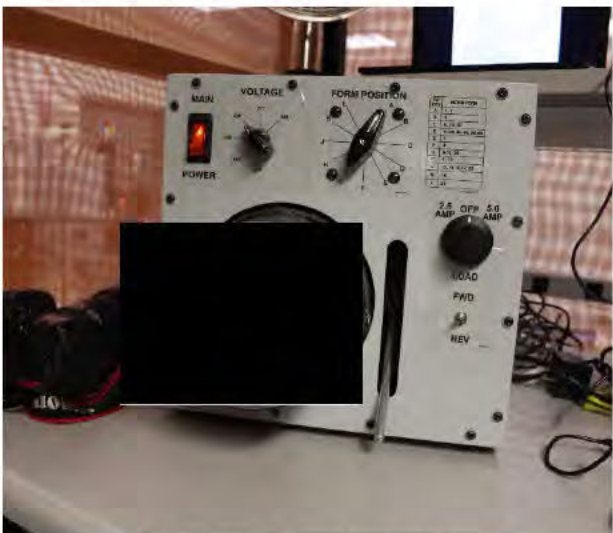
Figure 23: Machine downloading data from a SmartMeter

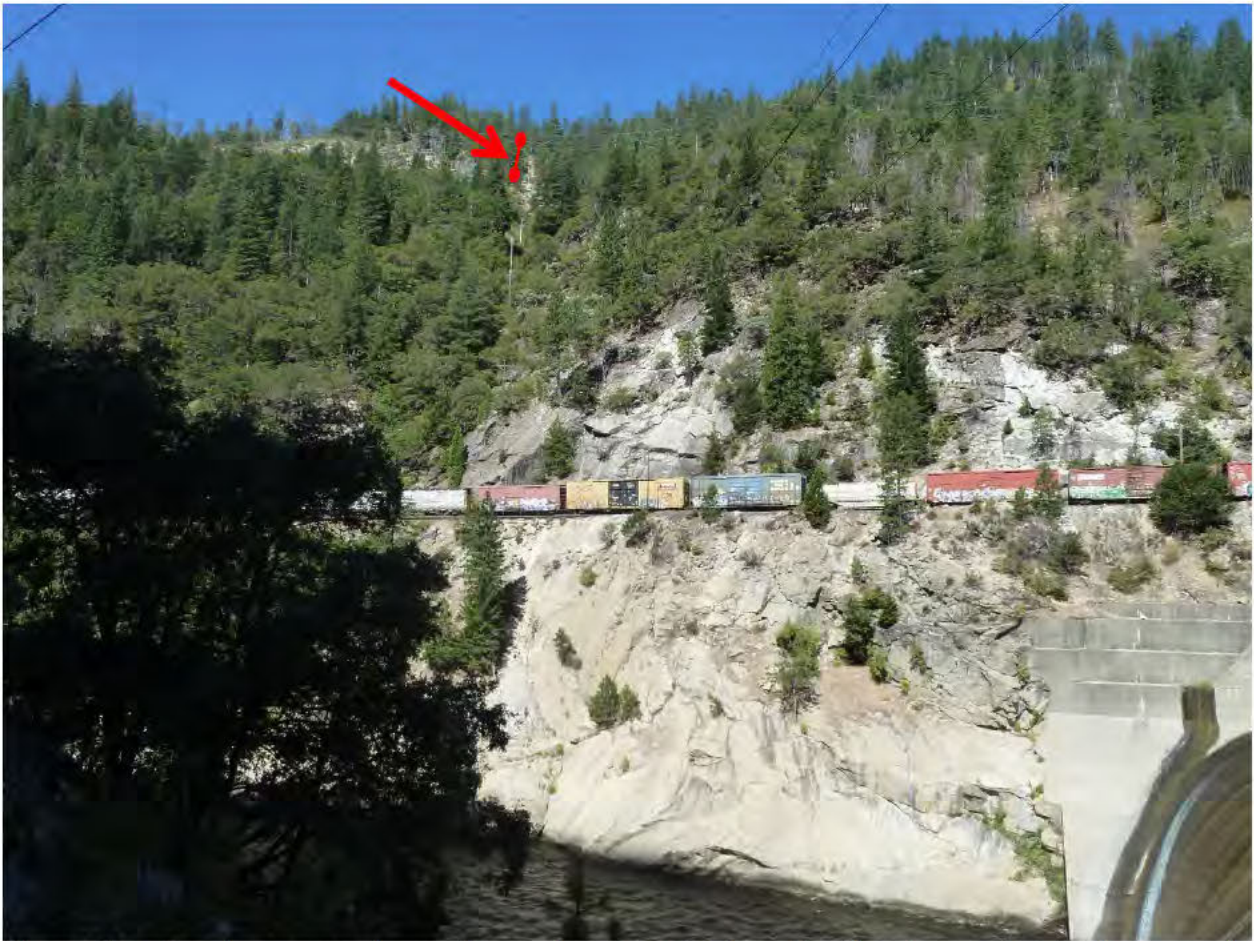
Figure 29: *This photo was taken on November 13, 2014 (per the photo's metadata). The span of interest is highlighted with the red arrow. The red line shows the length of the span. The top oval connected to the red line is adjacent to Pole 100403908 which supports Fuse 17733. The bottom oval connected to the red line is adjacent to Pole 100403909, which is closer to where the tree rested after falling onto the line. The photo was taken as part of a pole replacement project at a pole lower down the hill.*
