**CALIFORNIA PUBLIC UTILITIES COMMISSION**  
**Safety and Enforcement Division**  
**Wildfire Safety and Enforcement Branch**

**Incident Investigation Report**

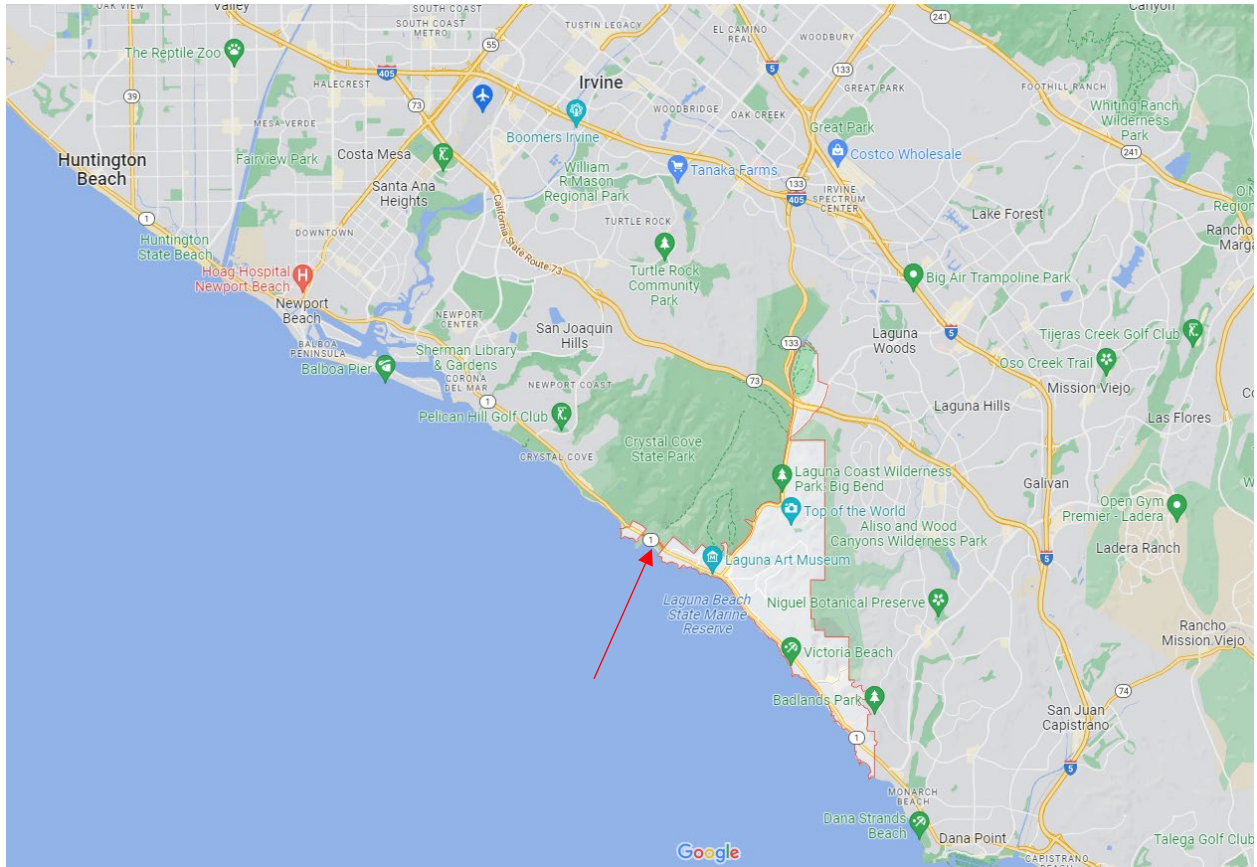
**Figure 1.** Vicinity map pointing to the Incident Location.

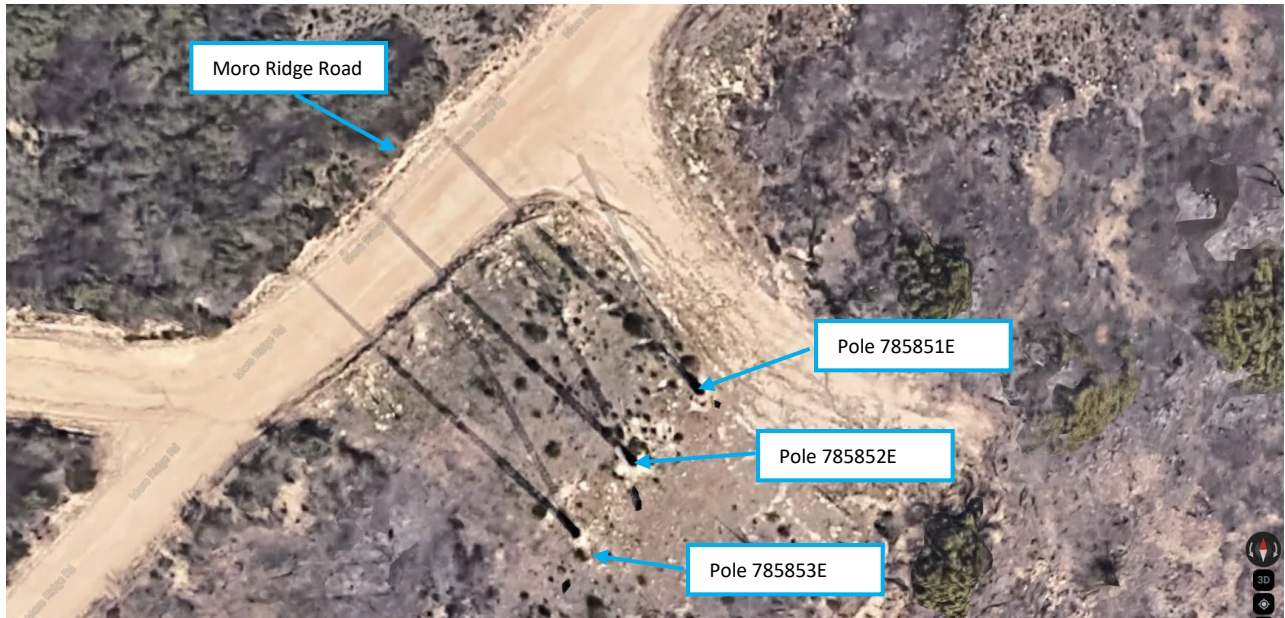
**Figure 3.** The Incident Poles near the SOA identified by OCFA.

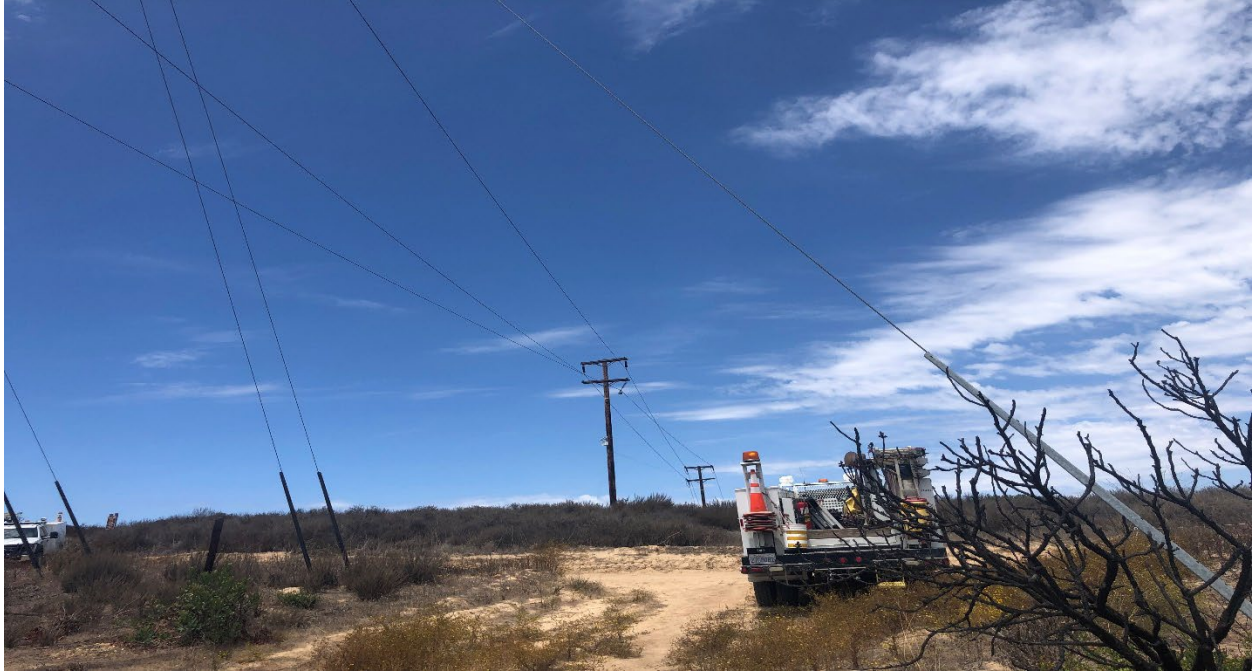
**Figure 7.** Photo of a single pole supporting three conductors west of Moro Ridge Road.

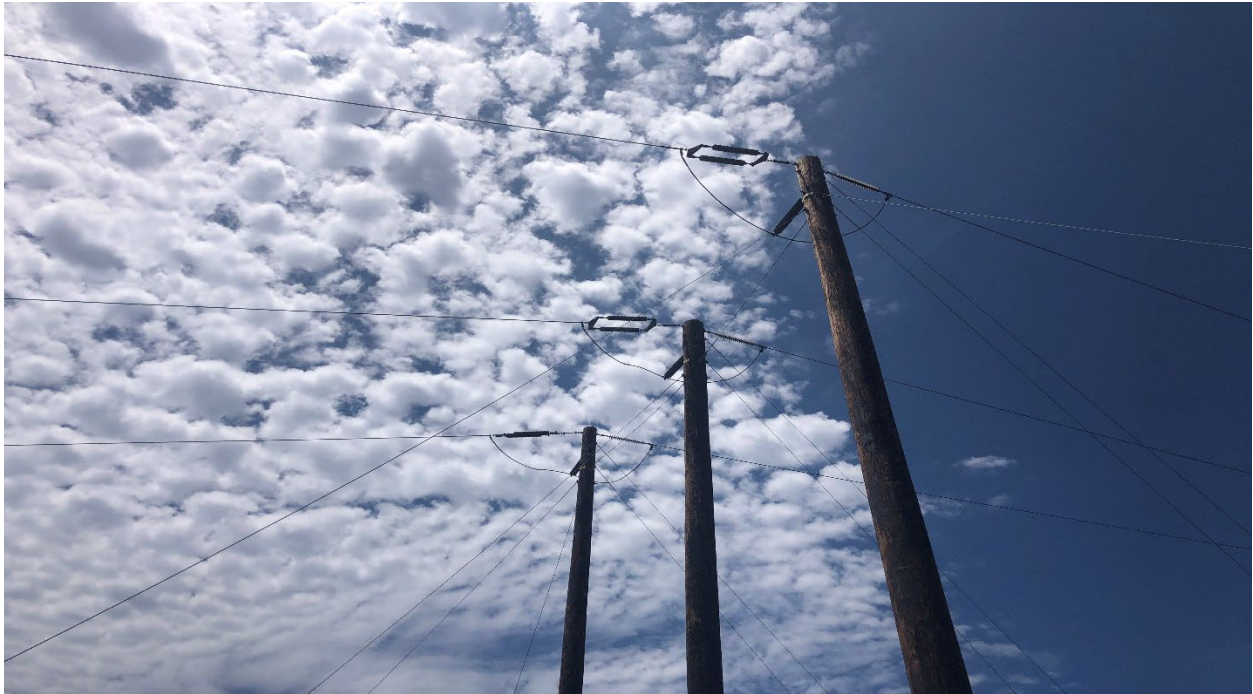
**Figure 8.** Photo of the Incident Poles showing conductor, equipment, and guy wire support.

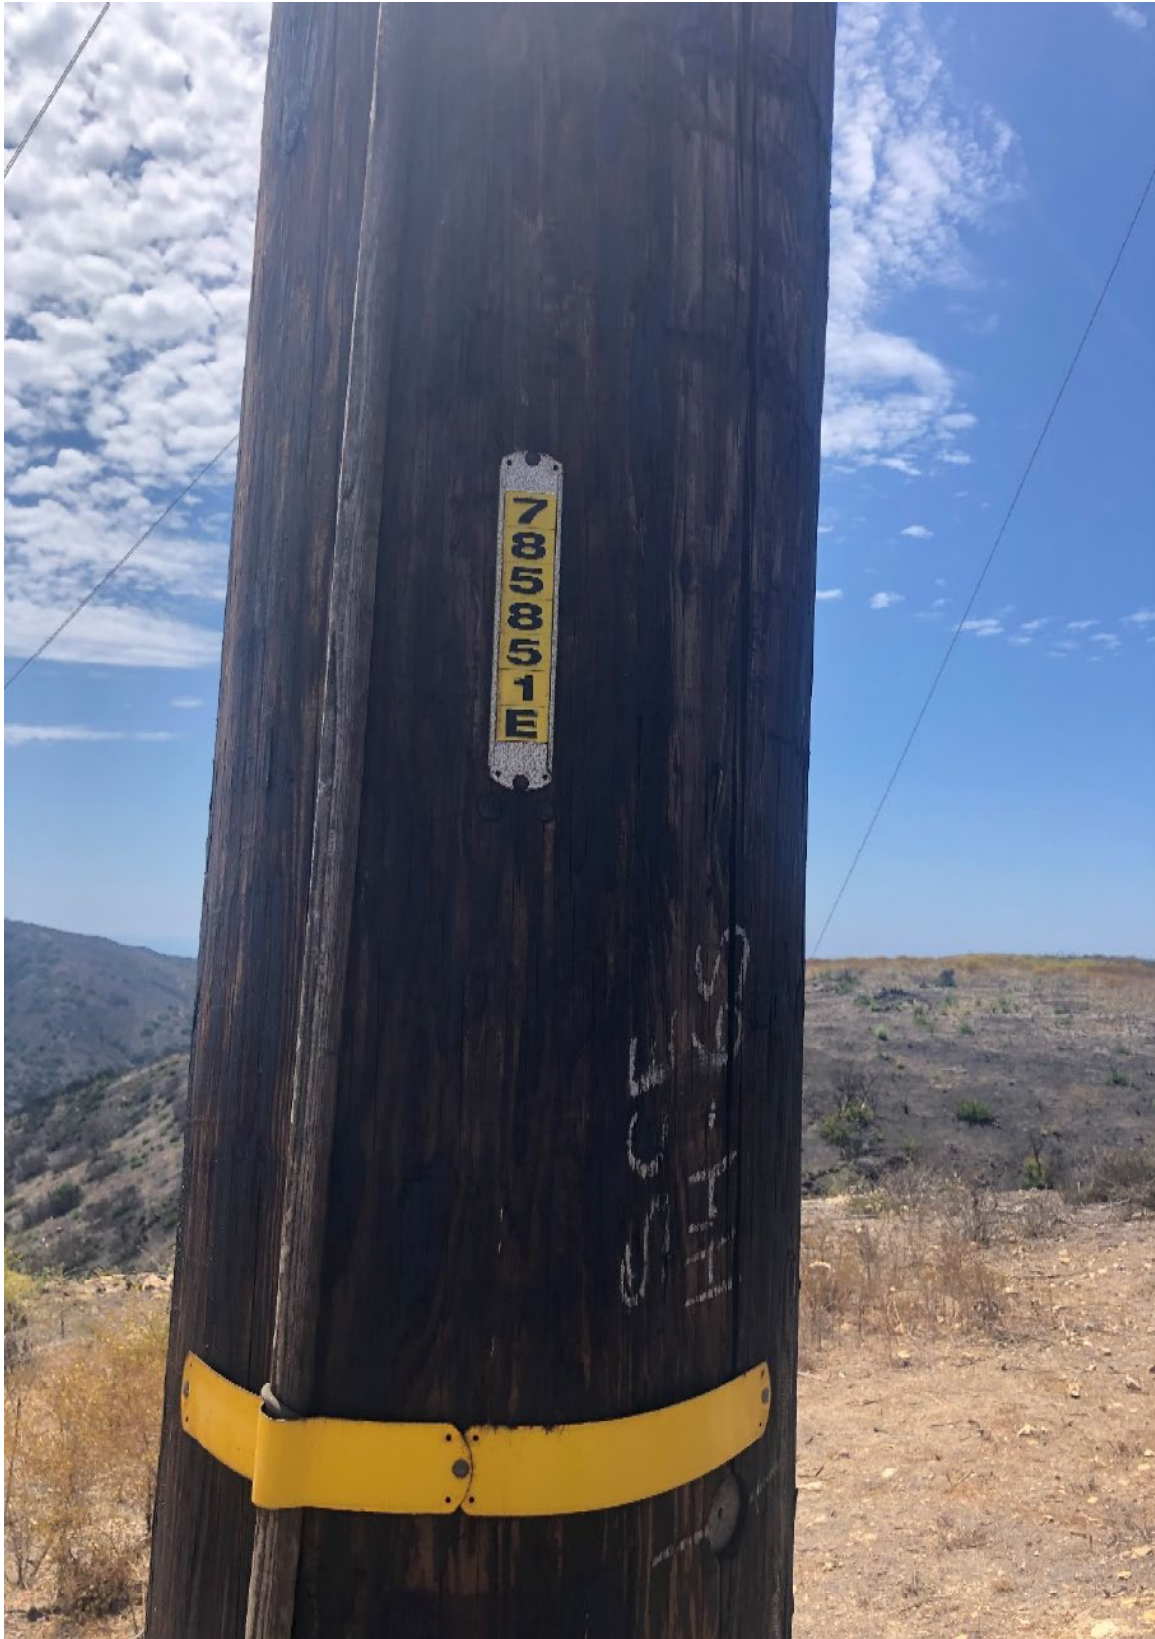
**Figure 9.** Close-up photo showing the condition of one of the Incident Poles supporting one of the conductors.

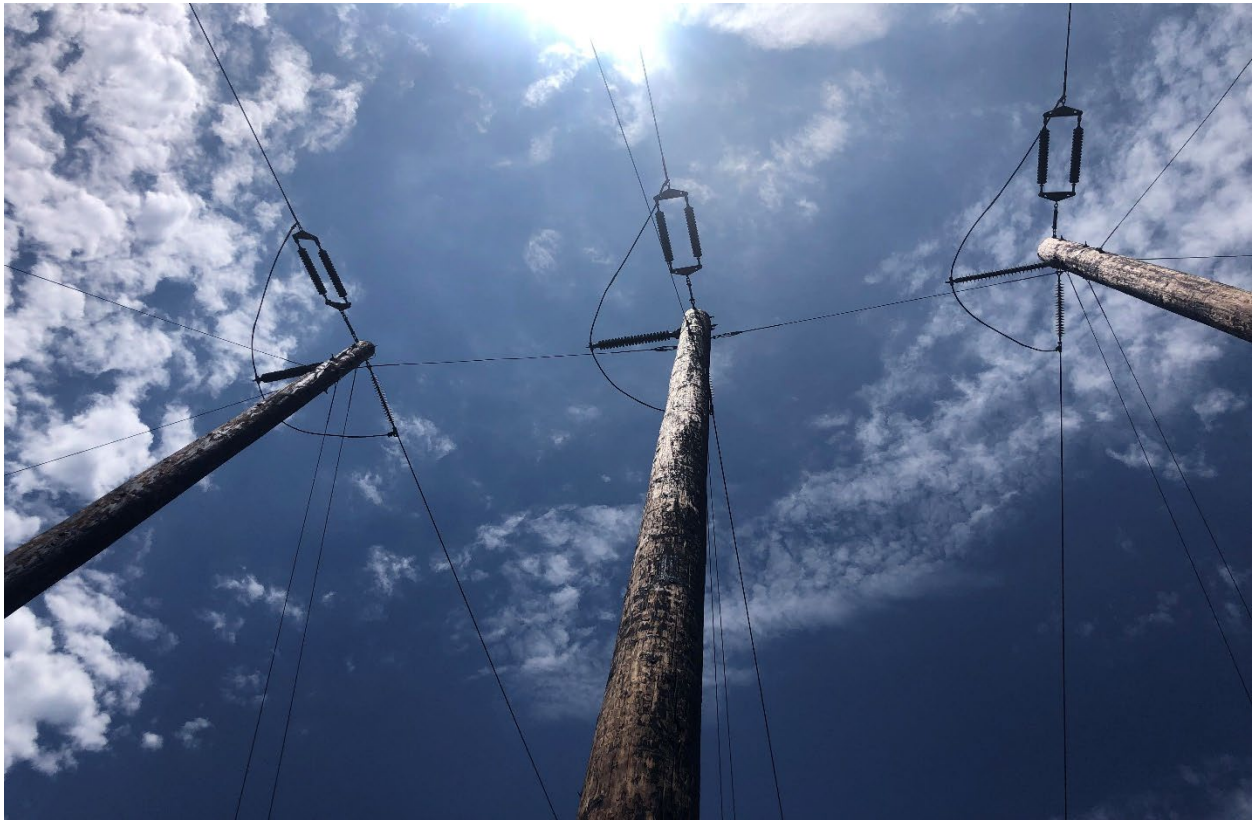
**Figure 10.** Photo showing the conductor and equipment supported on Incident Poles.

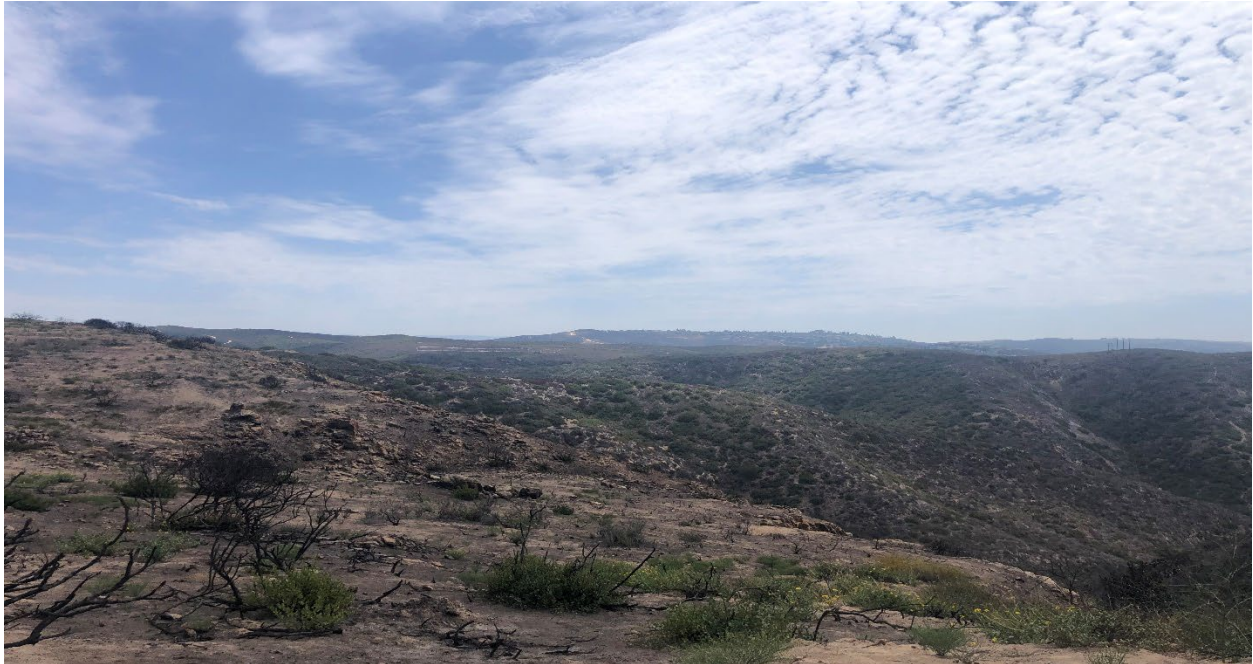
**Figure 11.** Photo showing the canyon with brush and few trees.
