PACIFIC GAS AND ELECTRIC COMPANY

CAP Issue No(s).: <u>120453562</u>

Report Rev: 01

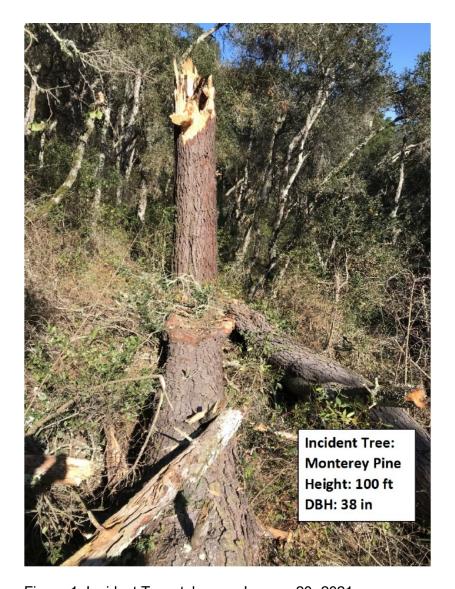
Figure 1: Incident Tree, taken on January 20, 2021

Upon arrival, the troubleman observed a fallen tree ("Incident Tree") and saw that one of two conductors on a single-phase span was down between two poles. The tree appeared to have failed and fell through the conductor mid-span causing it to come down. The ensuing fire, which CAL FIRE suppressed, burned until January 21, 2021 and was approximately 37 acres in size and there were no injuries, fatalities, or structure damage reported. The troubleman examined the upstream fuse and saw that it was open which had resulted in the loss of power for three customers. The troubleman made the area safe by cutting the downed conductor and created a repair tag for a restoration crew.
