CALIFORNIA PUBLIC UTILITIES COMMISSION
Safety and Enforcement Division
Incident Investigation Report

Incident Number: E20140827-01

Location of Incident: 150 Metcalf Rd
San Jose, CA 95138
County: Santa Clara

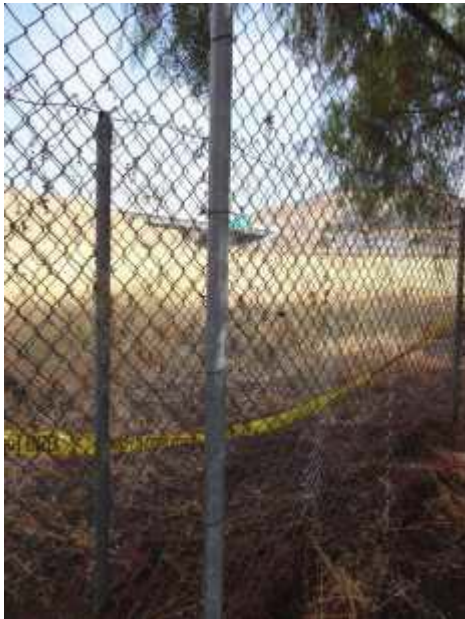
Figure 2. (left) Repaired Northwest fence (facing highway 101 from West to East)

On August 28, 2014, SED's investigator visited the Metcalf Substation, met with PG&E Investigator 2 [REDACTED] and Regulatory Supervisor [REDACTED] to debrief them regarding the stolen construction equipment and breached fence. SED's investigator observed that the Northeast perimeter fence of Metcalf substation runs parallel to state highway 101 and is easily accessible through the dirt path. The Northwest perimeter fence surrounding the general construction yard is almost perpendicular to the highway and is also accessible through the dirt field. [REDACTED] breach points along the Northeast and Northwest perimeter fences (see Figure 1 above) that surround the construction yard and operations yard (230 kV yard) were found. The suspects could have accessed PG&E's property from the highway (see Figure 2).

evaluating PG&E's security management for weaknesses). Additionally, PG&E received a permit to build an opaque wall on September 22, 2014 and has proceeded to construct the new wall around the perimeter of Metcalf substation.
