CALIFORNIA PUBLIC UTILITIES COMMISSION
Safety and Enforcement Division
Electric Safety and Reliability Branch

Incident Investigation Report

Incident Number: E20191027-01

Utility: Pacific Gas and Electric Company (PG&E)

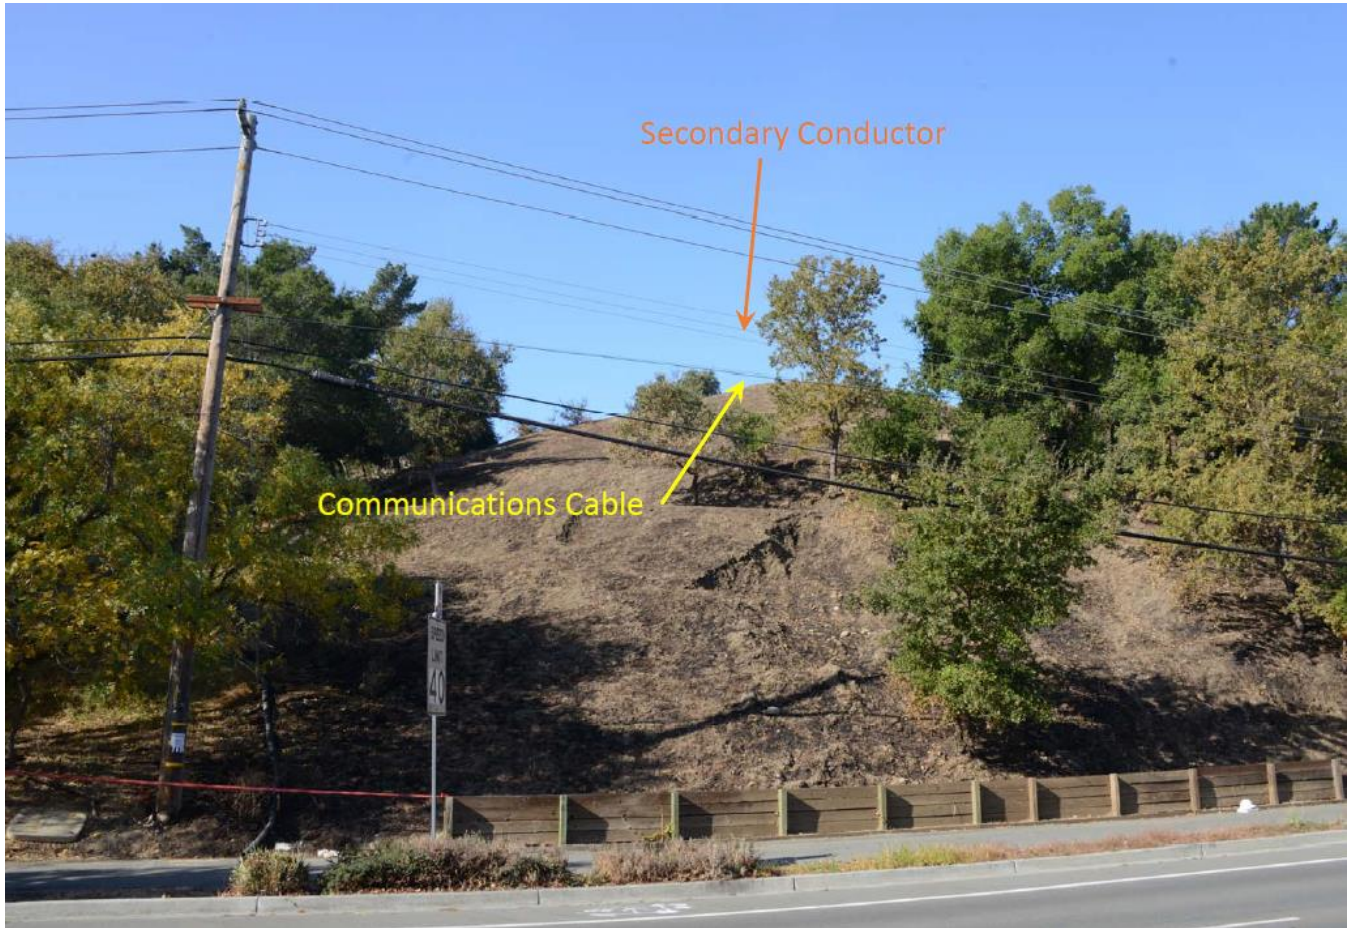
At the location near where the fire started, PG&E observed broken lash wire on a communication cable. The wire was broken and in pieces. The troubleman removed several small pieces of the wire that had melted onto the secondary conductor throughout the span (see Figures 1, 2, and 3). He then trimmed and removed excess lash wire to prevent further contact and used zip-tie to re-lash the cable.¹

Figure 1. Incident location where the communication lash wire broke loose and contacted PG&E's Rossmoor 1104 12 kV secondary conductors.

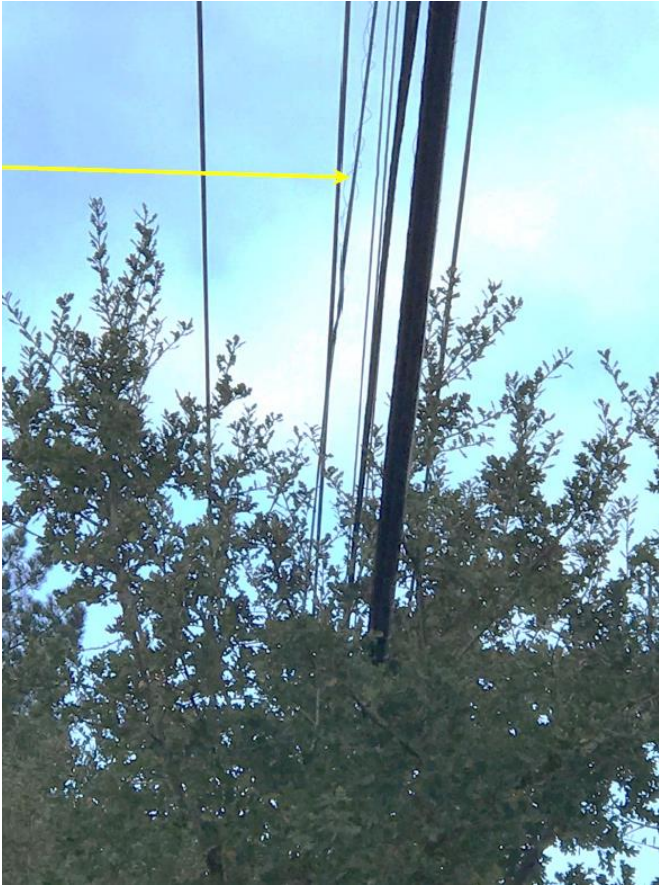
Figure 2. Photo showing broken/loose lash wire on communication cable.

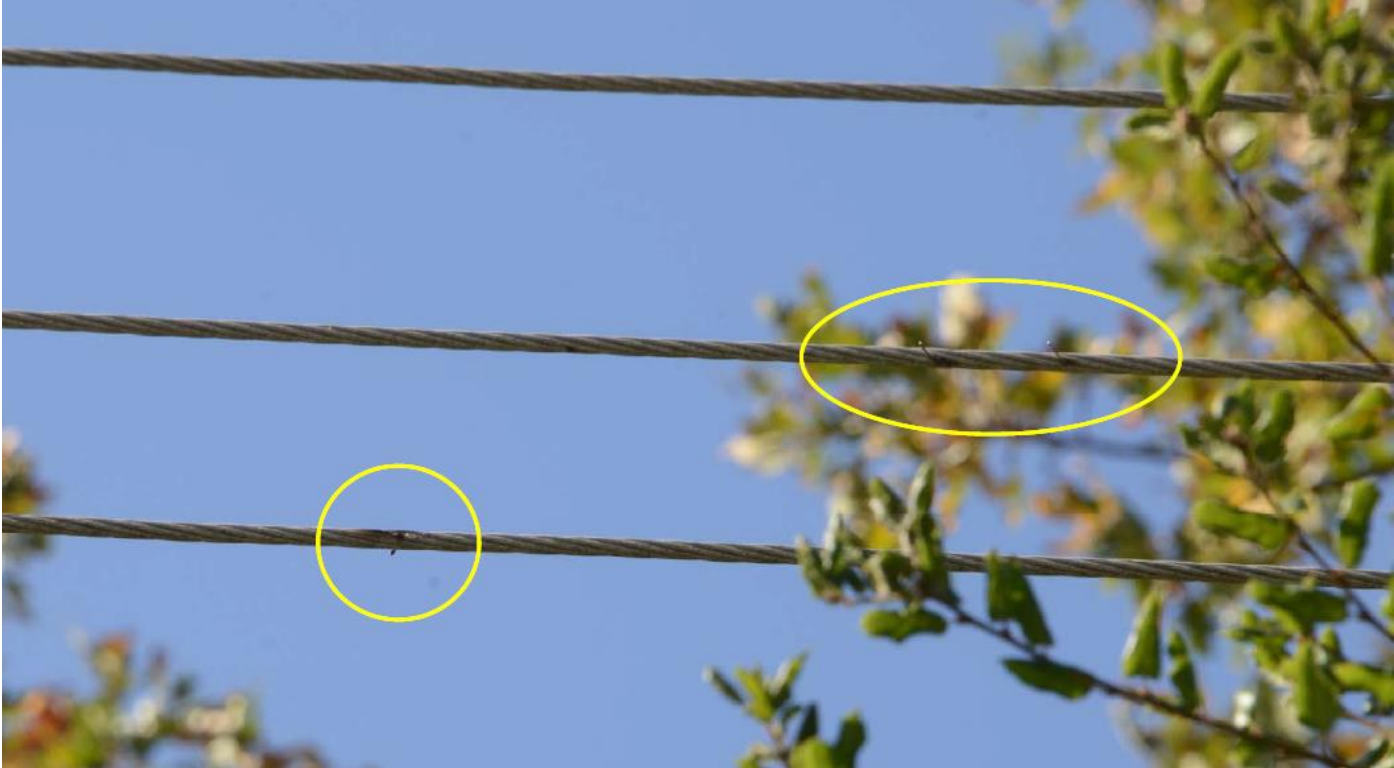
Figure 3. Photo showing pieces of lash wire strand fused to the secondary conductors where they made contact.

The lash wire evidently contacted PG&E's Rossmoor 1104 12 kV secondary conductors at multiple places along the conductor span. However, PG&E stated that no protective device operated on the circuit and no customers lost service from the incident, i.e. there was no outage.² Because no protective device operated and lash wires are typically of small diameters (0.038" to 0.045" diameter), I inferred that the contact was short-lived, i.e. the wire burned and shorted itself before the fault current was able to travel a conducive path to ground, which would have resulted in a ground fault and opened fuse.

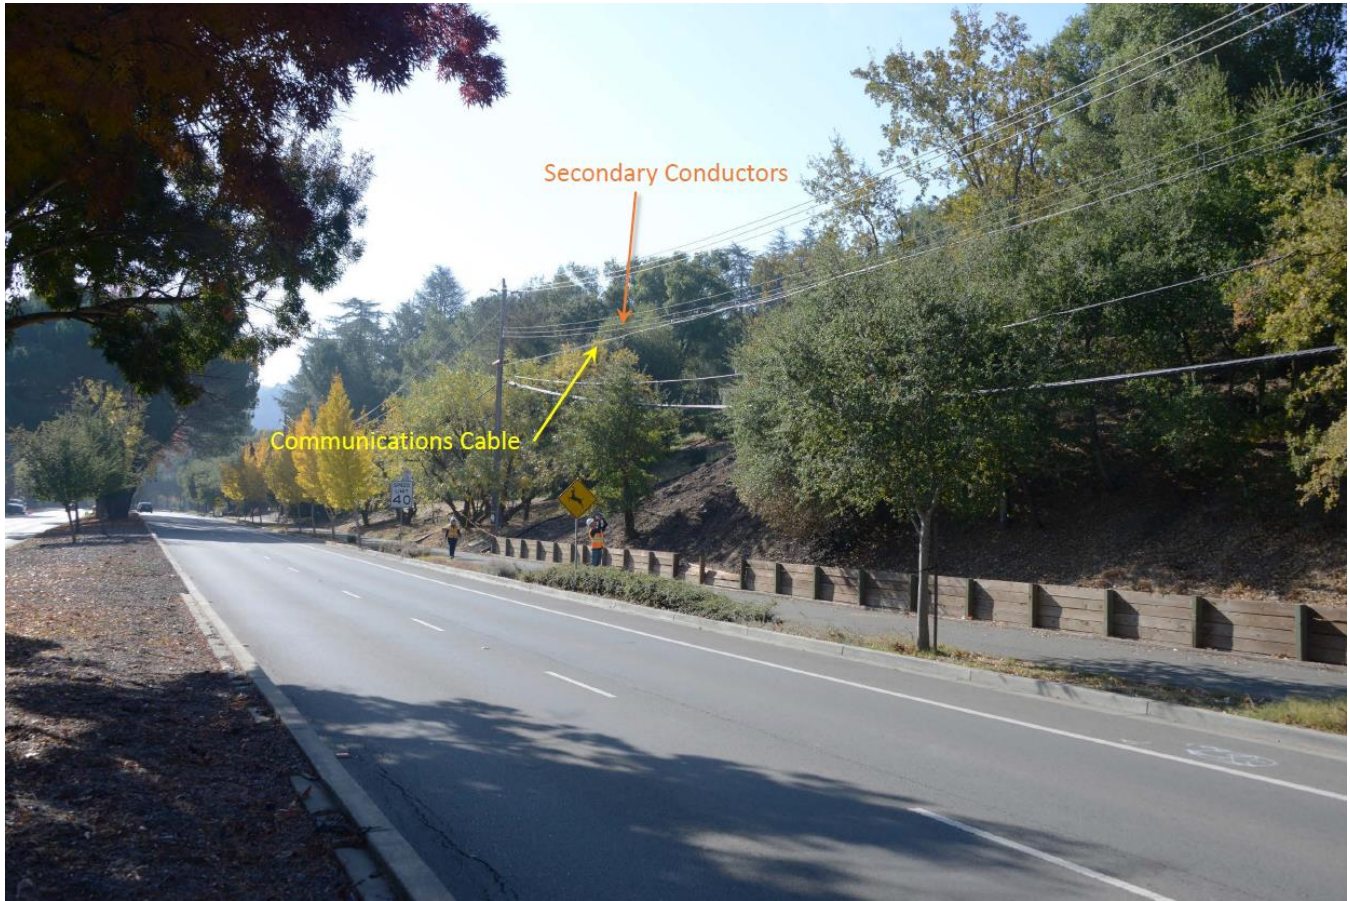
However, PG&E's records indicate its facilities were involved and could have been the ignition source.³ PG&E's report from its Outage Information System (OIS) states that the communication cable was "*pulled in too high and is at same height as secondary rack open wire. Lashing on phone line came loose and with wind pushed into secondary causing arc and grass fire under span*". This statement is consistent with the physical evidence that PG&E troubleman observed onsite, e.g. broken/loose lash wire and wire strands fused onto the conductors. In response to a data request, PG&E estimated there was less than approximately 1 ½ feet of horizontal clearance (and no vertical clearance) between its secondary conductors and the communication cable where the two made contact.⁴ The 12 kV energized conductors were essentially at the same height as the communication cable. Further, the vertical distance between their attachment points on the southern pole is only approximately **4 feet** (the southern pole is the pole nearest to the location where the lash wire contacted the conductors and is identified by Pole #110458878).

Per General Order 95, Rule 38, Table 2: Basic Minimum Allowable Clearance of Wires from Other Wires at Crossings, in Midspans and at Supports, Case No. 8 (Communication Conductors and Service Drops), Column F (7,500 - 20,000 Volts), the vertical clearance required between the 12 kV conductors and the communication cable is 72 inches or 6 feet.⁵

Figure 4. Photo showing the secondary conductors and communication cable are at the same height where the two made contact.

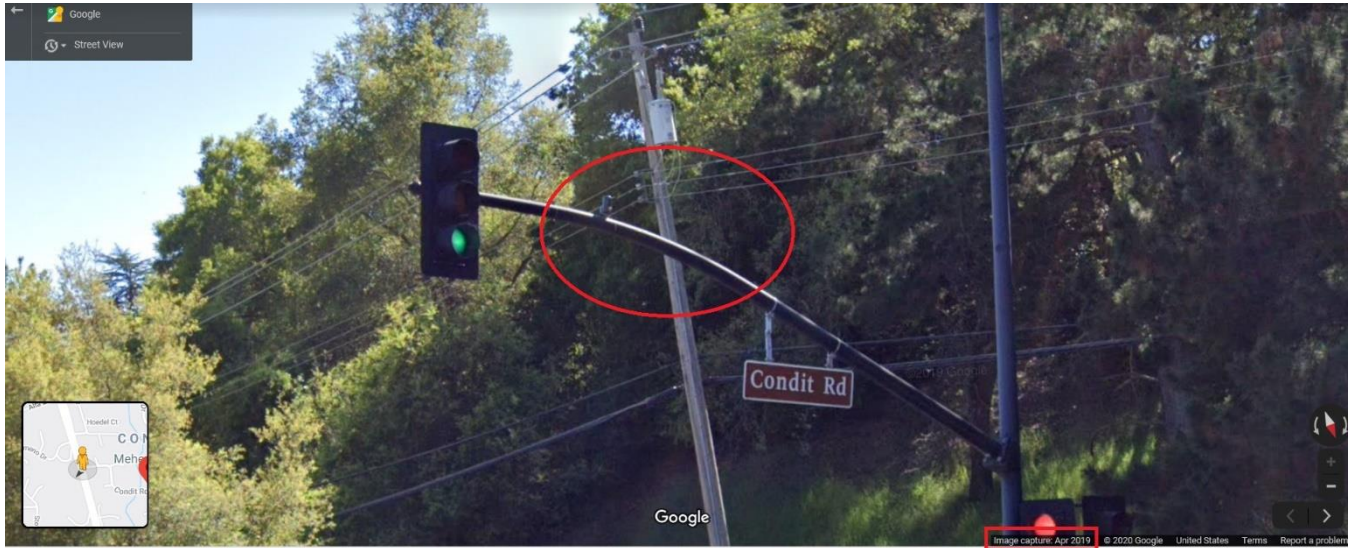
Irrespective of whether PG&E’s facilities caused the fire, ESRB’s investigation focused on whether the incident was a result of failures to comply with Commission General Orders. ESRB determined the communication cable belongs to Verizon and was installed sometime between June 26, 2019 (date of PG&E’s Approval-To-Attach) and October 27, 2019 (date of the incident).⁶ PG&E’s most recent patrol inspection on the line occurred on April 15, 2019 (approximately two month prior to when the cable should have been installed). Google Street View images captured in April and June 2019 also confirmed the cable had not yet been installed during those times (see Figures 5 and 6). Therefore, PG&E would not had been able to detect the clearance violation in its April 15, 2019 inspection because the cable was not installed at the time.

Figure 5. Google Street View image captured in **April 2019** confirmed the communication cable had not yet been installed at the time.
Source: Google Maps

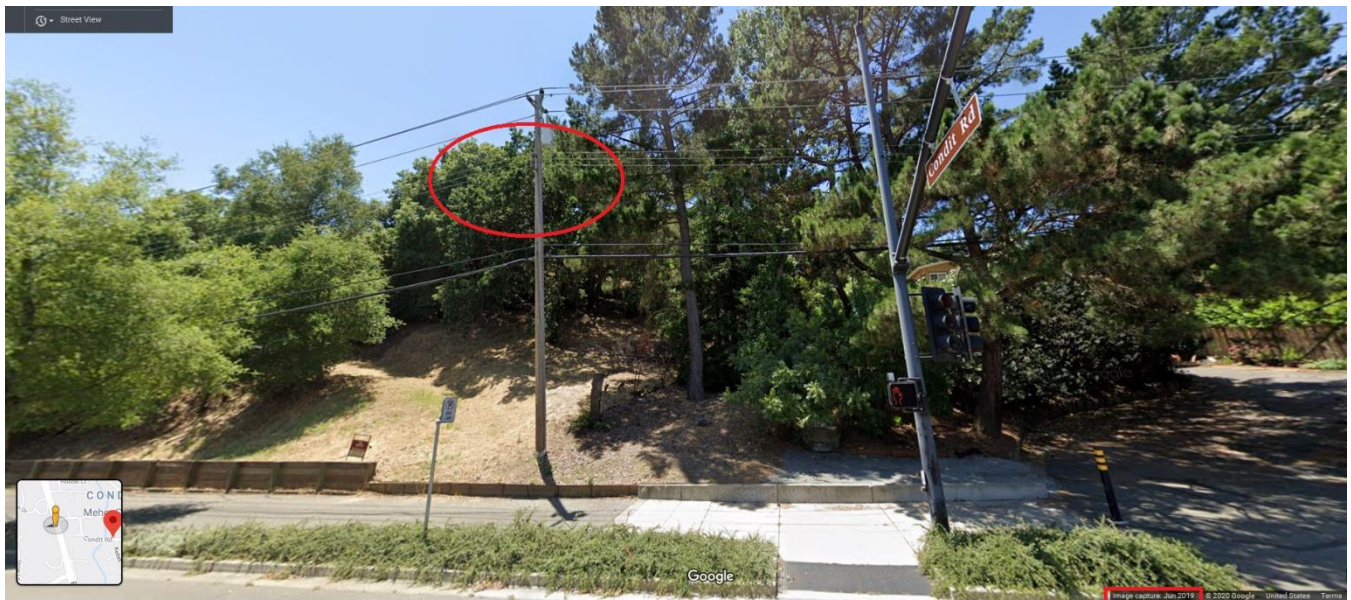
Figure 6. Google Street View image captured in **June 2019** confirmed the communication cable had not yet been installed at the time.
Source: Google Maps
