**Enclosure 2 – PG&E Moss Landing Tower Collapse Direct
Cause Analysis**

**Moss Landing Tower
Collapse Analysis**

December 23, 2015

Doc. no. 1507946.000 - 2517

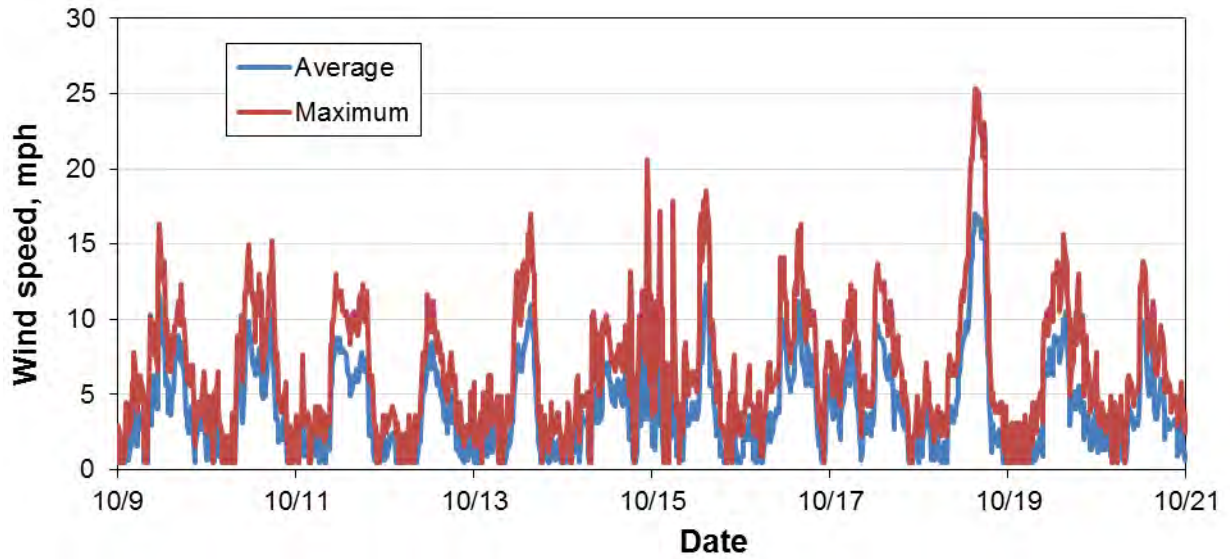
Using wind speeds measured at nearby Elkhorn Slough, the wind pressure on the tower and attached conductors at the time of the accident was well below the design wind loads considered in Black & Veatch's analysis, and was determined not to be a major contributor to the collapse. Figure 5 shows the average and maximum wind speeds recorded near the site from the date the conductor stringing was completed to the time of collapse. Figure 6 shows the maximum and average wind speeds near the site the day the tower collapsed. We understand that the tower collapsed at about 7:00 am, at which time the wind loads would have been negligible.

Figure 5. Maximum and average wind speeds recorded at Elkhorn Slough October 9, 2015 to October 21, 2015.⁵

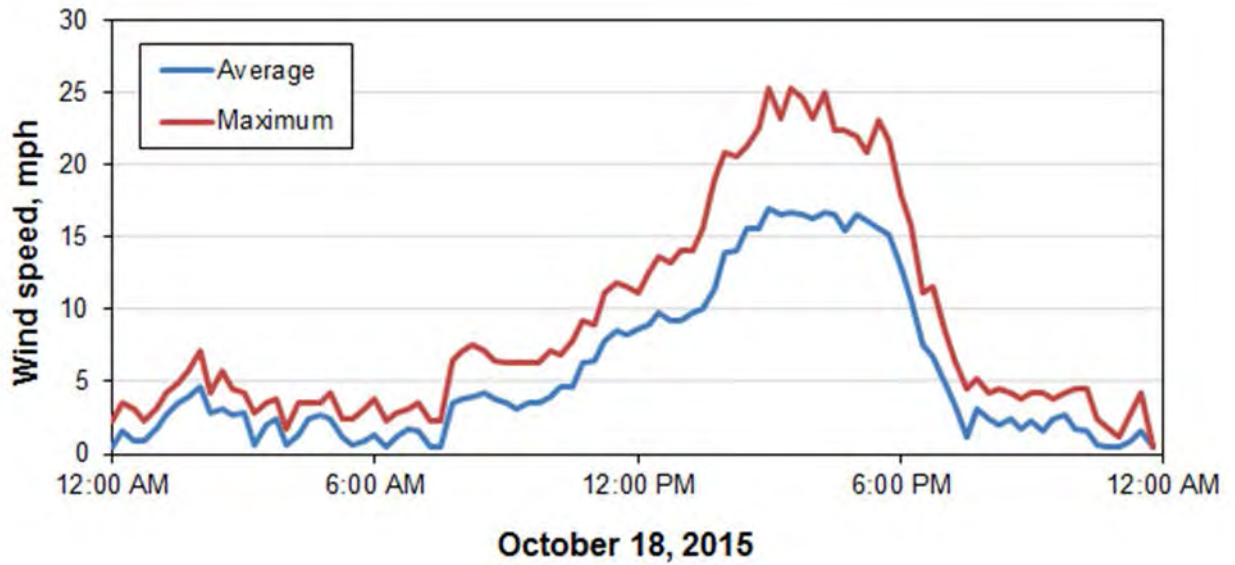
Figure 6. Maximum and average wind speeds recorded at Elkhorn Slough on October 18, 2015.⁶

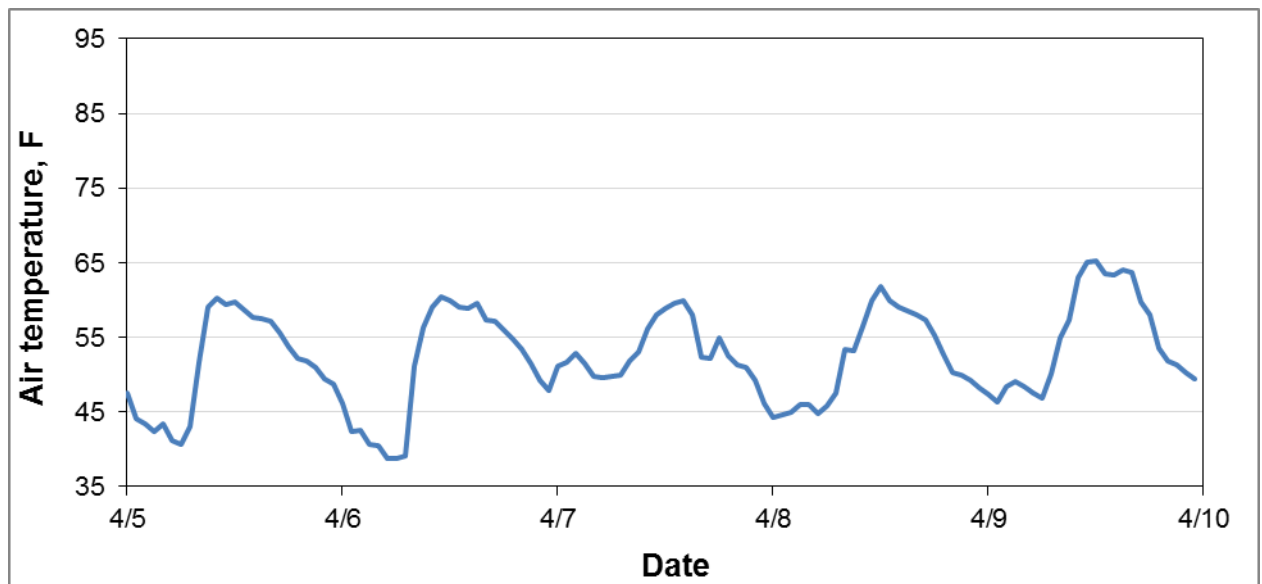
The ambient air temperatures over the period of tower erection (April 6-8, 2015) are shown in Figure 7, and the ambient air temperatures from the date the conductor stringing was completed to the time of collapse are shown in Figure 8. All of these recordings were obtained from a weather station located approximately two miles from the site as shown in Figure 9. While one can conclude that extreme temperature was not a contributor to the collapse, the effect of cool temperatures on the subject steel and the resulting fracture morphology is discussed in a later section.

Figure 7. Ambient air temperature at Elkhorn Slough, April 5, 2015 to April 9, 2015.⁵

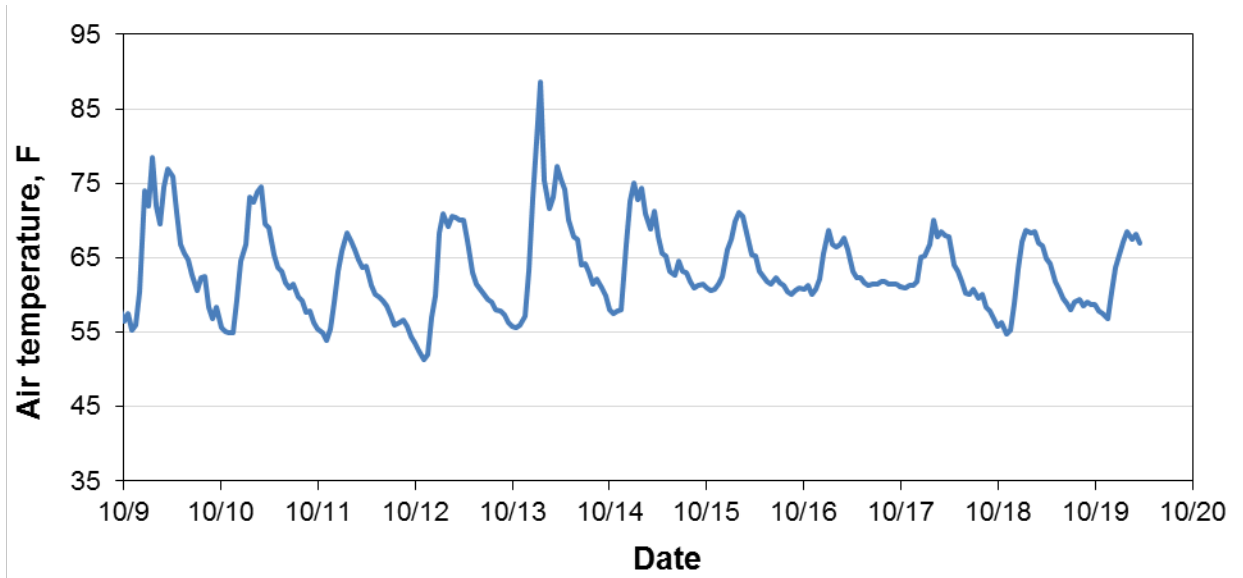
Figure 8. Ambient air temperature at Elkhorn Slough, October 9, 2015 to October 20, 2015.⁵

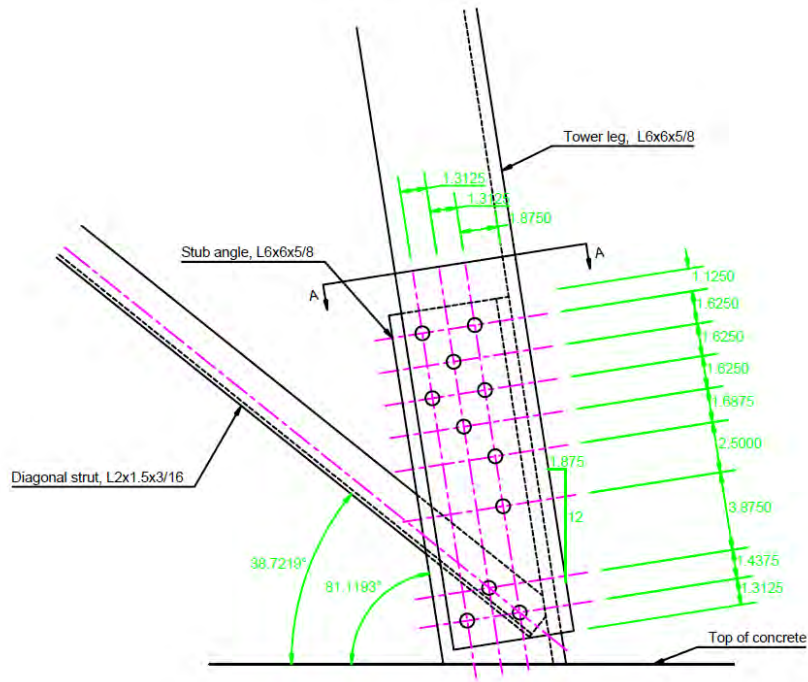
Figure 12. Bolted connection at base of tower 61/268.

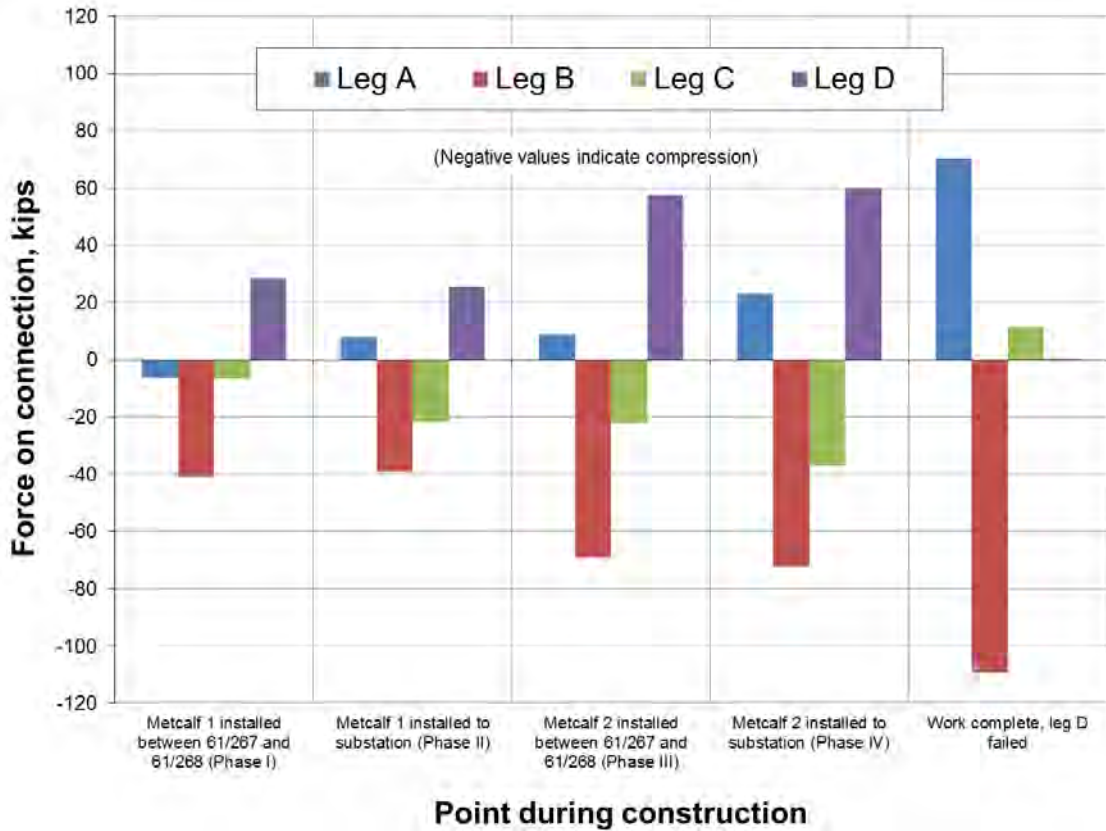
Figure 13 shows a summary of the axial force demands on each foundation stub angle at the end of each installation phase. The axial force is a combination of the tension or compression load in the tower leg as well as the component of the diagonal strut braces forces (see Figure 12) oriented along the leg axis. (Any compression resistance of the diagonal struts was neglected in the model since the slenderness, KL/r , of those elements exceeds 200.) The axial tension in the stub angles at the critical section was compared to the tensile rupture strength (R_n) of 338 kips per the requirements of AISC 360, 13th edition, Section J4.1 (assuming $F_u = 65$ ksi). As can be seen, the expected tension in the tower stub angles due to construction loads (including the load at the time of failure) remain well below half the expected strength. The nominal compressive strength (P_n) of the leg according to AISC Section E5 was calculated to be 170 kips.

In conclusion, the design of the stub angles, and in particular the strength of the critical section, is adequate for the intended loads from construction up to the time of failure.

Figure 13. Axial forces on tower stub angle connections.

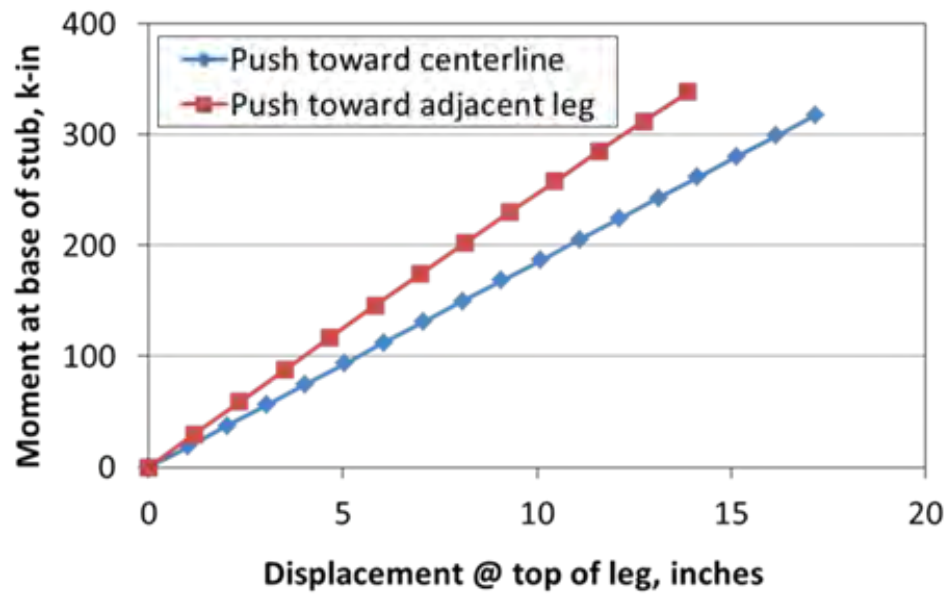
Figure 18. Moment demand at base of stub versus displacement at top of leg.

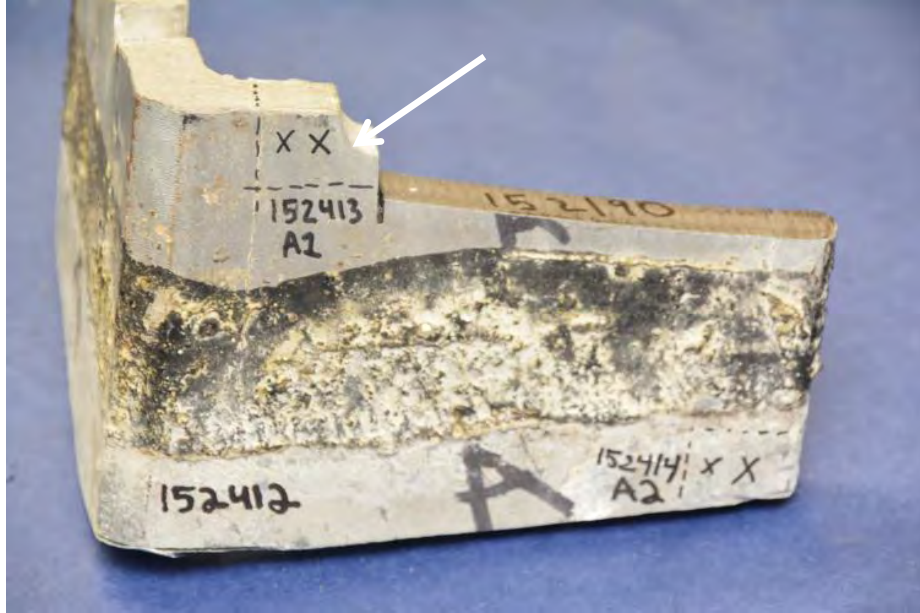
Specific locations of the incident stubs were cross sectioned, mounted, polished and etched for metallographic interpretation of the microstructure. The sectioning of the material surrounding the hole at the Stub A fracture origin, is shown in Figure 30. Metallographic examination showed significant plastic deformation at the holes, consistent with hole-punching with no subsequent reaming, as shown in Figure 31 and Figure 32. The base microstructure of the incident stubs was ferrite/ pearlite (Figure 33), as would be expected for this steel.

Figure 30. Photograph that shows representative sectioning location for metallographic analysis in Stub A (indicated by arrow). The “x x” indicates the metallographic section location.

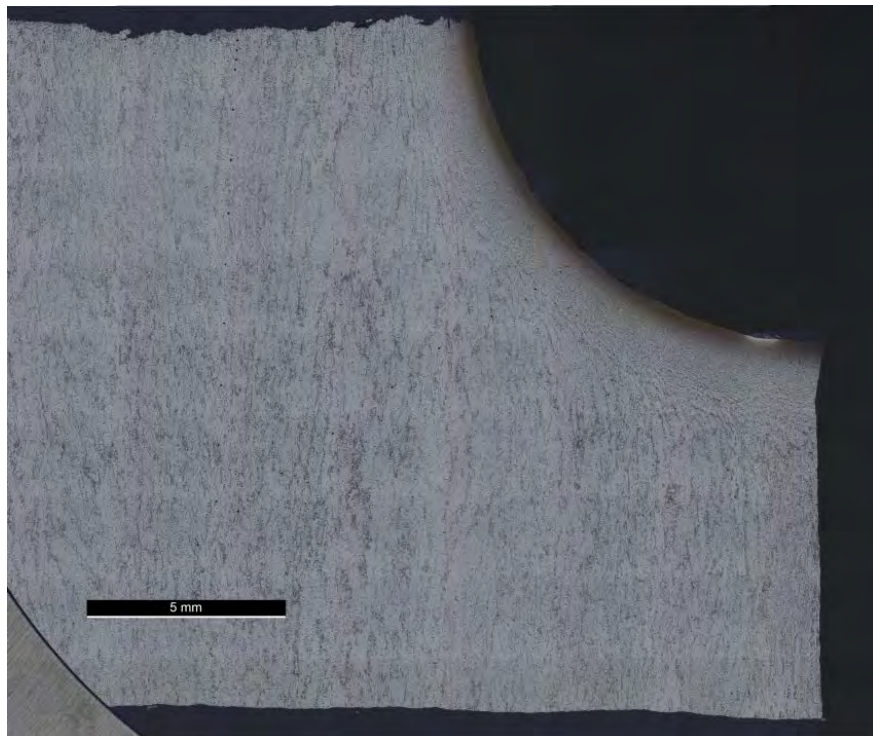
Figure 31. Low-magnification metallographic montage that shows microstructure at and away from one of the two Stub D punched-hole fracture origins.

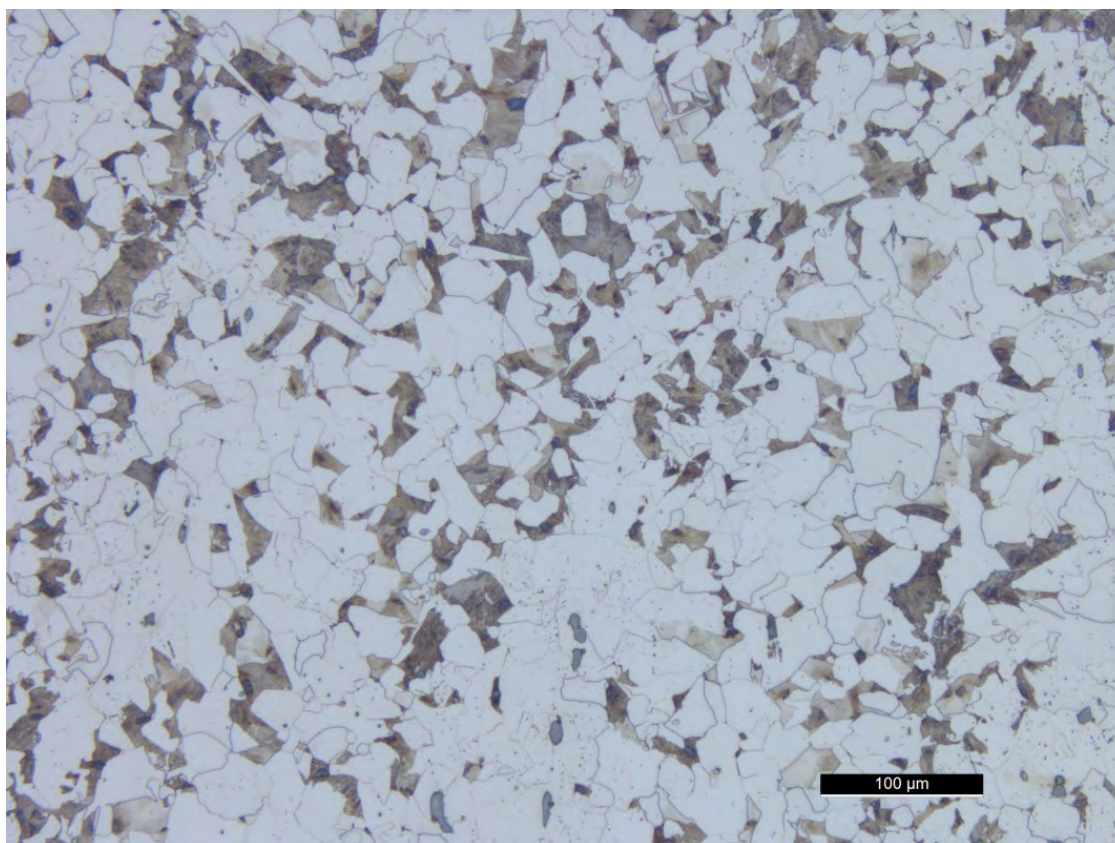
Figure 33. Representative metallographic images of the base metal microstructure observed in each of the stubs.

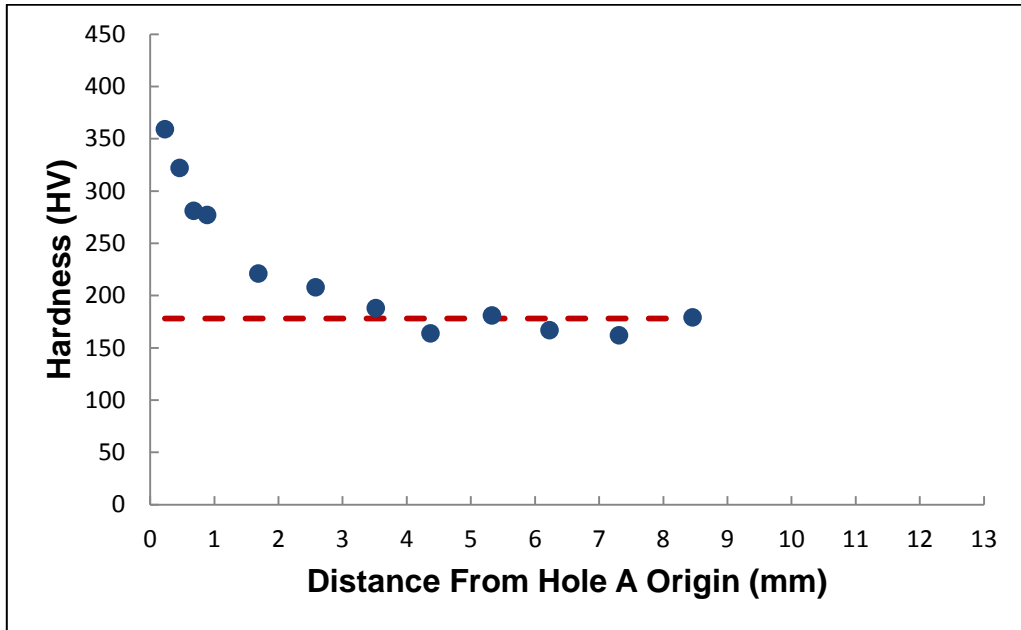
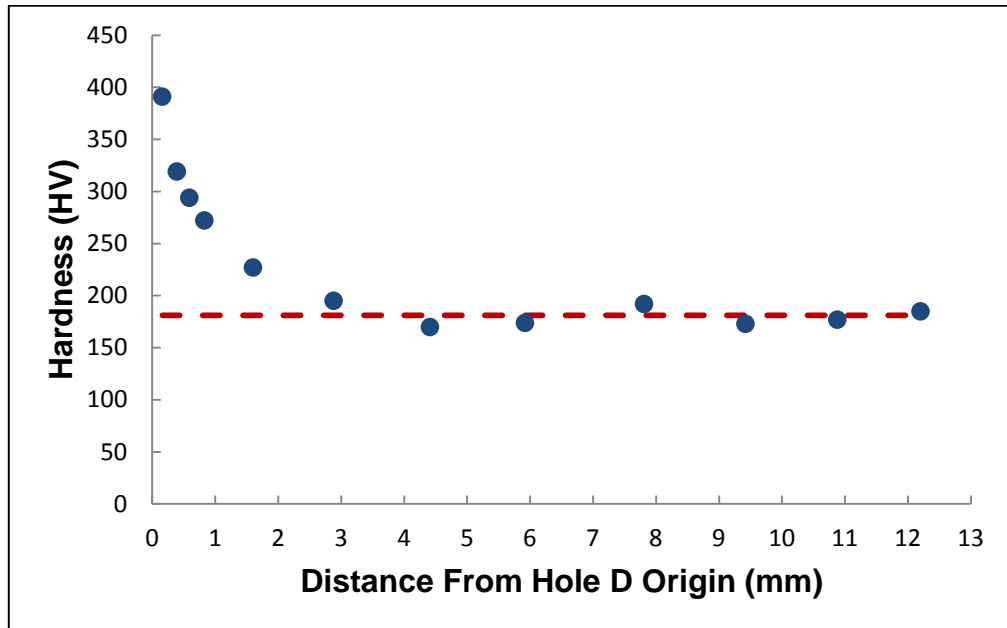
Microhardness traverses were taken that included material near and distant to the punched holes, including fracture origin locations. Plots from representative microhardness traverses are shown in Figure 34. Microhardness readings taken near the holes showed significant hardening, associated with the localized plastic deformation that occurs during the punching process. Further than approximately three millimeters from the holes, the zone of plastic deformation diminished, and the hardness values were roughly constant. The hardest areas adjacent to the holes were between roughly 350 and 400 on the Vickers scale, roughly equivalent to local tensile strengths of 160 to 200 ksi. The base metal hardness (away from the holes) was approximately 170 on the Vickers scale, predictive of a tensile strength of approximately 80 ksi; similar to strengths observed during tensile testing of each of the stubs.

Figure 34. Microhardness profile plots for Stub A and D holes at fracture origin locations.

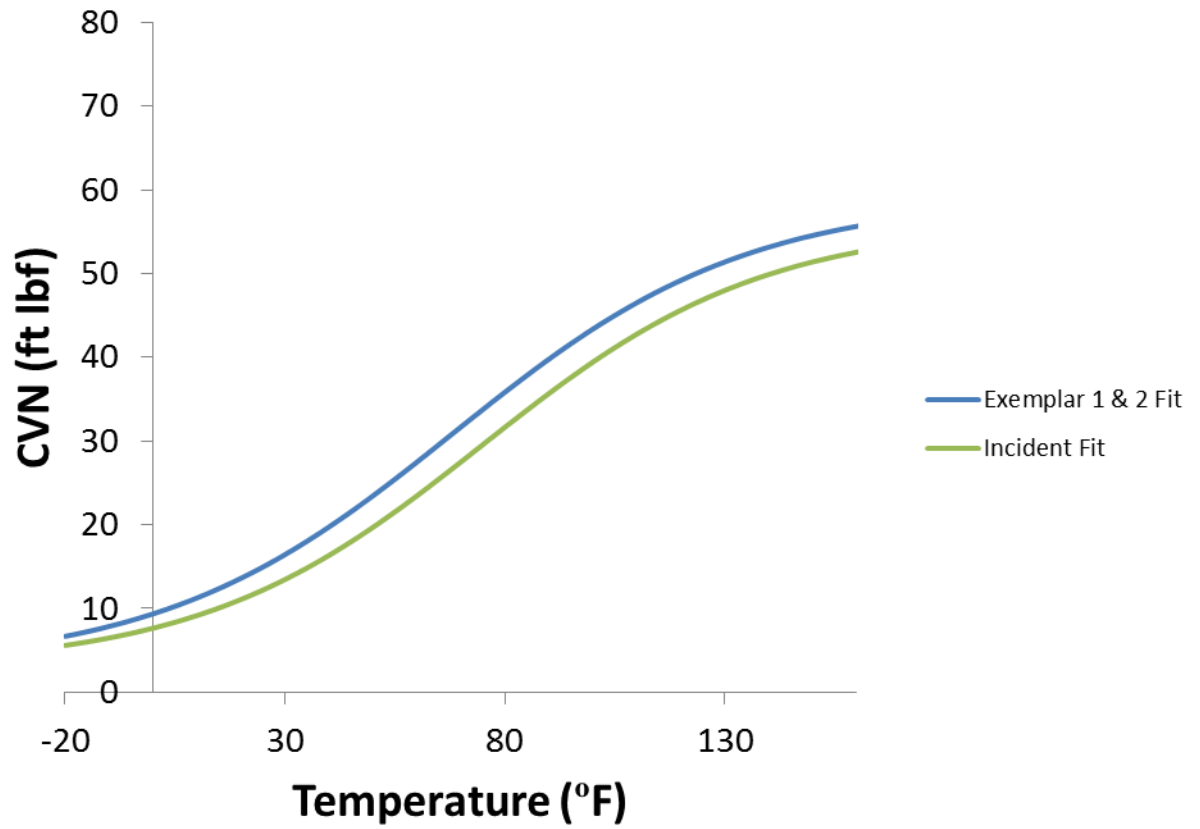
Specimens removed from Stub A were tested at a full series of temperatures ranging from -20°F to 140 °F. Specimens from Stubs B, C, D and Exemplars were tested at representative temperatures selected based on the test results of Stub A. The CVN impact energy of all incident samples were plotted versus test temperature (Figure 36), and curve-fit to the hyperbolic tangent equation (Figure 37) shown below as suggested by Standard API 579-1/ASME FFS-1 2007 Page F-14.

Comparison of ductile-to-brittle transition temperature (DBTT) behavior between the incident and exemplar stubs is shown in Figure 36 through Figure 38. The results show that the non-galvanized Exemplar Stubs 1 and 2 may have a slightly lower DBTT than the incident stubs. The small difference in toughness may be associated with strain aging that occurred during galvanizing of the incident stubs. Exemplar 3, which has lower carbon and sulfur levels, appears to have the best toughness/ transition behavior of all stubs. The DBTT of the incident stubs was approximately 70°F, above the estimated 55°F temperature at the time of the

Figure 37. Hyperbolic tangent (per API 579) curve-fit CVN data as a function of test temperature for Incident and Exemplar 1 and 2 stubs.

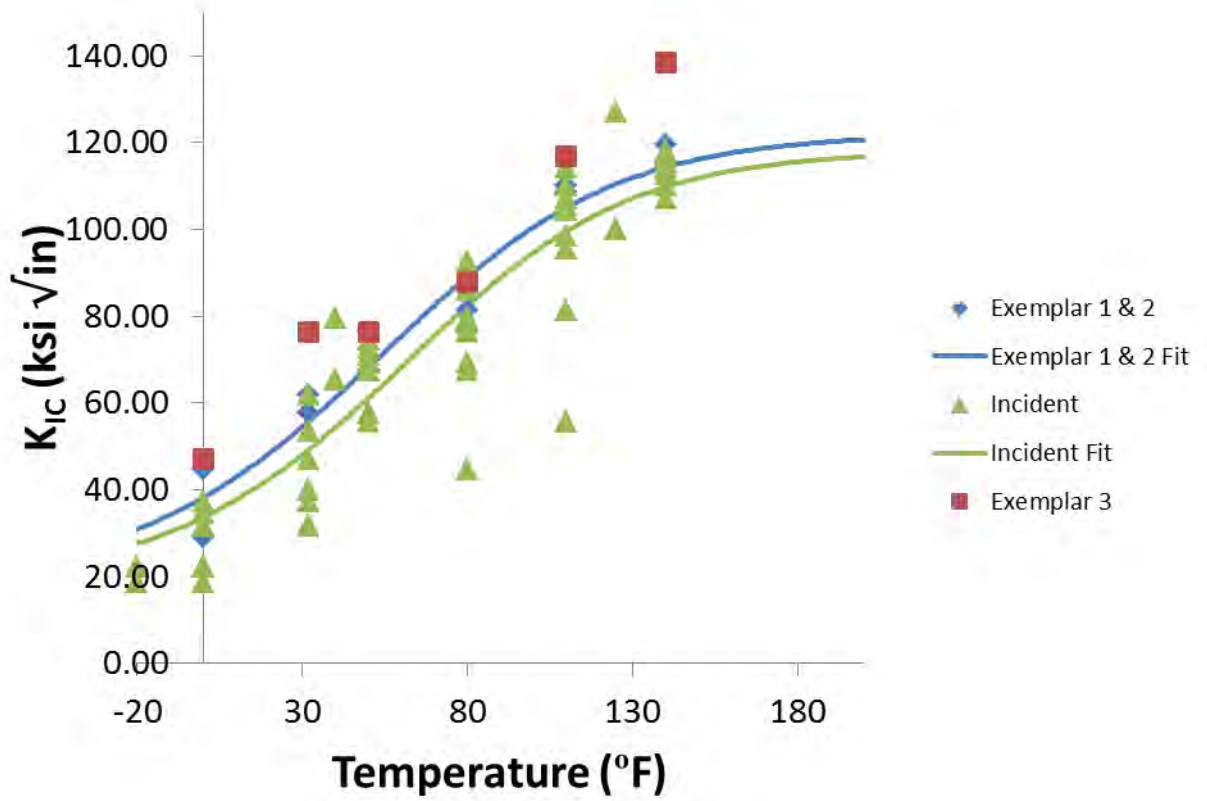
Static fracture toughness (K_{IC}) at different temperatures was converted from the CVN impact energy by using $K_{IC} - CVN$ correlations as suggested by Standard API 579-1/ASME FFS-1 2007 Page F-14. The equation below was used to estimate the lower bound as recommended in WRC 265. The plot of static fracture toughness as a function of test temperature is shown in Figure 38.

Figure 38. Stress intensity factor as a function of temperature converted from CVN test results.

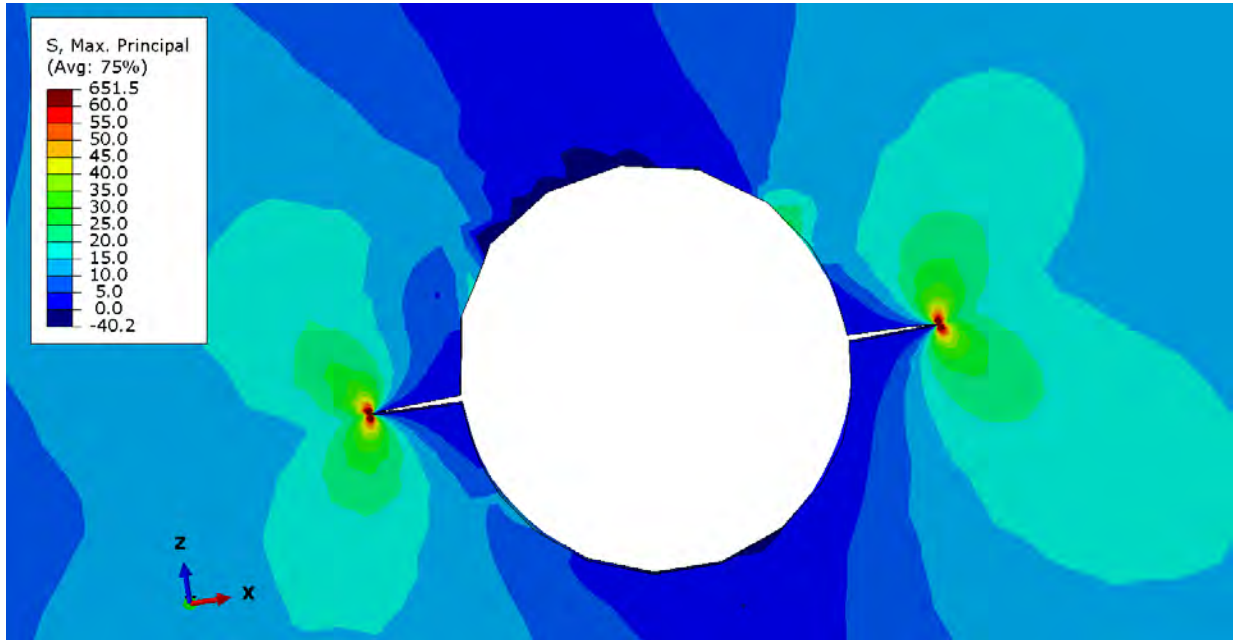
Figure 46. Stress concentrations located at the 4.0 mm crack fronts for “Stub-D” with an even bolt-load distribution. Deformation scale = 20.

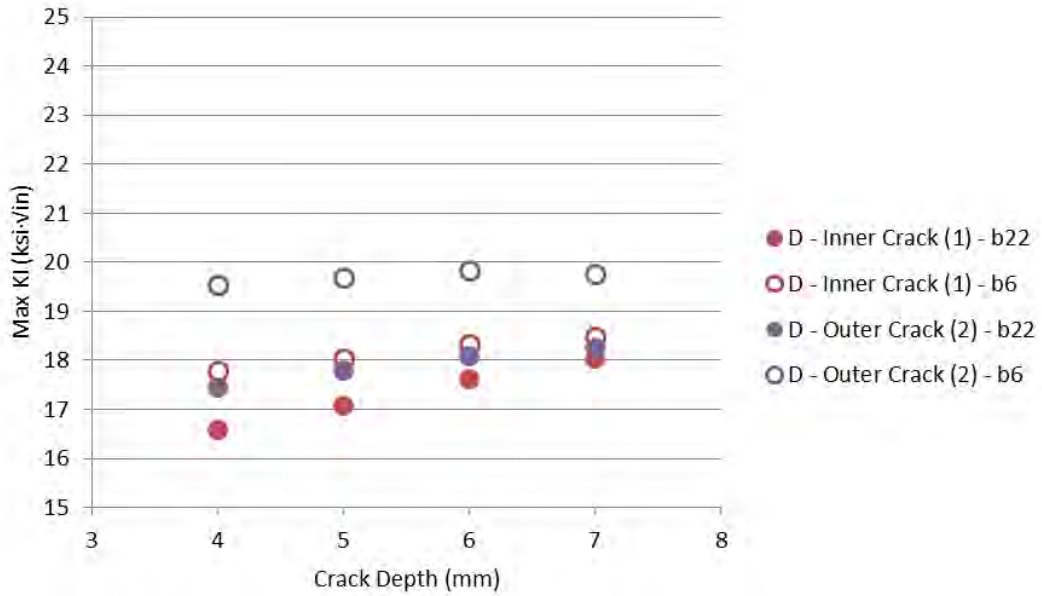
The axial “Stub-D” and “Stub-A” load cases are summarized in Figure 48-Figure 51. The maximum stress intensity factor along the crack front versus crack depth for the given nominal “Stub-D” and “Stub-A” load conditions are summarized in Figure 48 and Figure 49. The maximum stress intensity factor along the crack front versus load amplification factor for the given nominal crack depth of 4.0 millimeters are summarized in Figure 50 and Figure 51. Each summary plot shows the even axial bolt-load distribution (over 22 bolt holes, denoted by b_{22}) and the localized bolt-load distribution (over the bottom 6 bolt holes, denoted by b_6) results. Since the stub-only moment analysis involved a single crack depth (4.0 mm), Figure 52 plots the stress intensity factor distribution along the crack fronts for both Moment 1 and Moment 2 load cases. Stress intensity factors for the extended-stub analysis were calculated at displacement increments of one inch, up to a maximum displacement of 17 inches, for each moment load case direction. Figure 53 plots maximum stress intensity factor as a function of applied displacement for the extended-stub model. Stress intensity factors were calculated using a volume-integral approach within the Franc3D software.

Figure 48. Maximum stress intensity factor vs. crack depth for the “Stub-D” condition (all tower stubs intact). ‘b22’ denotes even bolt-load distribution. ‘b6’ denotes localized bolt-load distribution.

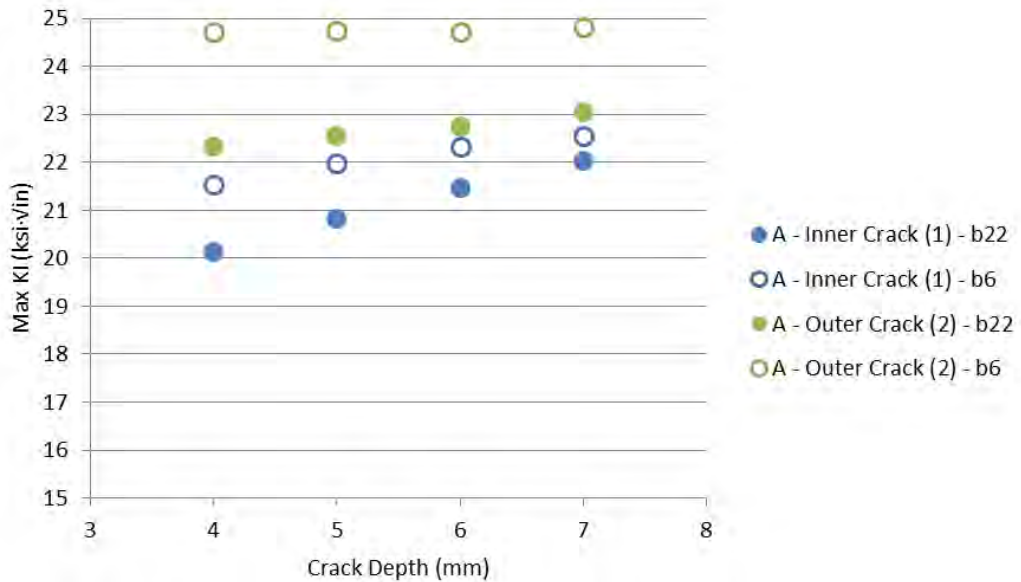
Figure 49. Maximum stress intensity factor vs. crack depth for the “Stub-A” condition (Stub D fractured). ‘b22’ denotes even bolt-load distribution. ‘b6’ denotes localized bolt-load distribution.

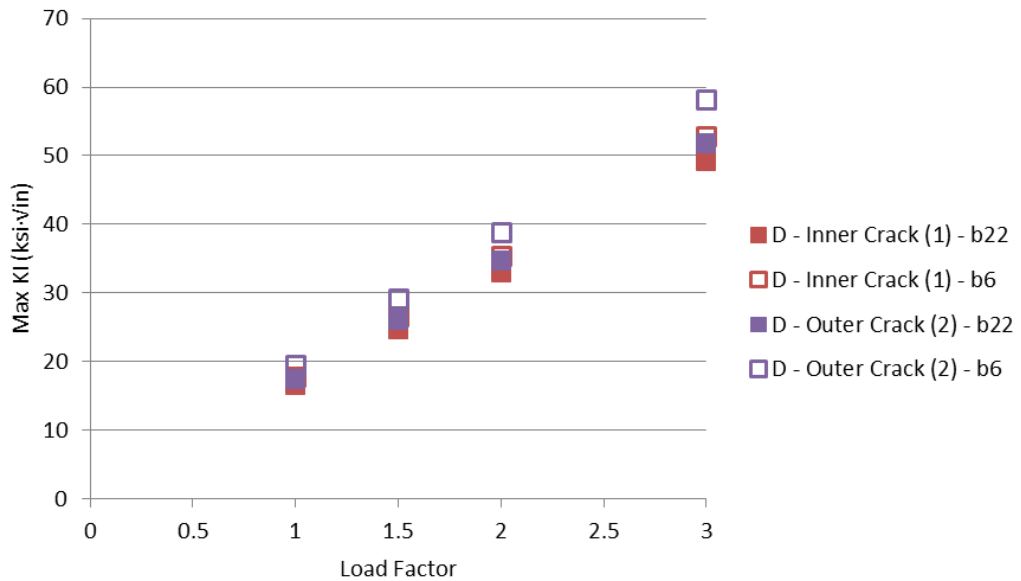
Figure 50. Maximum stress intensity factor vs. load factor for the “Stub-D” condition (all tower stubs intact). ‘b22’ denotes even bolt-load distribution. ‘b6’ denotes localized bolt-load distribution. Crack depth is 4.0 mm.

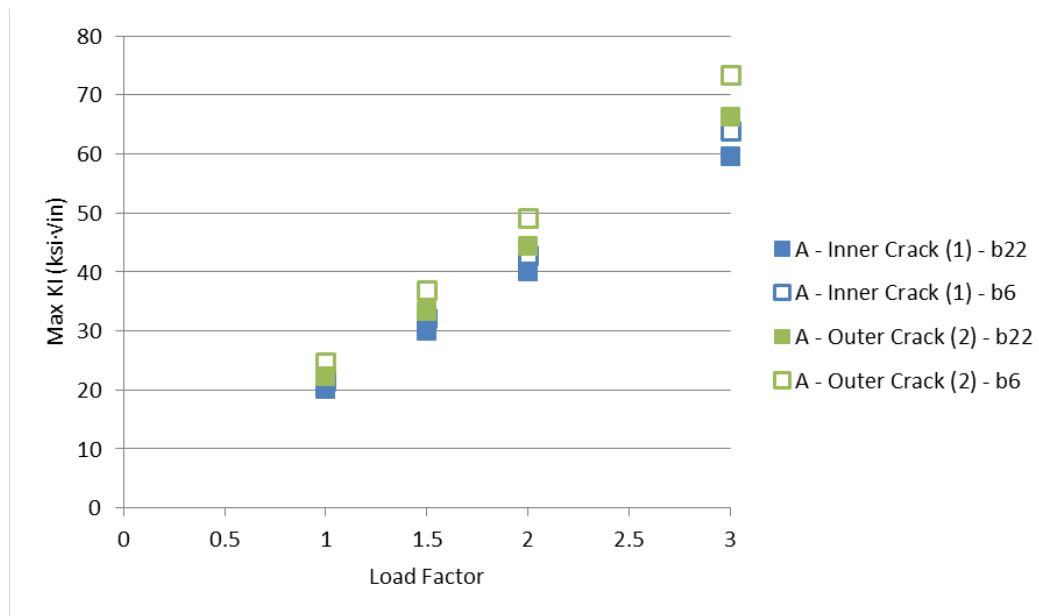
Figure 51. Maximum stress intensity factor vs. load factor for the “Stub-A” condition (Stub D fractured). ‘b22’ denotes even bolt-load distribution. ‘b6’ denotes localized bolt-load distribution. Crack depth is 4.0 mm.

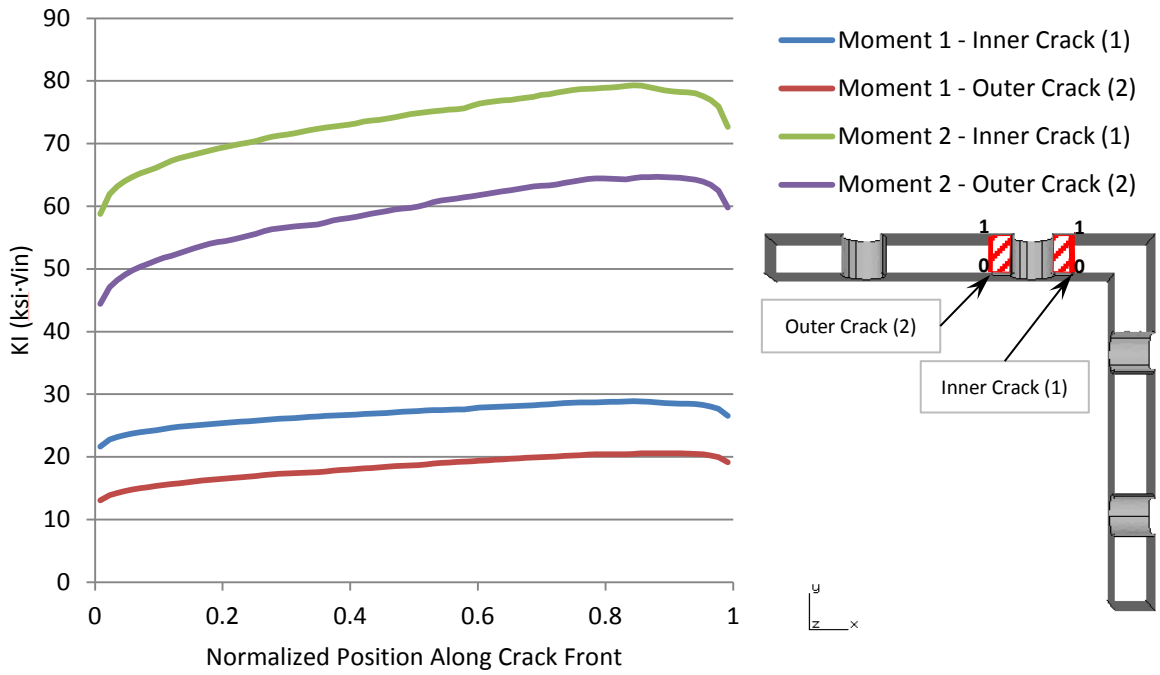
Figure 52. Stress intensity factor distributions along the crack fronts for stub-only Moment 1 and Moment 2 load cases. Normalized position along the crack front is plotted from the inside (0) to the outside (1) of the stub. Crack depth is 4.0 mm.

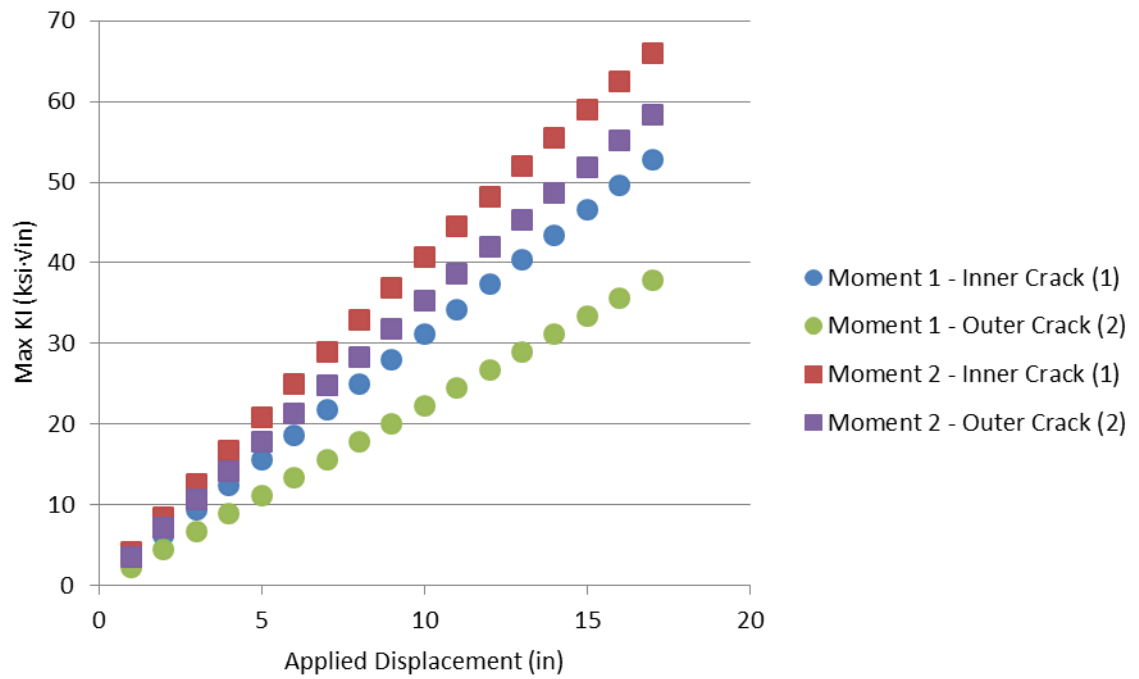
Figure 53. Maximum stress intensity factor vs. applied displacement for extended-stub Moment 1 and Moment 2 load cases. Crack depth is 4.0 mm.
