CALIFORNIA PUBLIC UTILITIES COMMISSION

Incident Investigation Report

Incident Number: G 20171127-2428

Utility: Pacific Gas and Electric PG&E

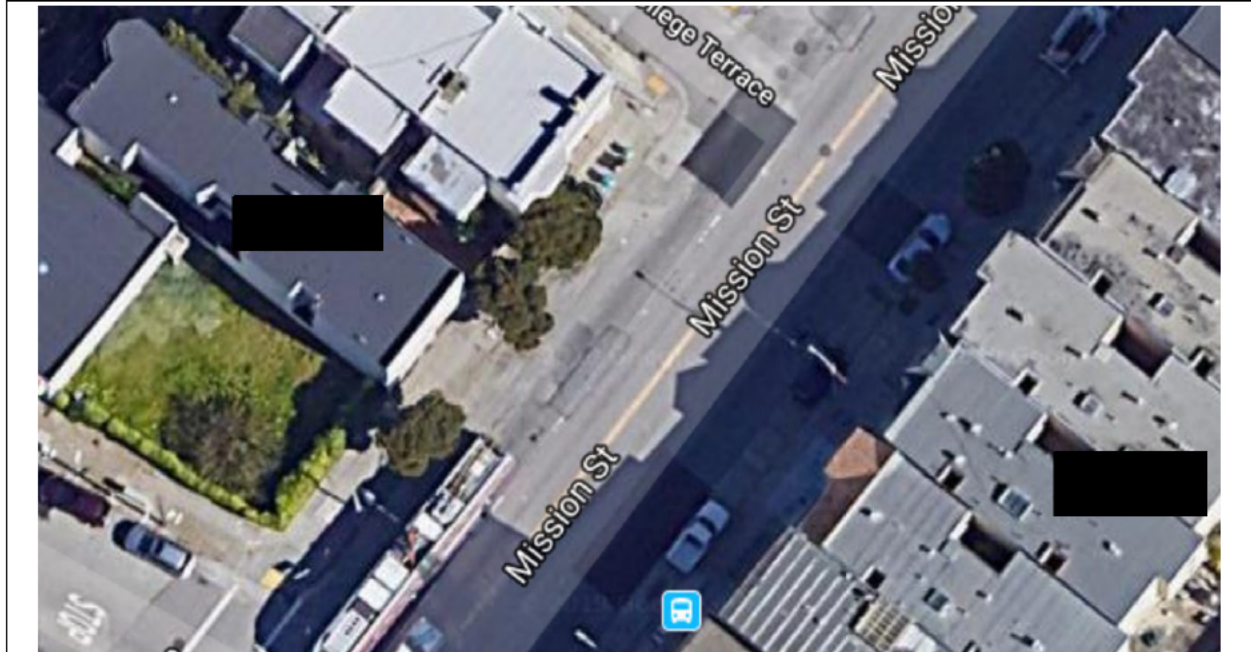
Figure 9. Google maps satellite view of [redacted] (incident house, yellow pin) and [redacted] (green pin).

incident location, as shown in Figure 8. Figure 9 shows the structure (green) that was previously serviced by the abandoned tee, as well as the location of the incident (yellow).
