SS-25 Root Cause Analysis

Webinar

CPUC Proceeding: I.19-06-016

November 1, 2019

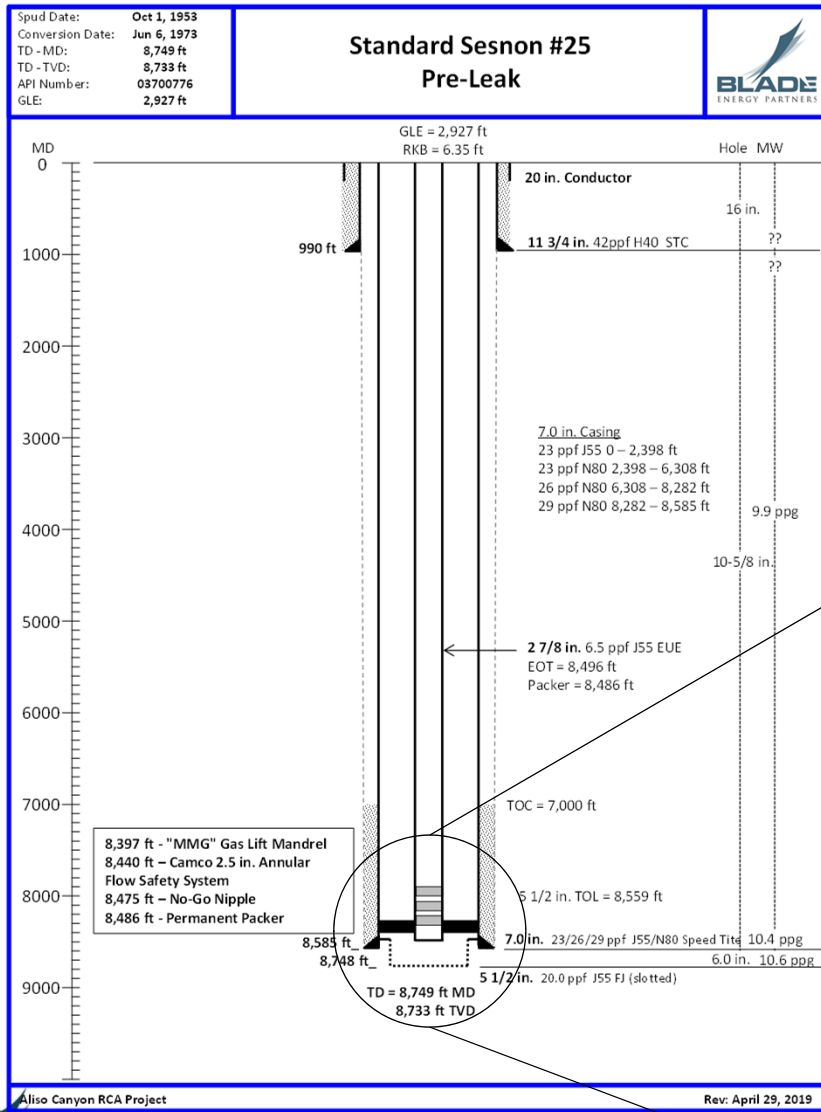
SS-25 Wellbore for Gas Storage

- Injection and withdrawal through the tubing and casing
- Casing flow was through open ports in the annular flow safety system above the packer
- 11 3/4 in. cementing problems
- No leaks or failures in SS-25 until October 23, 2015

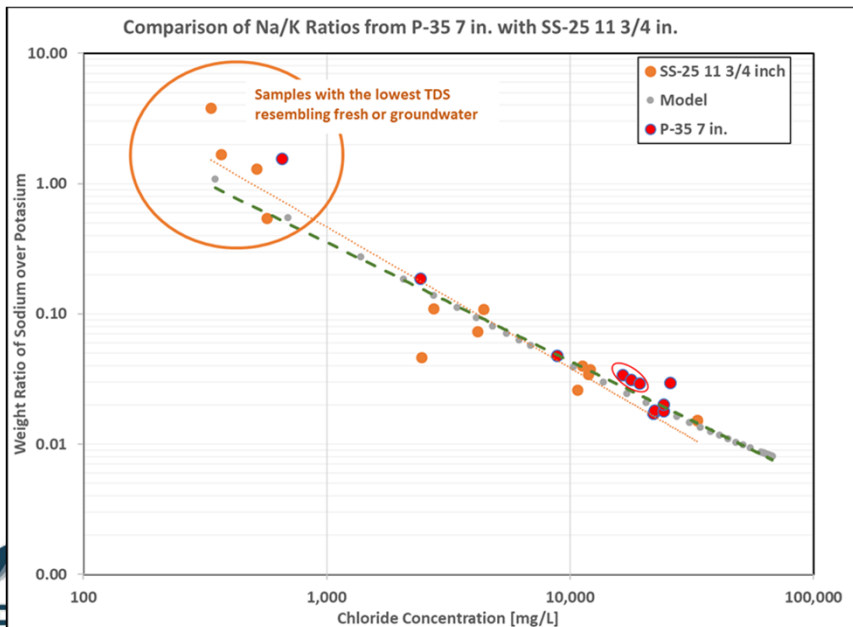
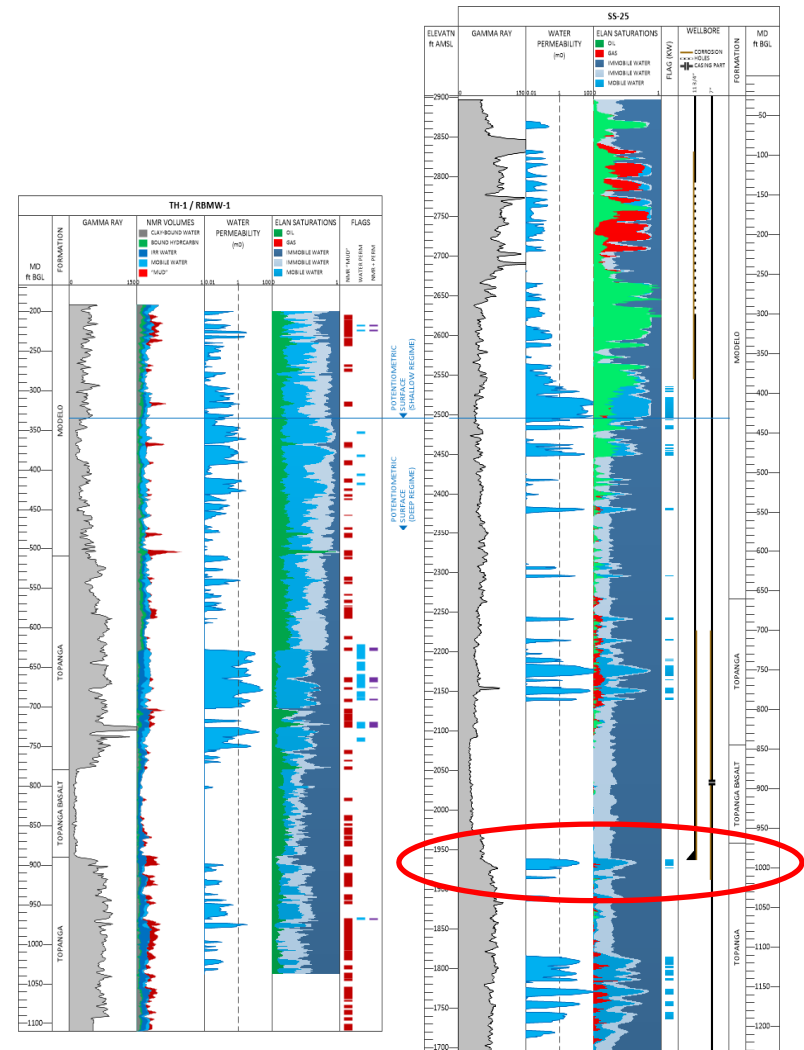
Water and Corrosive Media

- Two boreholes were drilled at SS-9 to assess location of ground water. Two distinct sources of ground water were identified.
 - Shallow (340 to 440 ft)
 - Deeper (900 to 1000 ft)
- Logged to assess the water layers
- Cased hole dynamics tester
 - Low salinity ground water clearly identified in certain samples

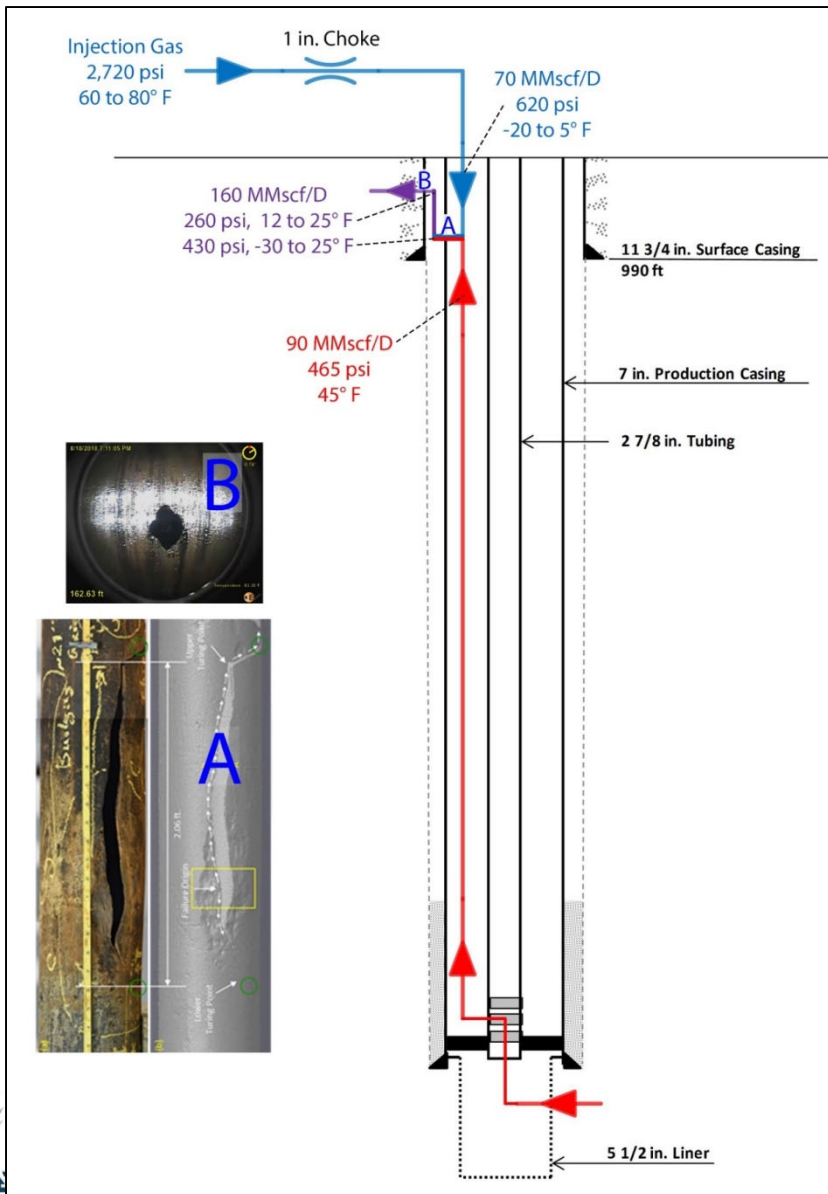
7 in. Casing Failure Sequence

October 23, 2015

- Well opened for injection between 3 and 4 AM
- Axial Rupture happened first
- Gas flow increased to a total of 160 mmscf/D
- Metal cooling resulted in brittleness and circumferential parting within hours of axial rupture
- All failures same day

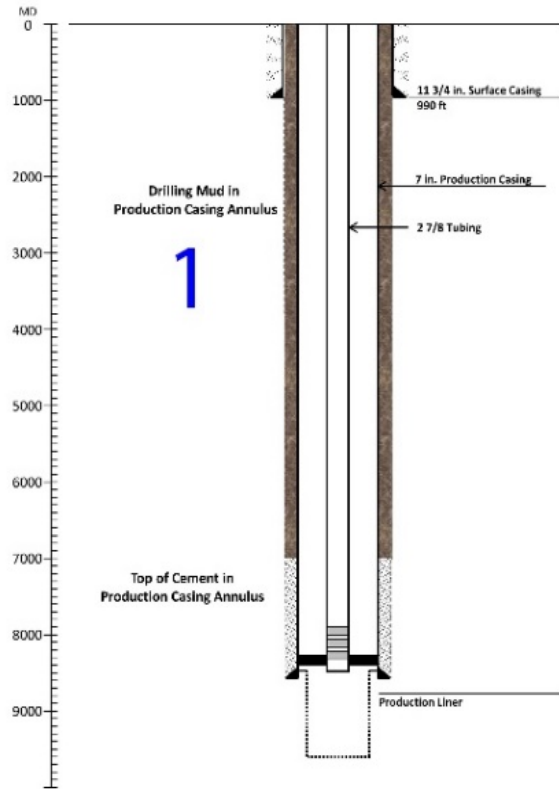
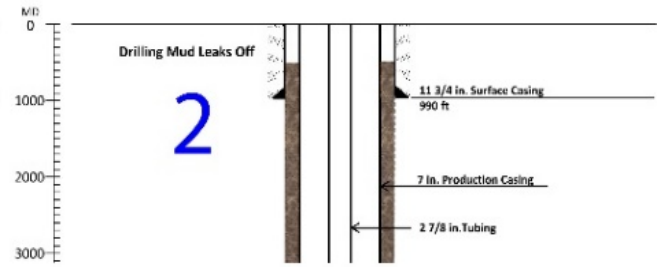
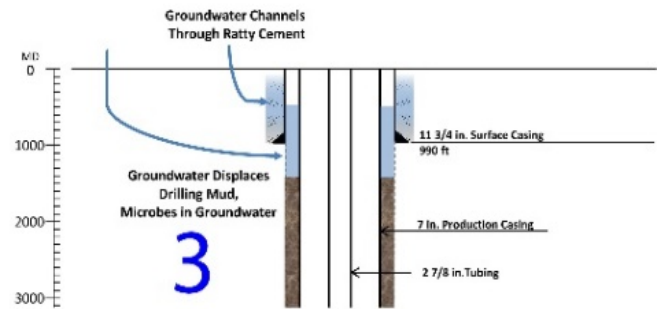
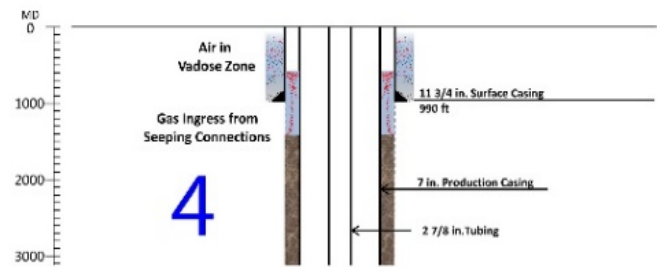
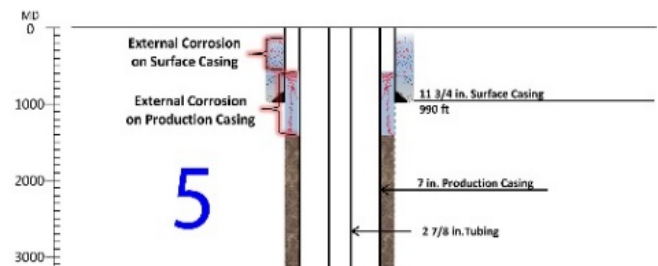
7 in. Corrosion

- Annulus groundwater ingress and egress
- Dry and wet seasons
- External corrosion due to microbes

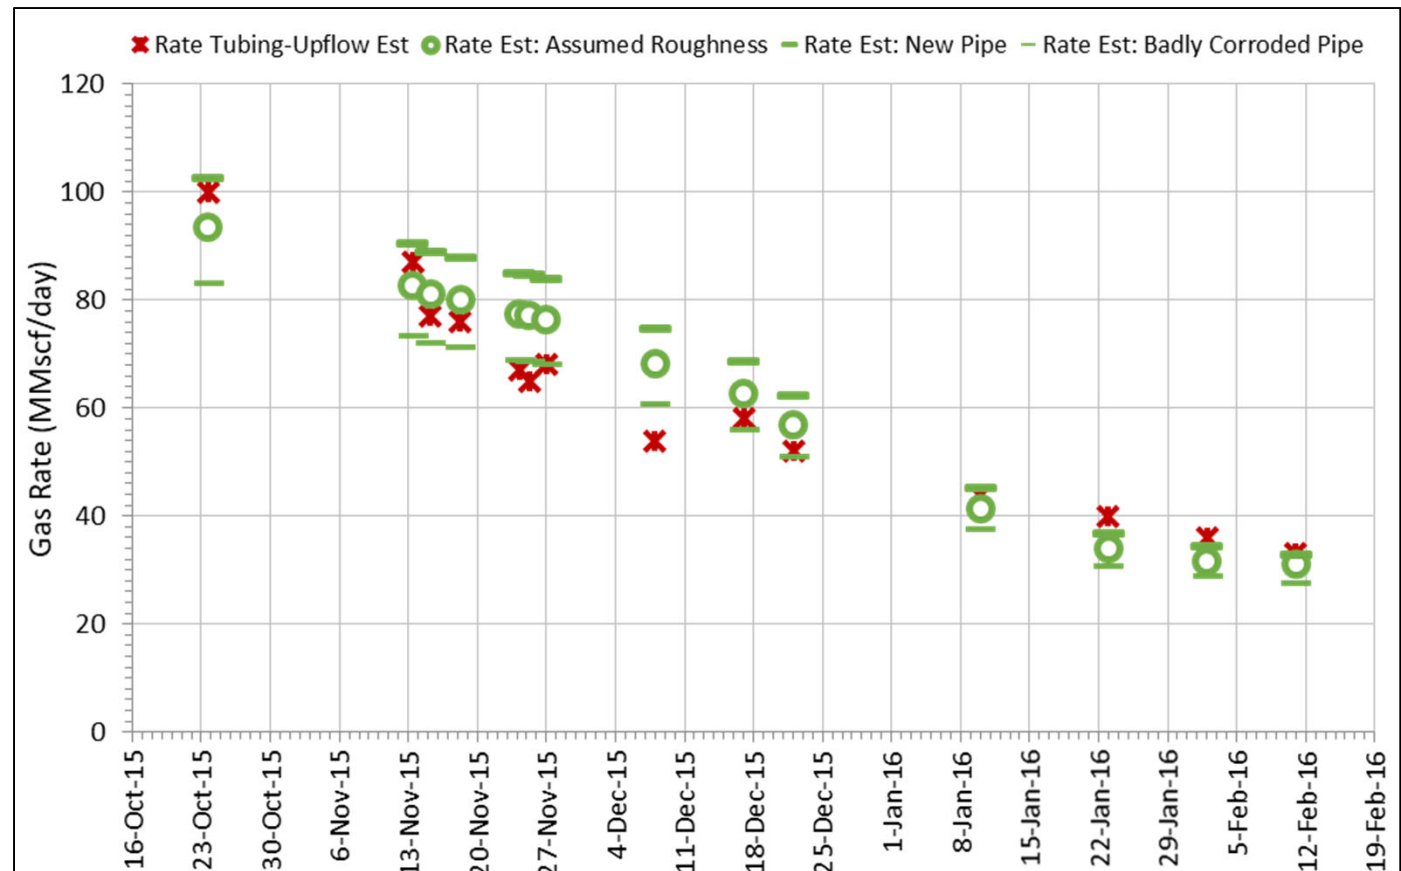
Estimated Leak Rate vs. Time Modeling

- Using flowing wellhead pressure, Shut in tubing to estimate bottom hole pressure and annulus dimensions to estimate flow rate -Upflow
- Matches the more detail Upflow-Inflow PROSPER models.

Different methods provided similar flow rates

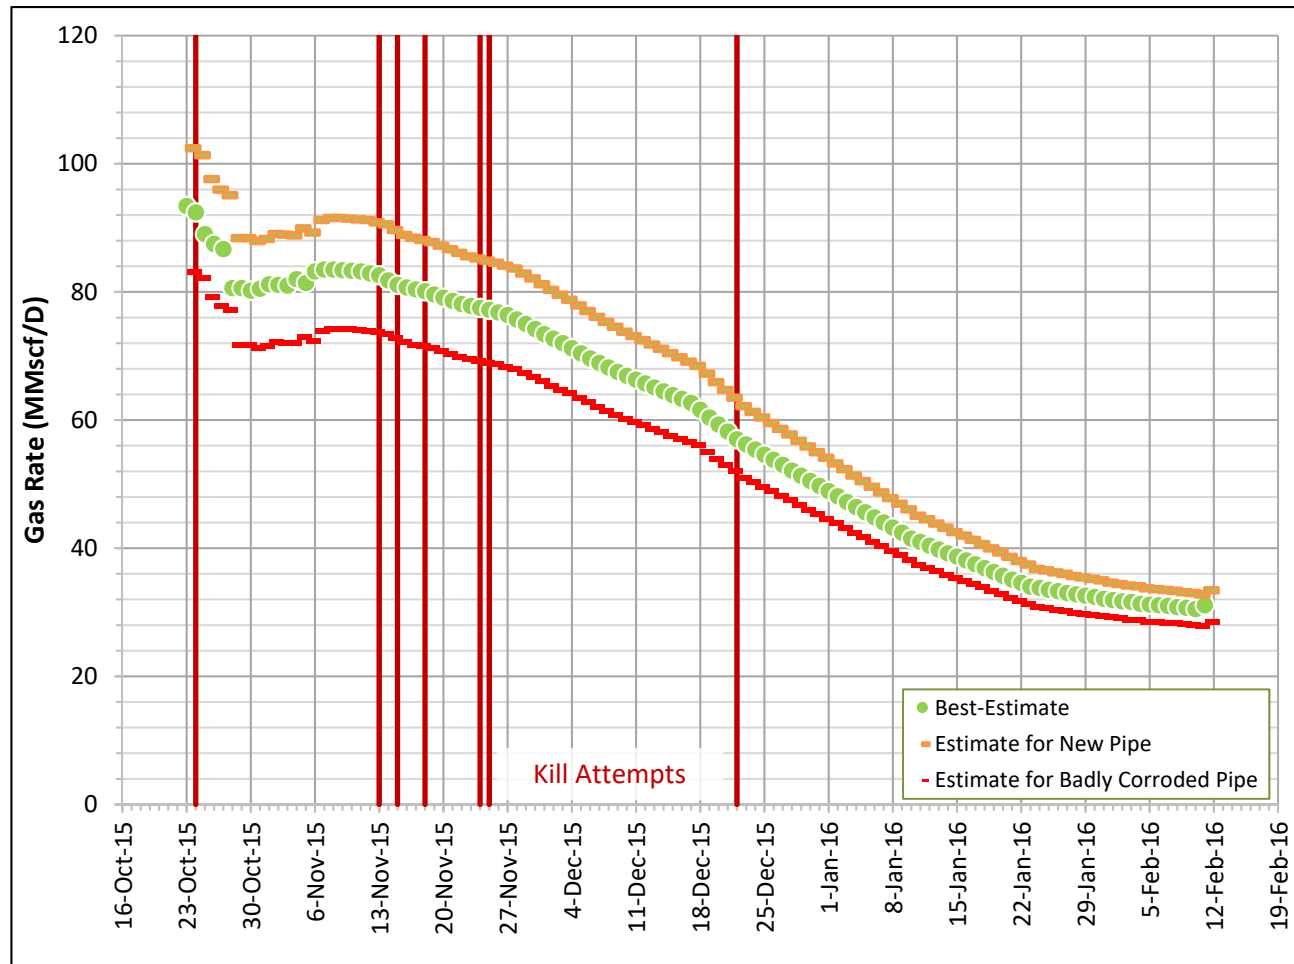
Well Flow Nodal Analysis Leak Rate vs. Time Modeling

Flow rates during each kill attempts essential for appropriate Kill Modeling

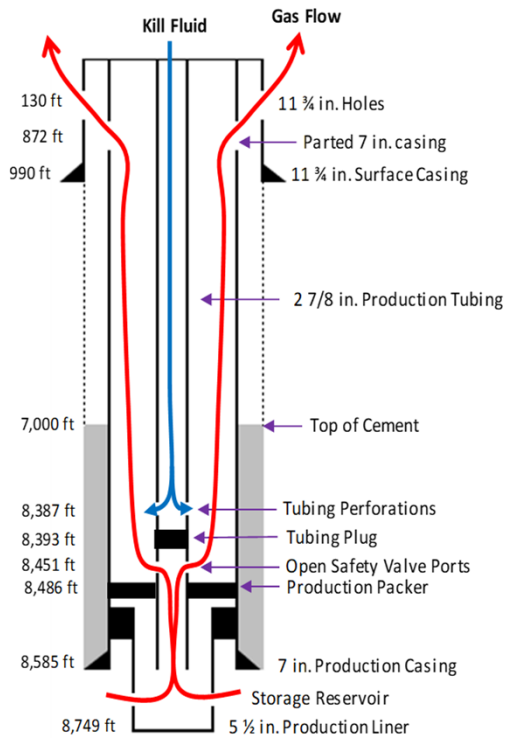
SS-25 Kill Attempts

- Drillbench Blowout Software was used for the modeling
- Kill attempt 1 – 6 used low density fluid, 8.3 – 10 ppg at 5 – 13 bpm
- Kill modeling predicts a kill was possible with 12 – 15 ppg fluid at 6 – 8 bpm
- No evidence of kill modeling through Kill attempt 6
- Kill attempt 7 was distinctly different and nearly successful; however conditions had deteriorated on location and was not safe to continue

Modeling and Assessment demonstrate that Kill could have been successful with heavier fluids at a higher pump rate

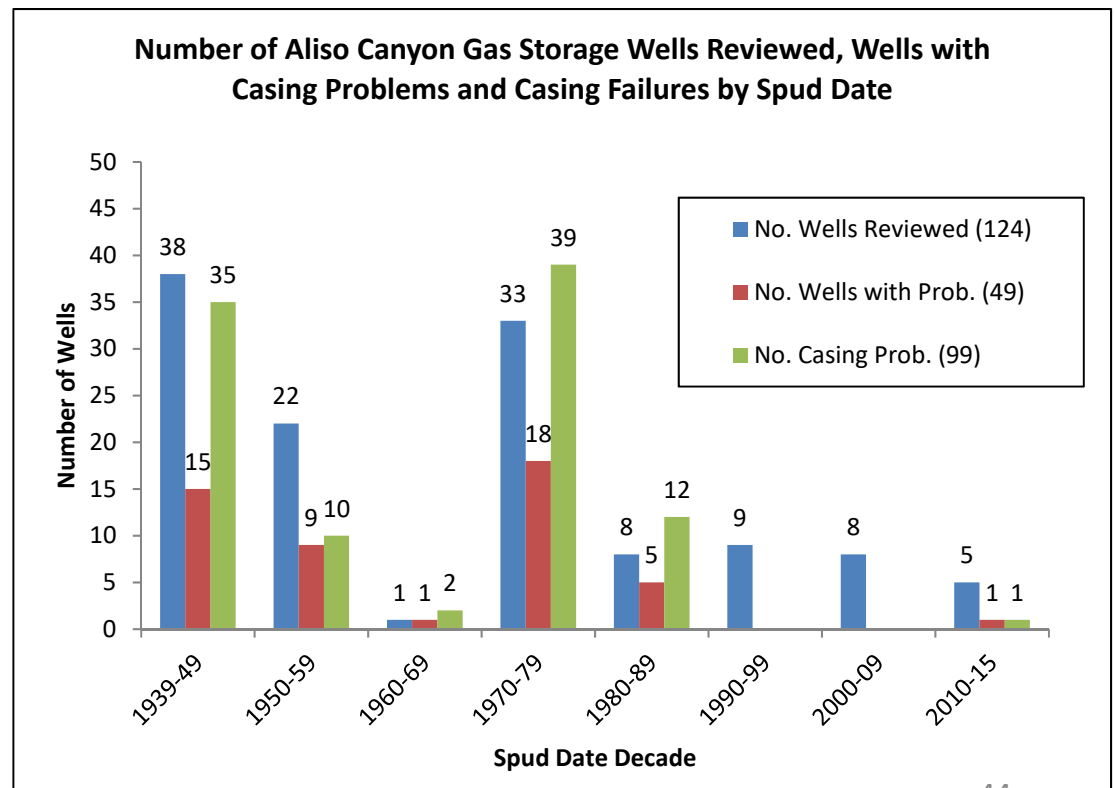
Aliso Canyon Historical Casing Failures

- 124 gas storage wells were evaluated for casing integrity
- 49 wells had casing failures
- 99 failures (63 casing leaks, 29 tight spots, 4 parted casing, 3 other)
- Repairs executed
 - Squeeze cementing
 - Inner casings
 - Scab liners
 - Casing patches
 - P&A
- No failure analysis reported
- No patterns of failures
 - Wide range of depths
 - Field wide failures

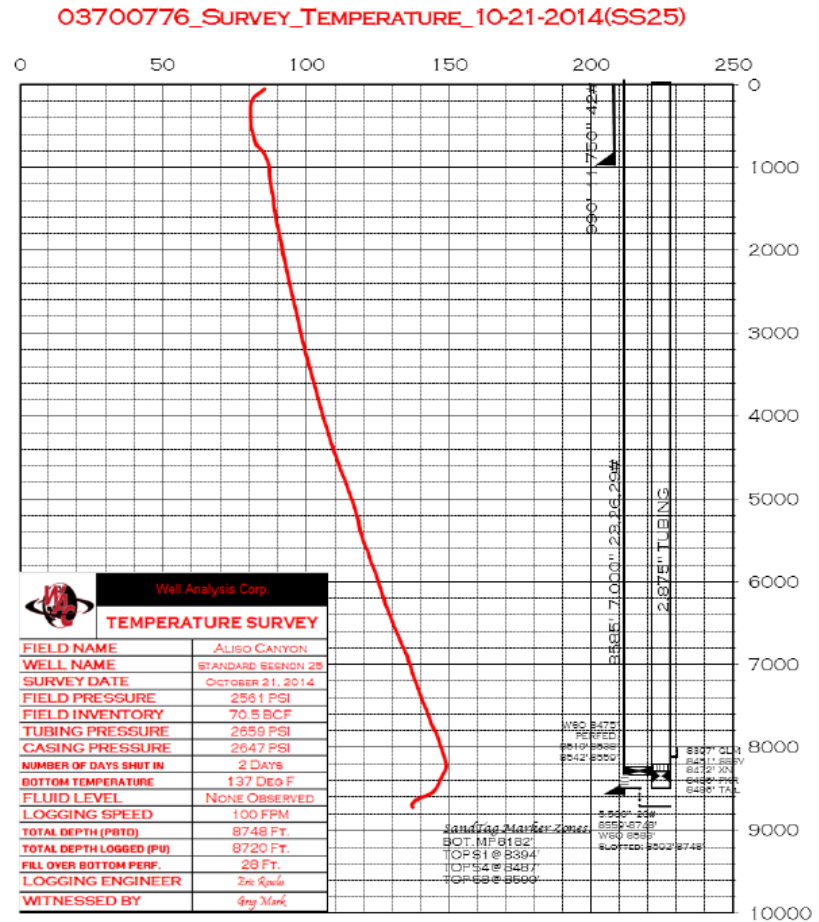
SS-25 Temperature Survey October 21, 2014

- Regulations required annual temperature surveys
- SS-25 complied with the requirements.
- No temperature anomalies--similar to previous surveys

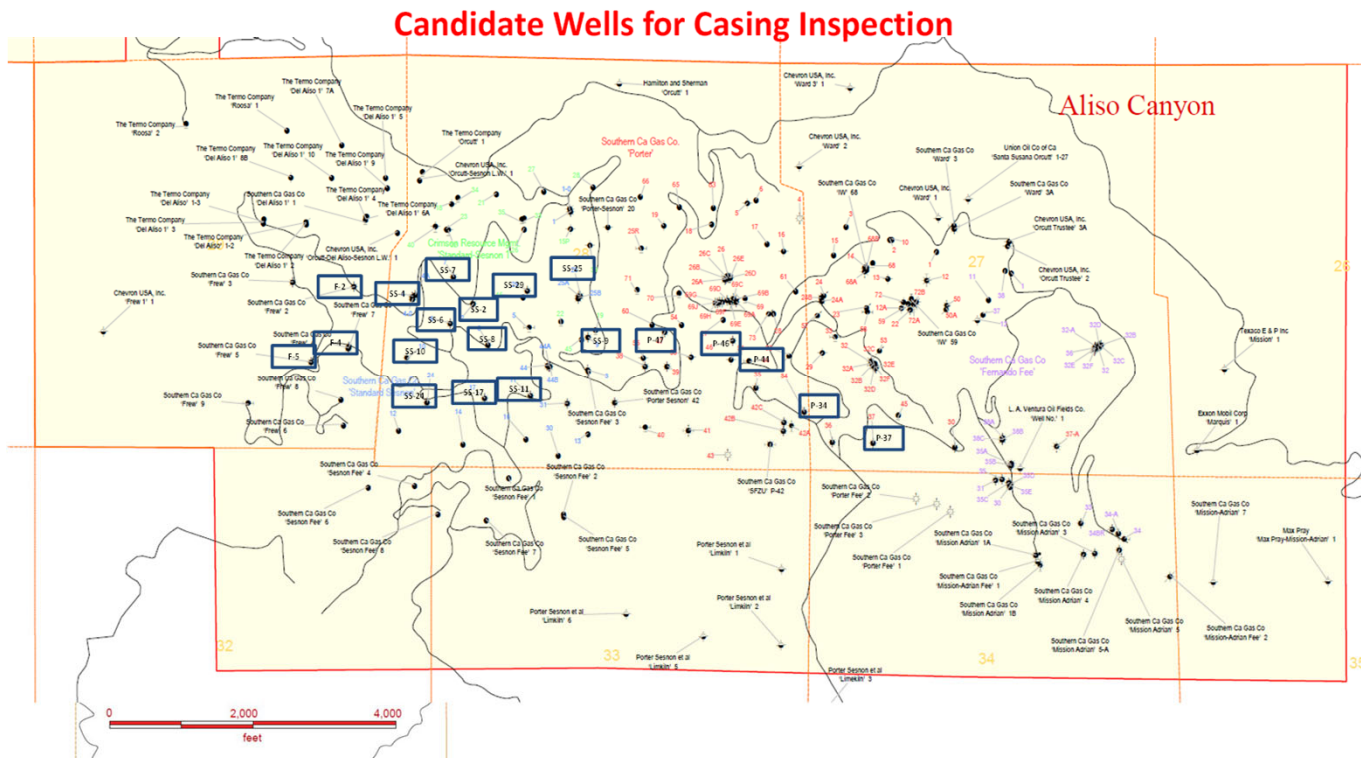
1988 Memo for Casing Inspection of 20 Wells

- Plan to log 20 wells (SS-25 was on the list as low priority)
- 7 wells were logged within 2 years; 5 wells showed external wall loss from 20 – 60%
- Inspection logs were not run in SS-25
