**CALIFORNIA PUBLIC UTILITIES COMMISSION**  
**Safety and Enforcement Division**  
**Electric Safety and Reliability Branch**

**Incident Investigation Report**

**Incident Number:** E20191030-01

**Location of the Incident:** 3505 Gateway Road  
Bethel Island, CA  
County: Contra Costa County

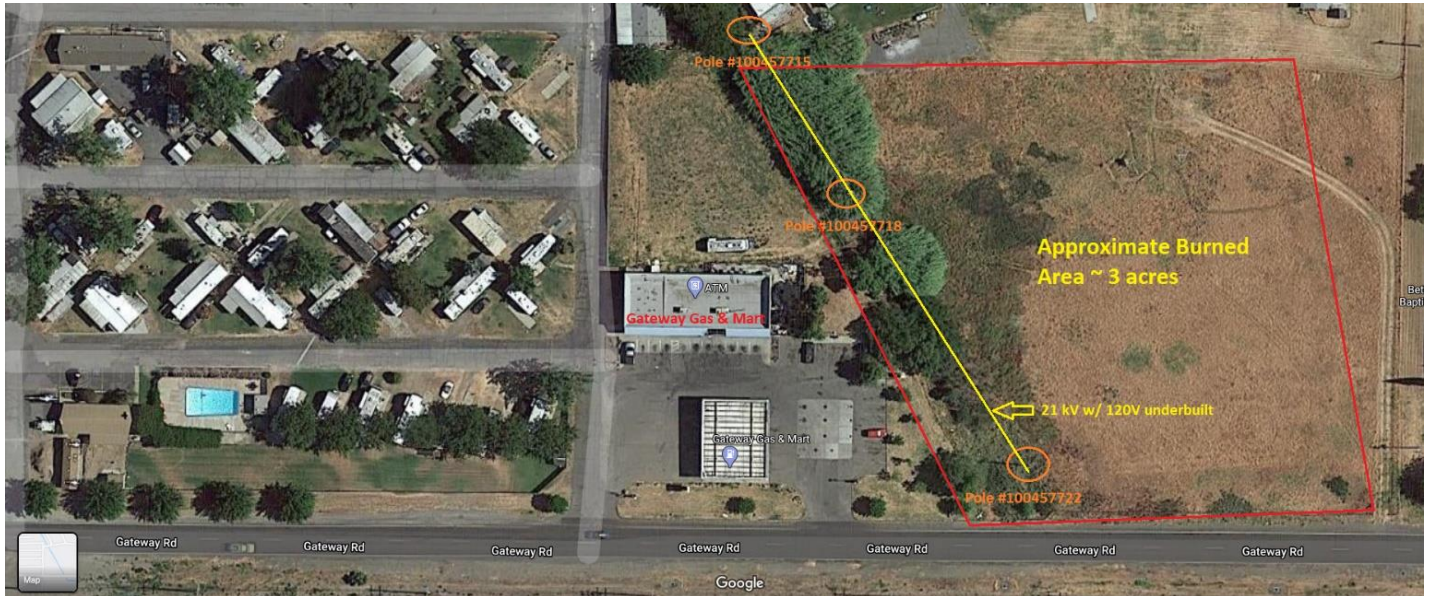
Figure 1: Google satellite image of the Gateway Gas & Mart and adjacent burned area.

PG&E's Brentwood 2112 is a 21 kV 3-phase overhead distribution circuit that spans across the burned area (see Figure 1). The circuit has a single split-phase 120/240V secondary underbuilt in rack configuration (see Figure 2). Several wooden poles, including Pole #100457718, were in the burned area. Pole #100457718 has two transformers. The large transformer steps power down from 21 kV to 3-phase 120/240V to serve the Gas & Mart via a quadplex service drop (three-phase neutral); the Gas & Mart has commercial refrigerators with large motor load that would require 3-phase power (instead of single-phase). The small transformer steps power down from 21 kV to a single split-phase 120/240V secondary (two hot legs plus neutral) to serve homes at the Santiago Mobile Home Park to the north of the incident location.
