The Safety and Enforcement Division (SED) of the California Public Utilities Commission conducted a **General Order (G.O.)112-F Comprehensive Operation and Maintenance Inspection of Southern California Gas Company (SoCalGas)'s Aliso Canyon Natural Gas Storage Field** Aliso Canyon (Inspection Unit) on April 5 through April 9 of 2021 for calendar years 2018 through 2020. SED conducted records review and field inspection of pipeline facilities in the Aliso Canyon area within the Inspection Unit.

SED staff identified one (1) notice of probable violation and four (4) areas of concern. Attached are SoCalGas' written responses.

2021 Aliso Canyon Natural Gas Storage Inspection
4/05/2021 to 4/09/2021

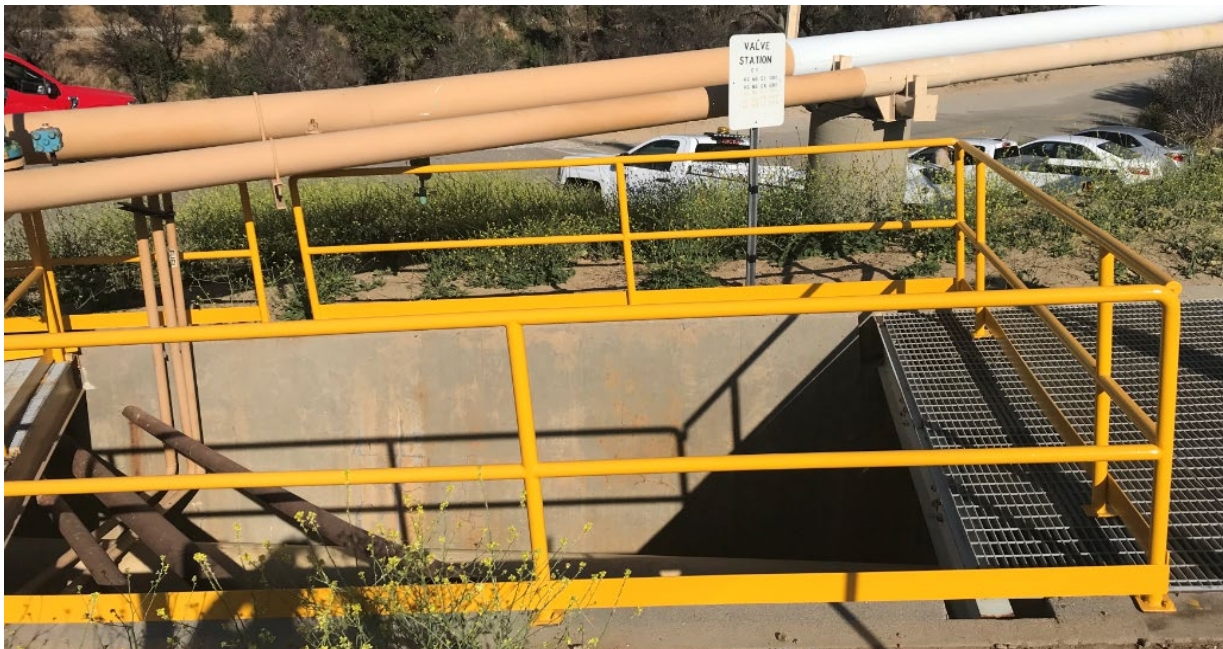
1. During the field inspection of Aliso Canyon facilities, SED observed that vault #5025-C-1 did not have fall protection system such as vault cover or guardrail to assure that the vault condition does not present a safety hazard to SoCalGas' employees and the public.
49 CFR §192.749 Vault Maintenance, Item (d) states:

SED finds SoCalGas in violation of G.O. 112-F, Reference Title 49 CFR, Part 192, §192.749(d) for failing to adequately protect its employees and the public from the potential safety hazard of falling into a vault and failing to provide an appropriate protection system to prevent such an occurrence.

As previously communicated to the SED on April 23, 2021, SoCalGas has installed a guard rail around the open end of the pipe trench at C-1 Valve Station. Below is a more recent photograph taken, after the guard rail was painted.
